KAREN LOOMIS, DAVID CALDWELL, JIM TATE, TICCA OGILVIE
AND EDWIN J. R. VAN BEEK

The Lamont and Queen Mary Harps

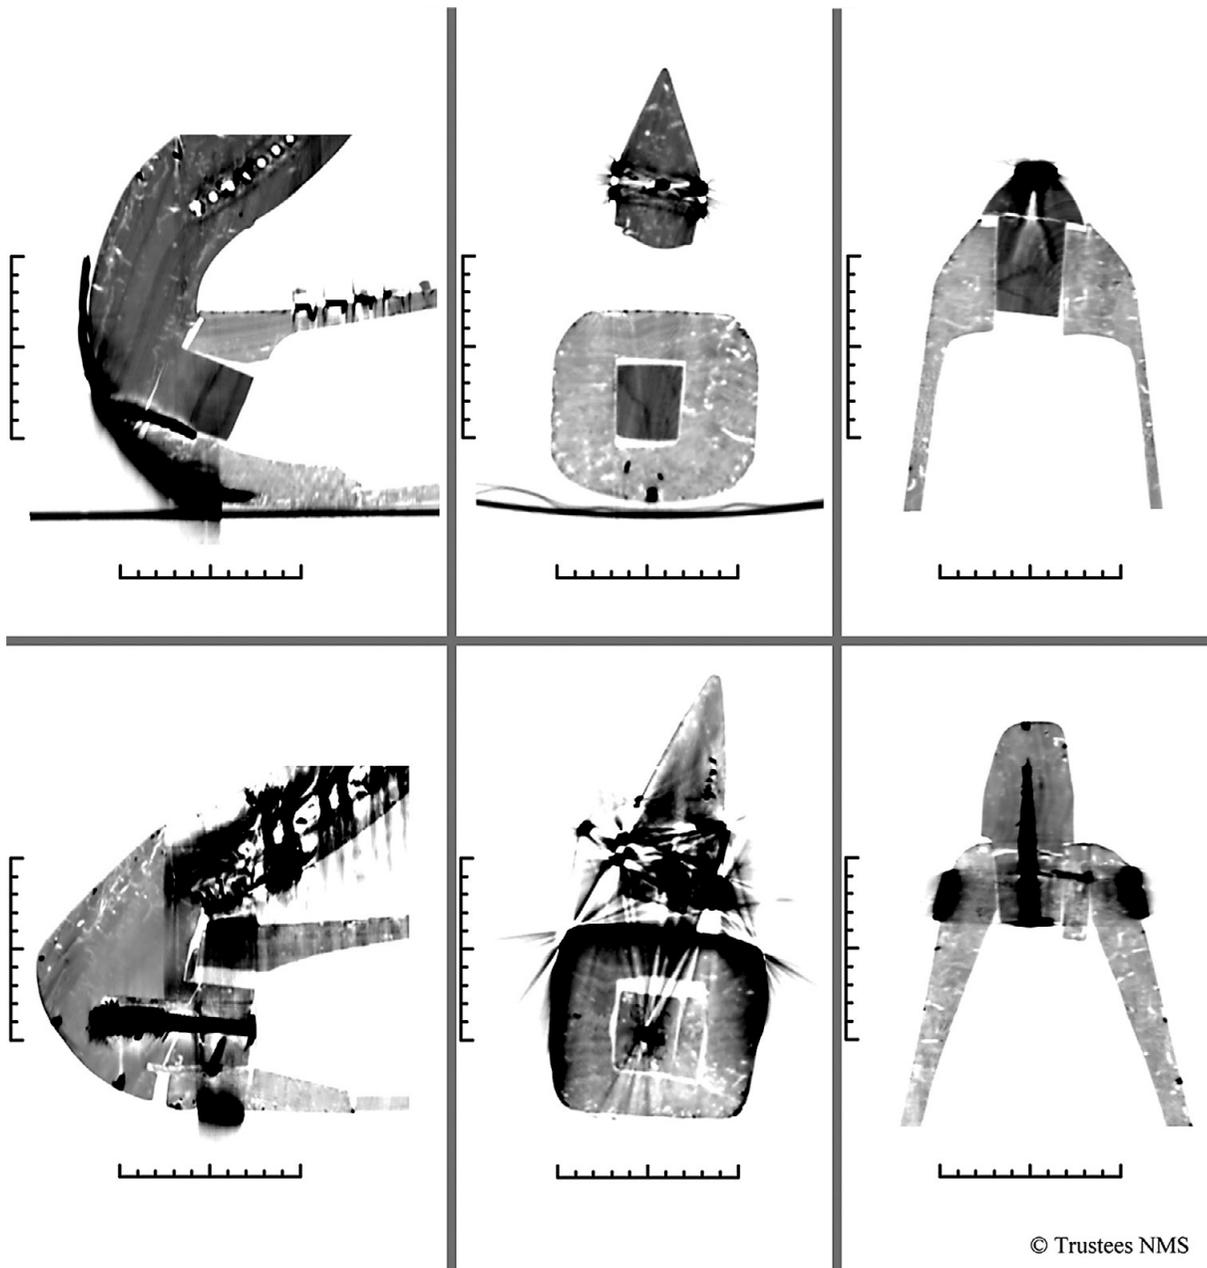
Figure 3. Three orthogonal views of the neck joint at the soundbox for the Queen Mary harp (top) and the Lamont harp (bottom). These tomograms are (from left to right) sagittal, axial, and coronal views (sideways, end on, and parallel to the top of the soundbox, respectively). Both harps have visible damage and repair work to this joint; scale: 1 tick: 1cm.

be cut at a slight forward angle, such that the back of the box is a little higher than the front. The face of the neck that seats against the box is likewise cut at an angle, and the tenon is cut at a slight angle to this face. When seated in the joint it is parallel to the long axis of the box.

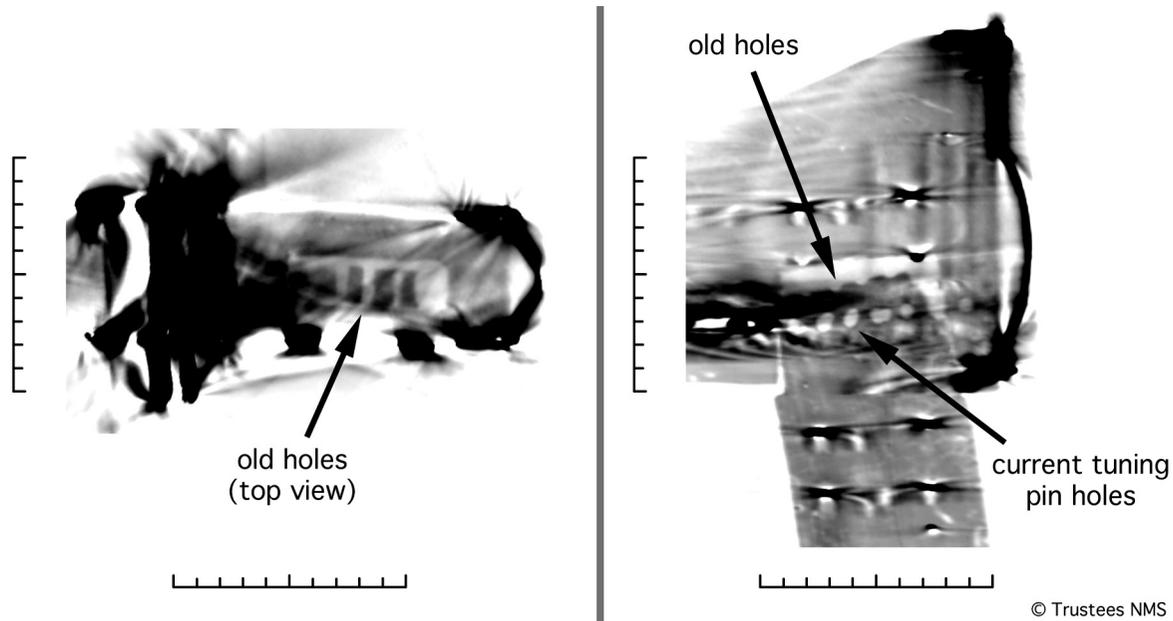
Figure 7. Two tomographic views of the forepillar tenon of the Lamont harp in the joint with the neck. The left-hand image is the view looking down from above the end of the tenon. The right-hand image is the view from the side. There appear to be the remnants of a second set of tuning pin holes on the end of the tenon. Scale 1 tick: 1cm.

At the top end of the forepillar, where it joins with the neck, hidden damage and repair to the forepillar tenon were discovered on the tomograms of the inside of the joint. On both the Queen Mary and Lamont harps, the tuning pin holes pass through the tenon in this joint. These holes are visible in the tomograms. On the Lamont harp, however, in addition to the expected line of tuning pin holes, the end of the tenon is scalloped by what appears to be the remains of a second line of holes, 1.7cm above the others (Figure 7). A possible explanation for this is that the original end of the tenon sheared off through the perforations created by these holes, and that the tenon was re-cut and resealed in the joint.

The damage to the tenon may have been caused by the lateral force applied to the joint by the twisting of the neck towards the left side of the harp as a result of the string tension. There are two large brass straps placed across this joint on the right-hand side of the forepillar. They are each affixed to the neck and forepillar with four large rivets, and prevent any further motion of the neck in this direction. Examination of the other side of the forepillar shows that the rivets have not been repositioned. If the tenon was re-cut and the forepillar shifted up by 1.7cm, these straps must have been put on the harp after the repair was completed. This is an interesting and potentially important point, as the Irish harp depicted by Praetorius in his *Syntagma musicum* and the Ballinderry harp fragments in the National Museum of Ireland are both equipped with similar straps in the same location.³⁶

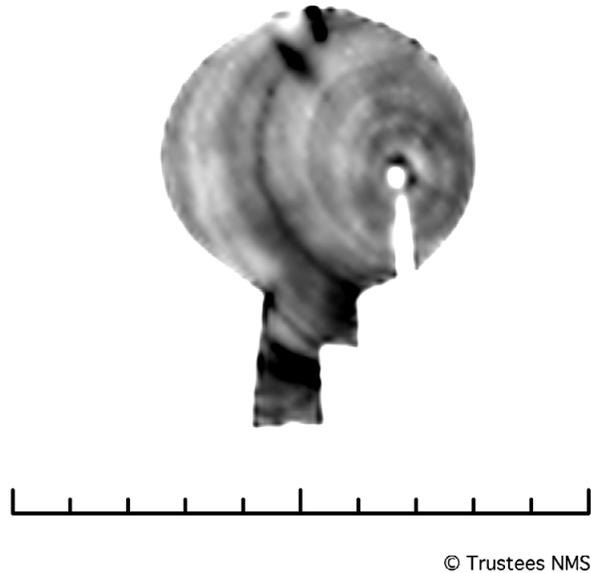
The forepillar is carved from a timber that includes the centre of the wood, and the pith is visible in the tomograms (Figure 10). The curvature of the forepillar closely follows the grain of the wood, which is itself curved, so it is likely that this member was fashioned from a curved limb. A crack 19cm in length on the left side of the T-section opens up from the pith at the centre of the wood and follows the grain. This is undoubtedly an instance of 'checking' as a consequence of including the centre of the wood in the finished piece. A 10cm cut-out section on the left side underneath the T-section has a crack at the back which is not related to the larger crack in the T-section. Traces of what appears to be glue can be seen in the tomograms of this smaller crack.

Figure 10. Tomographic slice across the forepillar of the Queen Mary harp. The growth rings of the wood are visible, and the pith can be seen to the right of centre in the forepillar. Some checking is also apparent. Scale 1 tick: 1cm.

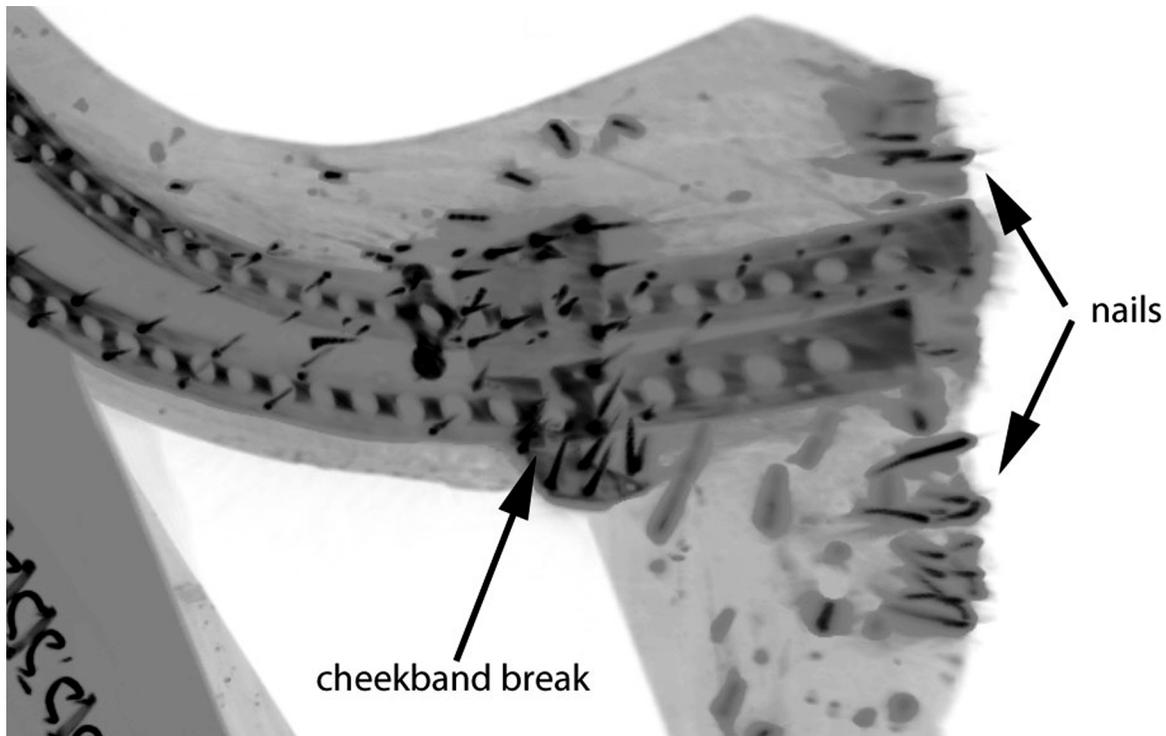
Figure 12. Tomographic three-dimensional projection of the end of the neck of the Queen Mary harp, where it joins with the forepillar. This three-quarter view shows the break in the cheekband and the long nails in the forepillar and neck end. These reportedly once held gold medallions with a portrait of Mary Queen of Scots and the arms of Scotland.

embedded in the wood along the sides and at the end of the neck at the forepillar as may be seen in Figure 12. The nails at the end of the neck extend 1–1.5cm into the wood. Internal cracks extend from two of the nail ends and follow the grain of the wood. These may have been caused by the nails, but similar cracks near the end of the neck where it joins with the forepillar are not associated with any nails. One moderately sized crack runs diagonally through the 25th tuning pin hole. On the right side of the neck, a metal patch is nailed over the cheek band at the 24th tuning pin hole. Armstrong noted this in his description of the Queen Mary harp and suspected that the patch was covering a break in the cheekband, based on the visible jog in the otherwise smooth curvature of the band.⁵⁴ Indeed, the tomograms reveal a clear break in the cheekband underneath the patch (Figure 12). Armstrong also suggested that the cracks in this end of the neck might have been the result of the forepillar pushing up on the end of the neck, which is being pressed against it by the tension of the strings.⁵⁵ The internal cracks visible in the tomograms tend to support this theory. Farther up the neck, towards the treble end of the harp, there are additional internal cracks. In the middle section of the neck, where the angle of the line of tuning pin holes is closely aligned with the direction of wood grain, a crack runs from the 8th or 9th hole to the 16th hole (Figure 8). It extends almost completely through the wood in places. The presence of the metal cheek bands may have prevented this section of the neck from sheering off under the tension of the strings. The cheek bands themselves are thin plates found upon analysis with XRF to be of a copper zinc alloy, with a high copper content.⁵⁶ One of the tuning pins has also been analyzed and found to be of nearly the same composition.

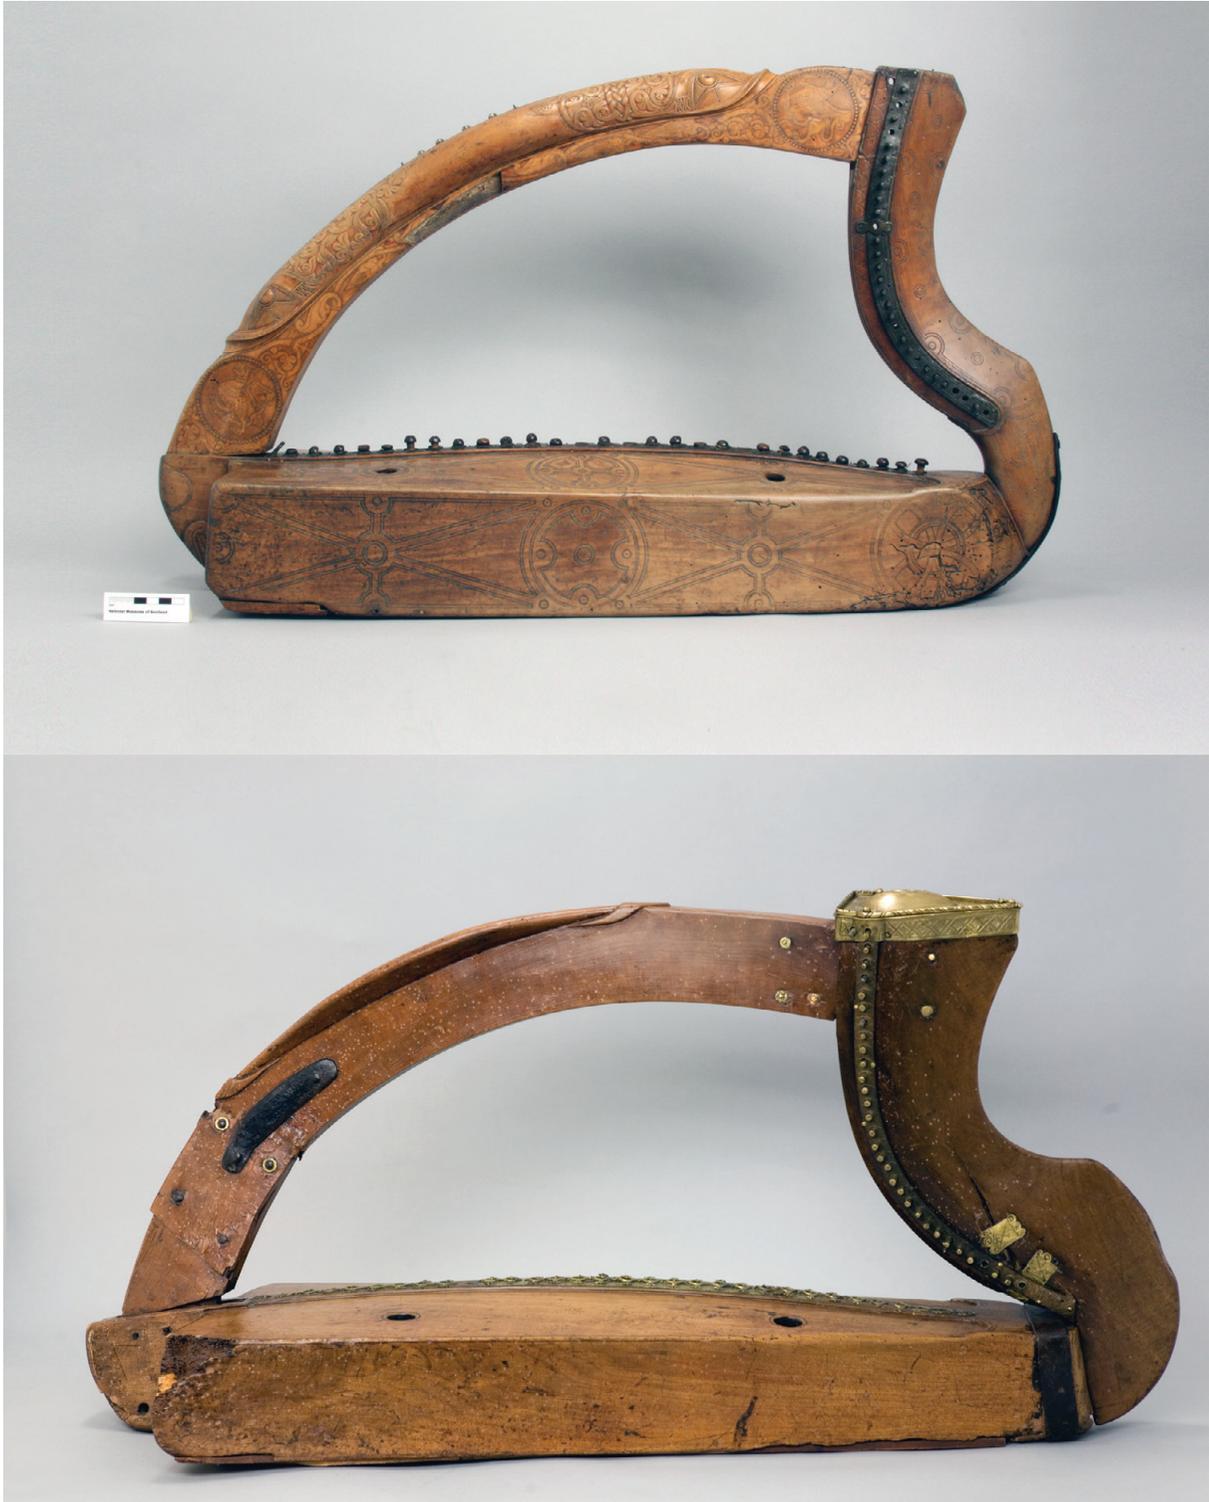
The forepillar of the Lamont harp displays prominent and dramatic visible damage and repair work. The forepillar is broken and has had the bottom portion replaced below the T-section (see Figure 1 in the colour section). The replaced section is joined to the original part of the forepillar by a scarf joint secured by four rivets and a pair of iron straps, as discussed by Armstrong.³² The forepillar is depicted with this break and repairs in engravings made for John Gunn's 1807 treatise on the Lamont and Queen Mary harps.³³ Visible damage to the wood at the scarf joint resulting from pivoting of the joint indicates that the harp was brought up to tension after this joint was made, suggesting that this is an old repair made during the working life of the instrument.³⁴

Figure 1. The Queen Mary harp (top) and Lamont harp (bottom), two of the earliest surviving Gaelic harps. The bottom photo shows damage and repair to the forepillar of the Lamont harp. Both harps are shown at the same scale. (National Museums of Scotland, Edinburgh) Top photo: K. Loomis; bottom photo: M. Goodwin. © Trustees NMS.

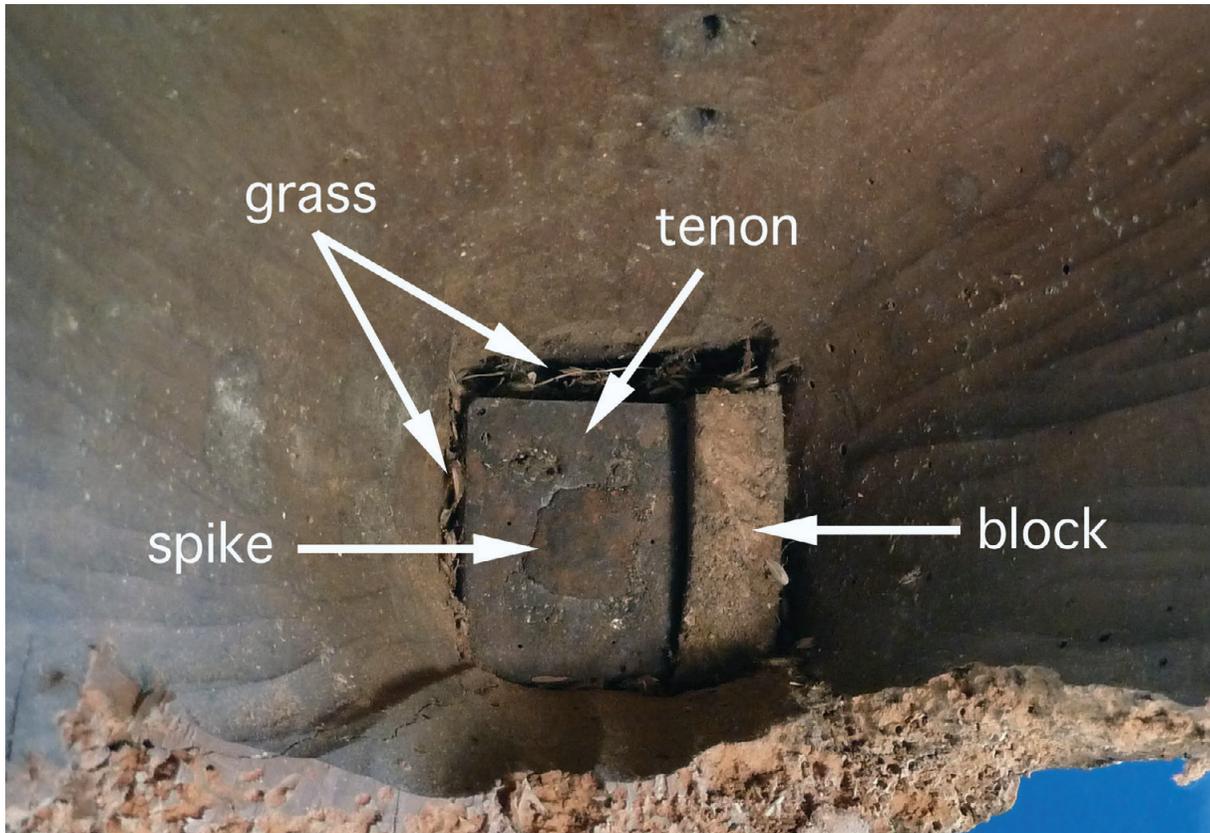
The back cover of the soundbox was removed and the interior examined and photographed (Figure 4

in the colour section). The inside of the soundbox had previously been examined by Hobrough, who described the following important findings in a report to the National Museum of Antiquities of Scotland: the tool marks; the undercutting of the treble end of the box; the visible interior portion of the neck joint (with repair work and grass); the damage and repair at the bass end of the box; and marks left by the string

The inside surface of the soundbox is smooth up to the point at the treble end at which the original opening in the back of the box would have terminated (the opening has enlarged due to extensive damage to the wood). The remainder of the box has been undercut up to the joint with the neck. The inside surface at this end is covered with long gouge marks aligned with the long axis of the box. Evidence from the tool marks suggests that at least two sizes of gouge were used. The ends of the gouge marks extend into the smoothed area of the box, indicating that at least some of the gouge work was undertaken after the surface of the rest of the box had been smoothed. There are also numerous indentations that appear in circular patterns around the string holes on the inside of the soundbox (see Figure 5 in the colour section). These indentations are on average 2.5cm in length, and were probably made by string toggles, as they are consistent with their expected size, shape and location. An initial count taken around a few representative holes places the number of toggle marks at approximately 30 to 40, but a closer examination will be undertaken to get a more precise count. These marks are an important clue to the age of the instrument, as they are a direct indication of the number of times the strings have been replaced. Closer in to the string holes, there are other indentations that appear to be from wire strings. There are also verdigris stains associated with some of these wire indentations, indicating that copper alloys were used for at least some of the wire stringing for this harp. It should be noted here that the bottom string hole in the bass, #32, does not appear to have any toggle or wire marks around it. The top string hole, #1, also does not appear to have any toggle or wire marks around it. String hole #2 has some toggle marks, but fewer than the other string holes (approximately 12–16, but this is a very rough estimate). The neck of this harp is cracked through the top two tuning pin holes, and Armstrong notes that these two tuning pins were probably not usable after the crack formed.¹⁷ There may be a link between this and the number of toggle marks around string

Figure 4. Interior of the soundbox of the Lamont harp showing toolmarks and repairs to the neck (photo by Karen Loomis, courtesy National Museums Scotland).

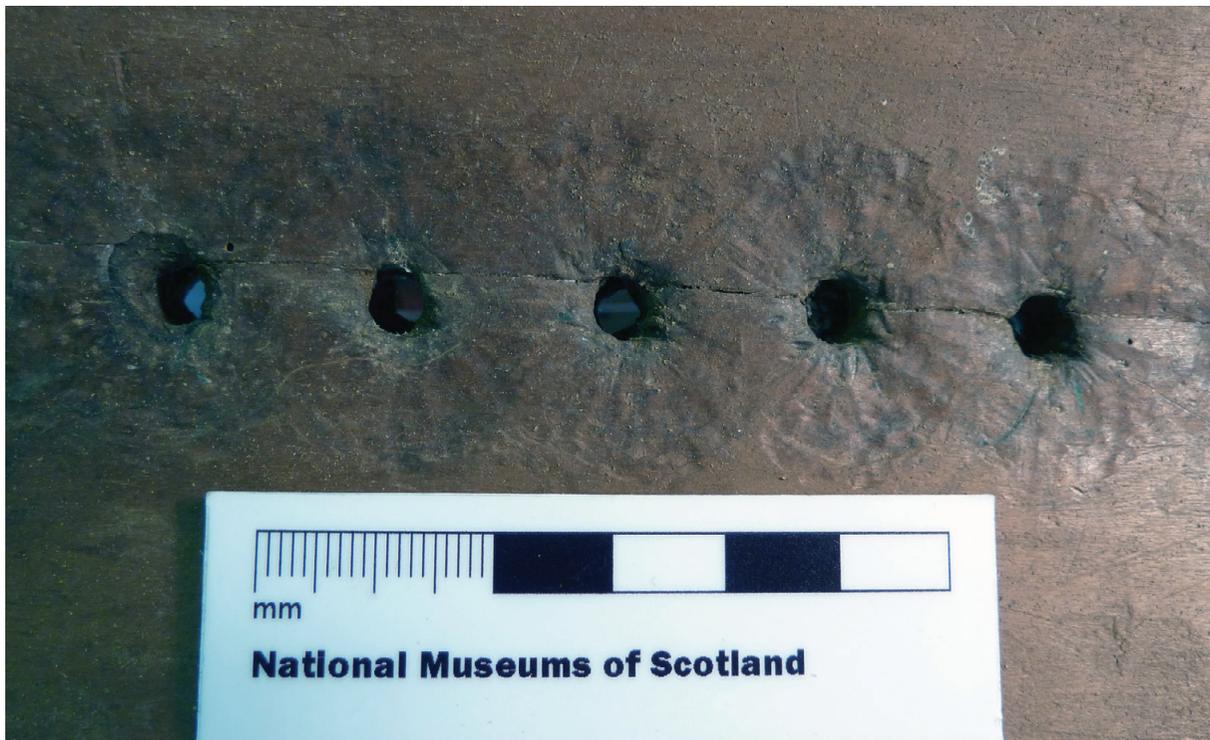
Figure 5. String toggle indentations, wire impressions, and verdigris stains around the string holes on the inside of the soundbox of the Lamont harp (photo by Karen Loomis, courtesy National Museums Scotland).

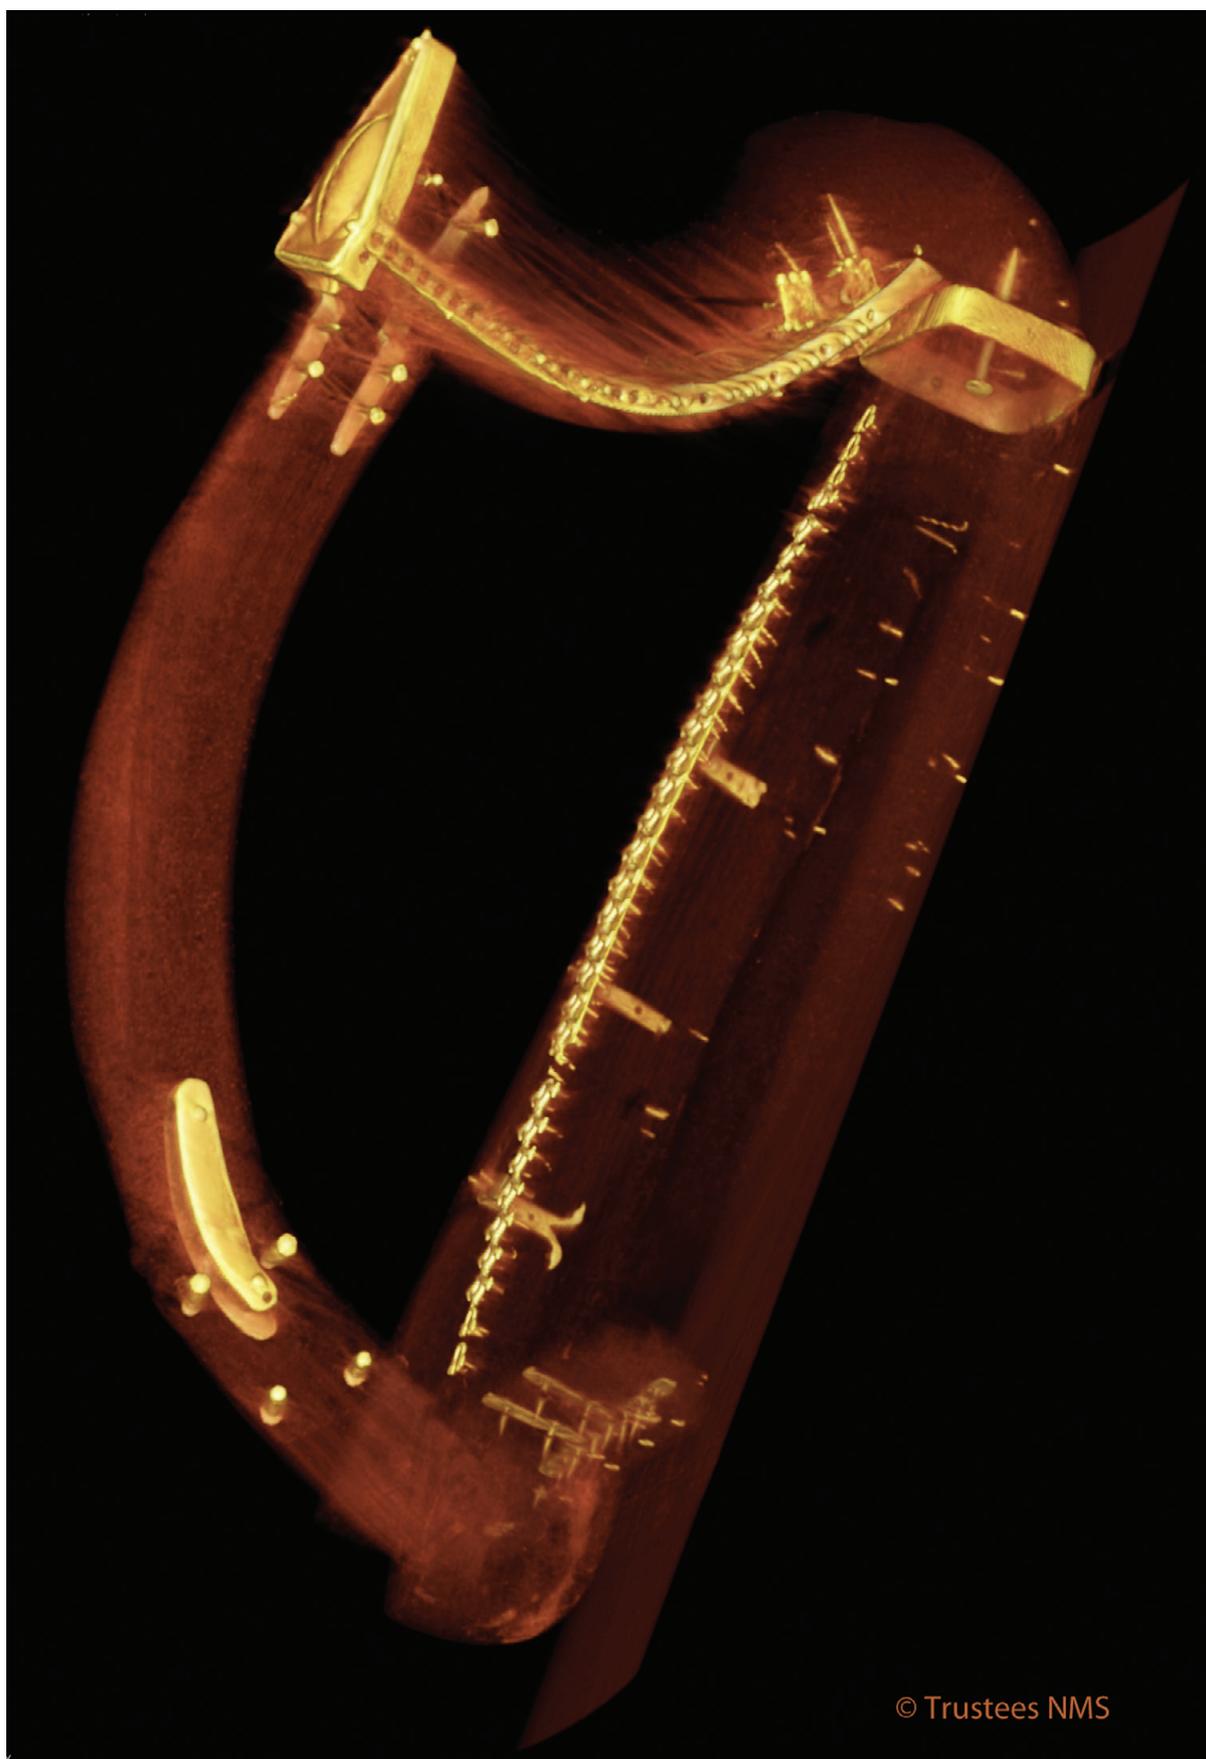
At the bass end of the interior of the box, an iron strap in the shape of a letter pi is nailed across the box directly above the foot (visible in the tomogram in Figure 6, in the colour section). The replacement block of wood that has been let into the foot is visible on visual inspection, as is a crack extending from this repair.¹⁹ There are two holes through the foot intended for dowels to secure it to the original wood. It is evident from the tomograms that these dowels are now missing and that the block has shifted upwards slightly under the weight of the harp. The iron strap has been partially forced out by the movement of this block. From a conservation standpoint, this is an important observation, because the harp is currently displayed upright with all of the weight of the instrument resting on the foot. There are now plans to redesign the display stand to take the weight off the foot and redistribute it over the base of the soundbox.

Figure 6. Tomographic volume rendering of the Lamont harp, showing metal repair work on the inside of the harp.

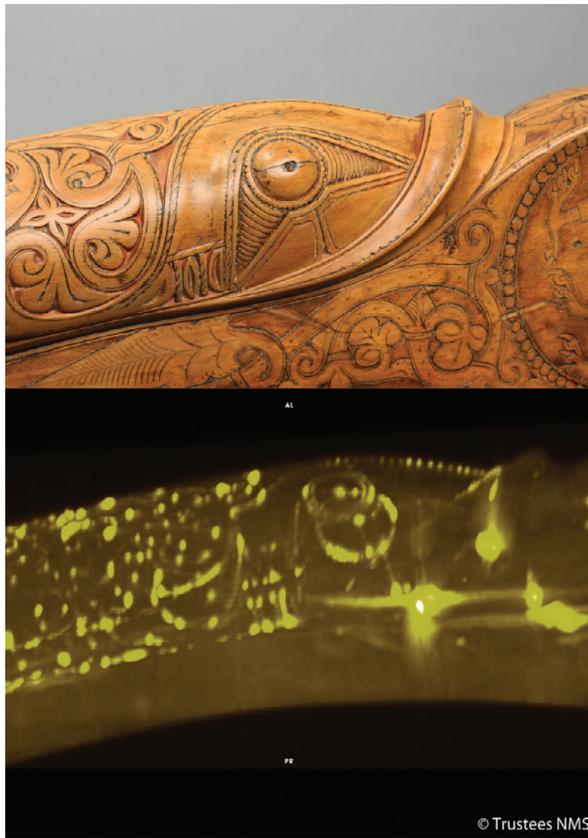
The decorative carving on the forepillar contains traces of a red pigment (see Figure 11 in the colour section). XRF analysis has shown that the pigment contains significant amounts of mercury, indicating that it is almost certainly vermilion.⁴⁹ A red pigment is also embedded in nail holes in the centres of the carved decorative eyes on the T-section, suggesting that they were originally painted red and that something was nailed into the centres after they were painted. The pigment in the eyes was analyzed with XRF and also found to contain a significant amount

of mercury. Vermilion pigment has so far only been detected on the forepillar, but the dark waxy substance found in the decorative work and surface crevices on the soundbox also appears in cracks and crevices on the forepillar.

Figure 11. *Photographic (top) and tomographic (bottom) views of a section of the forepillar of the Queen Mary harp revealing traces of vermilion (photo by Karen Loomis, courtesy National Museums Scotland).*

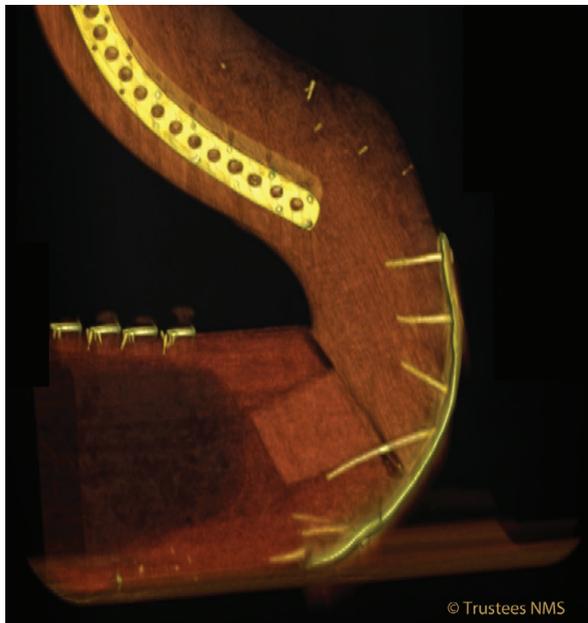
A sturdy iron strap has been nailed across the neck joint at the soundbox and a small wooden wedge inserted at the back. Six heavy iron nails are driven through the strap: three into the neck and three into the back of the soundbox. The strap is clearly a repair (or remediation), as it covers up some of the decorative work on the neck. The CT scanning has revealed the full extent of the damage and repairs (see Figure 13 in the colour section). The tenon has a crack that opens up from the back right-hand corner and follows the grain of the wood. The neck has lifted about 3mm out of its joint and has tilted slightly forwards and towards the left side of the harp. A metal rod extends through the neck and into the joint. The three nails driven through the iron strap into the neck extend deep into the wood. The nails driven into the soundbox are bent, following the grain of the wood. The small wooden wedge fills the gap that has opened up at the back of the joint.

Figure 13. *Tomographic volume rendering of the neck joint at the soundbox of the Queen Mary harp. The nails holding an iron strap in place can be seen, as well as a crack in the tenon. A metal rod, not driven through the strap, is visible at the back of the joint, wedged in between the mortise and tenon.*

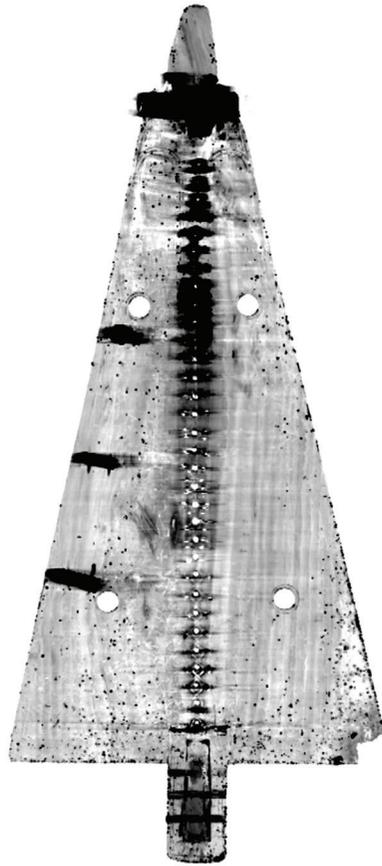
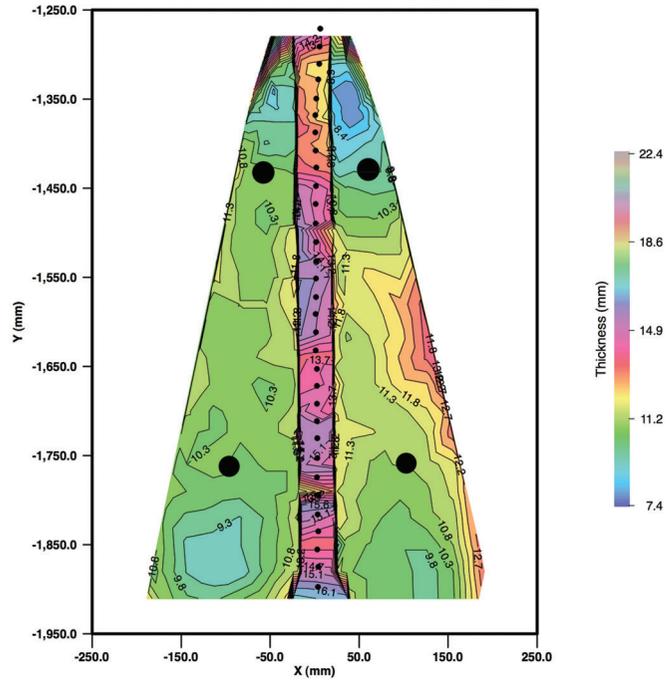
Lamont Harp
soundboard thickness

The contour map of the soundboard of the Lamont harp also has some interesting features. As with the Queen Mary harp, the soundboard is thinner in the treble, decreasing in thickness from approximately 10mm at the upper sound holes to around 8.5mm on the right-hand side and 8mm on the left-hand side. This area of the soundboard appears to be thinner overall on the left-hand side, possibly as a result of the mortise being enlarged on that side for the repairs to the neck tenon. The midsection of the soundboard is

Figure 14. (Facing page, top) *Contour map of the soundboard of the Lamont harp. Thickness increases towards the red end of the colour spectrum (with the exception of the thickest contours on the string band, which had to wrap back around to the blues). Each contour represents a change in thickness of 0.5mm. The colours used in this map represent the same thicknesses in the contour map of the soundboard of the Queen Mary harp. A tomogram of the soundboard is included in the figure for comparison with the appearance of the wood. (Tomogram © Trustees NMS).*
