The Queen Mary and Lamont Harps: A Study of Structural Breaks and Repairs

A thesis submitted for the MMus in Musical Instrument Research

by Karen A. Loomis 0957990

16 August 2010

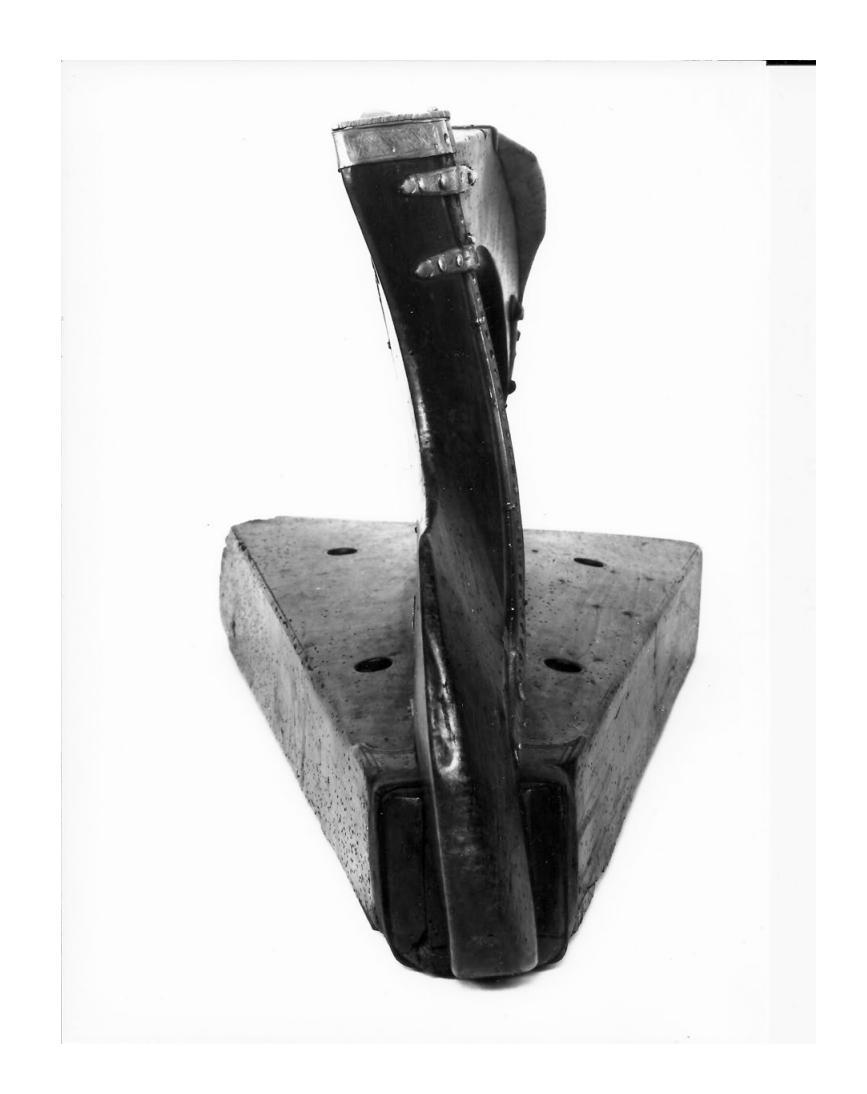
Figure 5.

End on view of the Lamont harp, showing twisting of the neck due to the torque exerted by the strings, which were strung from the left side. Courtesy of the National Museums of Scotland, 5x7 negative film, date unknown.

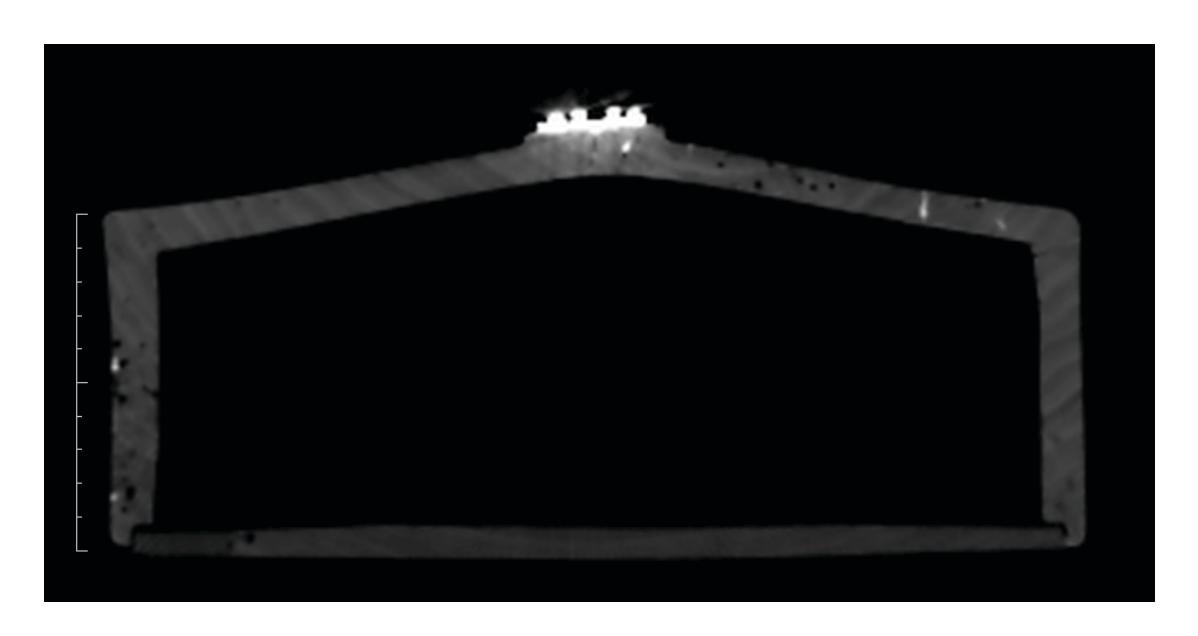
Figure 6.

CT cross-section of the Lamont harp soundbox showing the raised "belly" on the front face (towards the top of the tomogram) and the left side pulled in slightly. Each tick on the scale in the tomogram equals 1 cm. Tomogram obtained at the Clinical Research Imaging Centre, courtesy of the National Museums of Scotland, 2D rendering by Karen Loomis.

The right side of the soundbox doesn't appear to be pulled in. A possible reason for this is evident upon examination of a repaired crack along that side of the box.

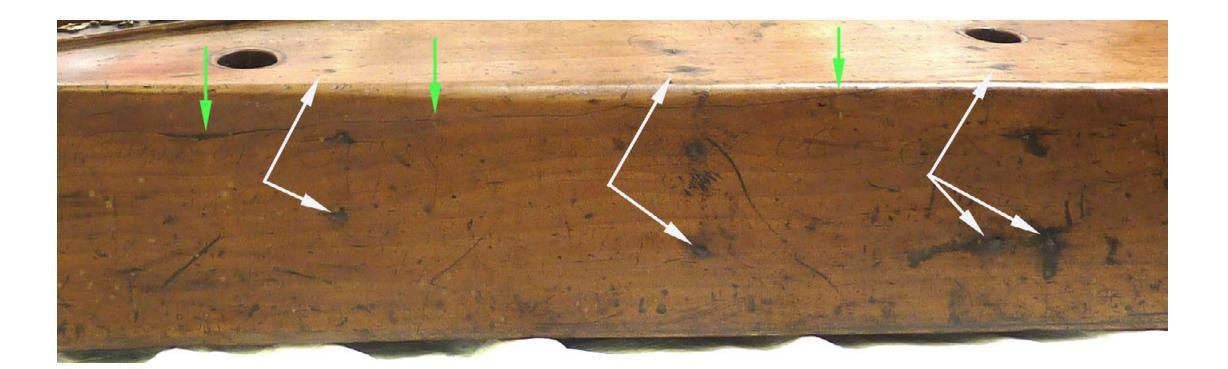
Figure 7.

Figure 7 is a photograph of the crack visible on the right side of the harp's soundbox. Also visible in the photograph are nail ends, which appear as lines of several small dark patches on the side and front face of the soundbox. Up to the present, it had been assumed this harp had had its soundbox strapped from the outside, in the manner of historical repairs to some other surviving Gaelic harps,²² and that the nail ends visible on the outside of the box were left behind, presumably after the straps had been removed.

Photograph of the right side of the Lamont harp soundbox, showing a crack (green arrows). Nail ends are visible as lines of small dark patches on the side and front face of the soundbox (white arrows). Photo by Karen Loomis, courtesy of the National Museums of Scotland.

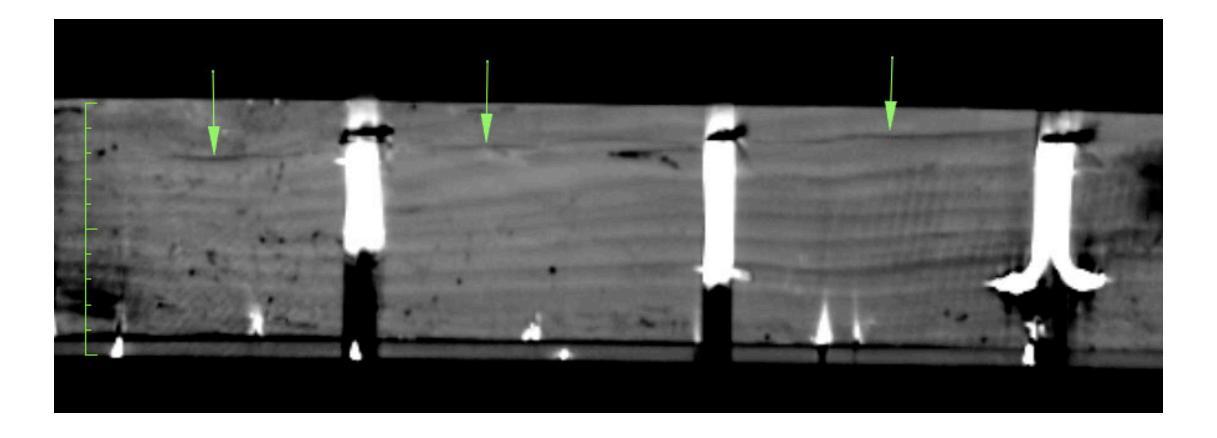
Figure 8.

Figure 8 shows a CT cross-section along the inside wall of the same area of the soundbox shown in figure 7. The crack visible on the outside can be seen running just below the front corner of the soundbox, although it follows a slightly different path on the outside surface of the box.

CT cross-section along the inside surface of the right side of the Lamont harp soundbox. A long thing crack running just below the top corner of the box is visible (arrowed). Also visible are three metal straps affixed to the inside of the soundbox. The scale is 1 tick = 1 cm. Tomogram obtained at the Clinical Research Imaging Centre, courtesy of the National Museums of Scotland, 2D rendering by Karen Loomis.

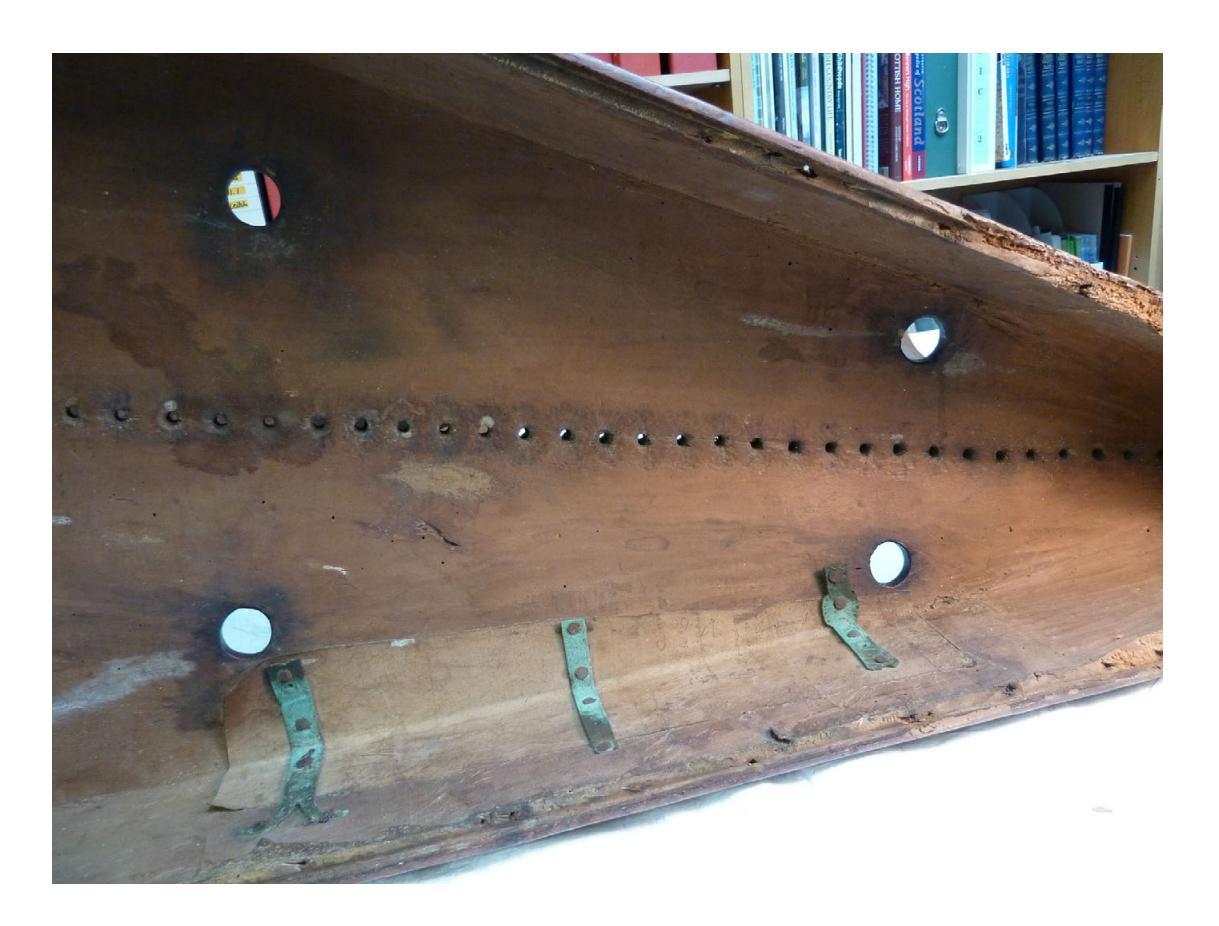
Figure 9.

Interior of the Lamont soundbox showing the metal straps and vellum patch used to repair the crack on the right side of the soundbox. Verdigris on the straps indicates that they are made of a copper alloy. The vellum has handwriting, which will be discussed in detail in a future paper. Photo by Karen Loomis, courtesy of the National Museums of Scotland.

At the beginning of this discussion, it was pointed out that, although the left side of the soundbox has pulled in, the right side of the soundbox has not. The crack provides a possible explanation for this. When the harp was brought under the tension of the strings, the soundbox deformed. The front pulled up and the left side pulled inwards. On the right side, it's possible that, instead of deforming, the wood failed and a crack formed, which acted like a hinge as the front of the soundbox pulled upwards.

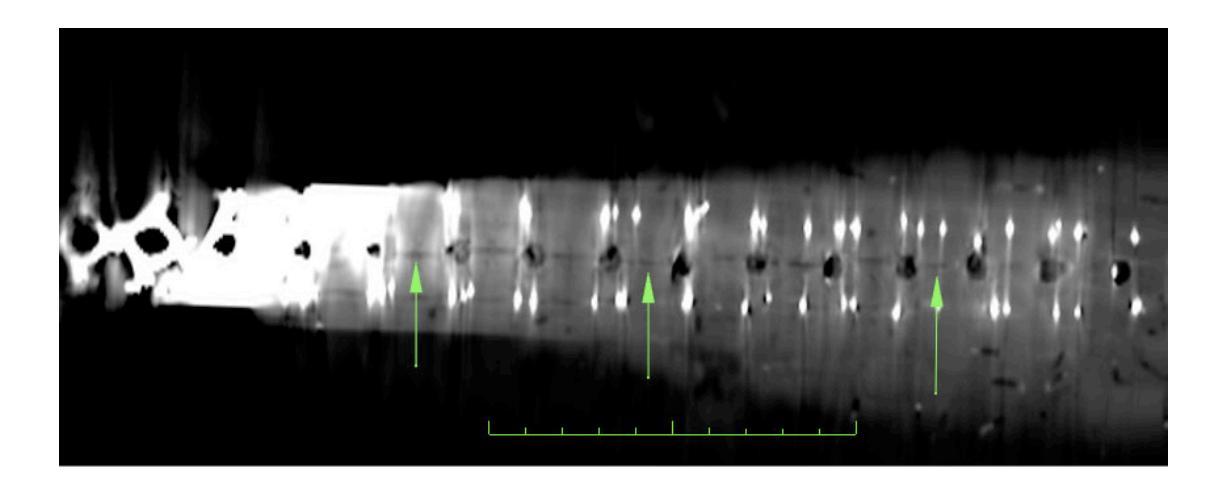
CT cross-section parallel to the front face of the soundbox of the Lamont harp, showing of a crack along the string band (arrowed). The treble end of the harp is towards the left side of the tomogram. The scale is 1 tick = 1 cm. The dark circles are the string holes and the bright dots are nails attaching the string shoes and a metal band to the front of the soundbox. Tomogram obtained at the Clinical Research Imaging Centre, courtesy of the National Museums of Scotland, 2D rendering by Karen Loomis.

The metal band was apparently put on the harp as a repair, as it is just slightly longer than the crack and is centered on it. Photographs of the interior of the soundbox confirmed the presence of the crack. Taking into consideration the tension of the strings pulling upwards on the string band, and the presence of the string holes perforating the front of the soundbox, it is not at all surprising to find a crack in this location.

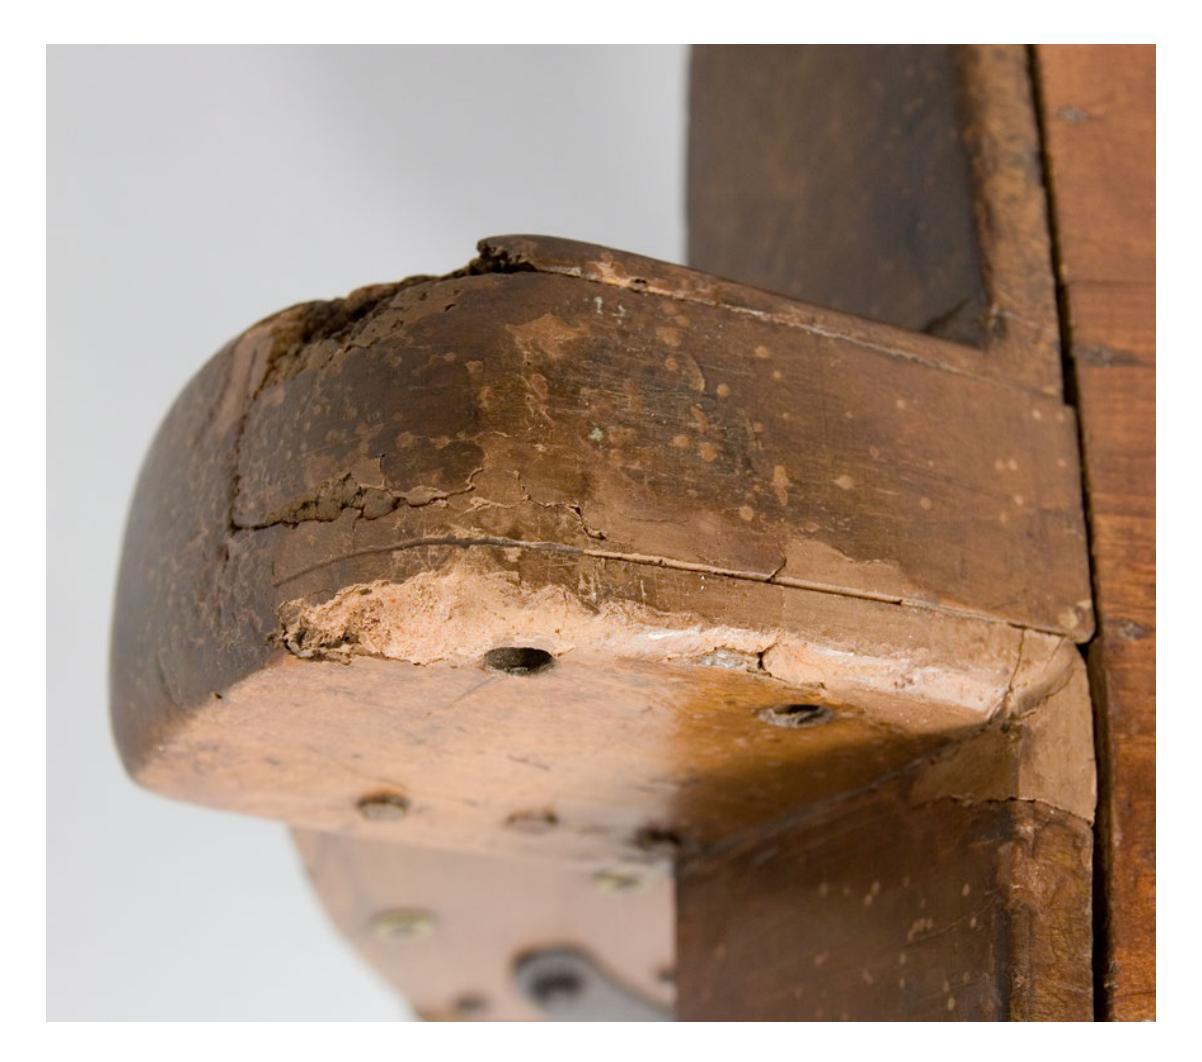
Figure 12.

The foot of the Lamont harp, showing the replacement block of wood that has been let into it. Photo: Maripat Goodwin, courtesy of the National Museums of Scotland.

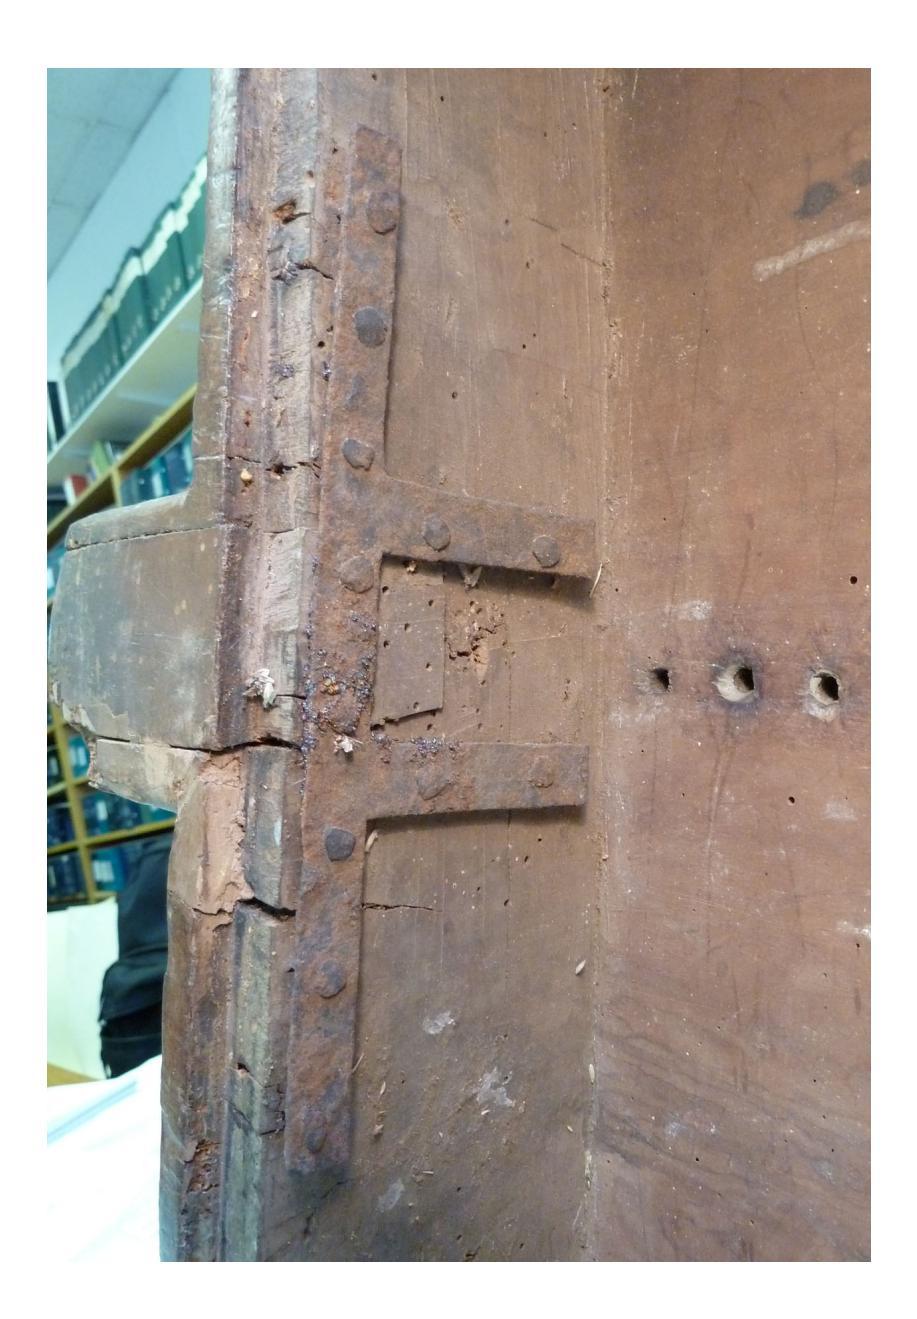
Interior view of the base of the Lamont harp soundbox, showing the block of wood inserted into the foot, and the metal strap nailed across it. Photo by Karen Loomis, courtesy of the National Museums of Scotland.

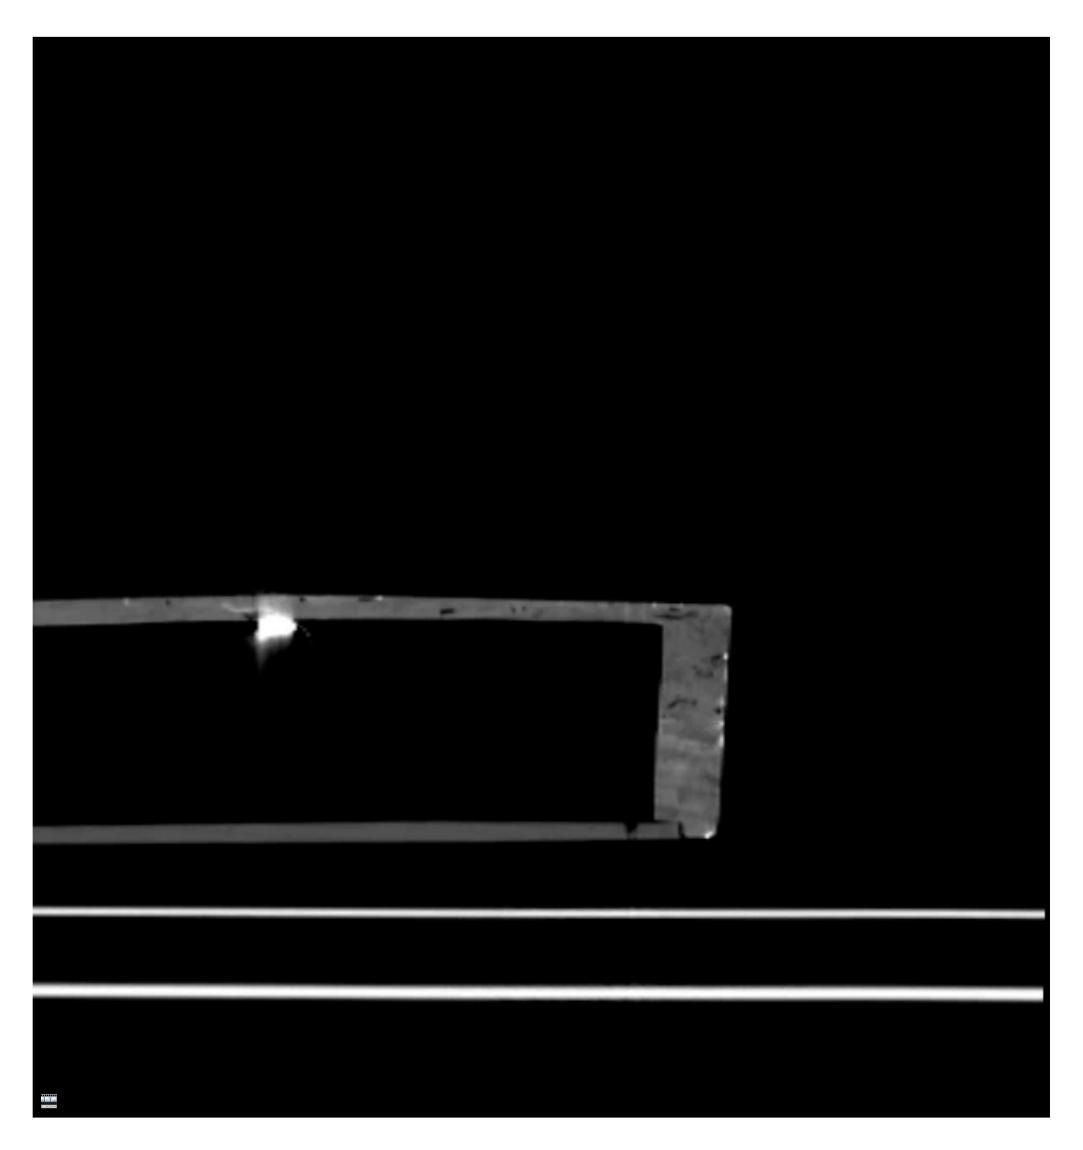
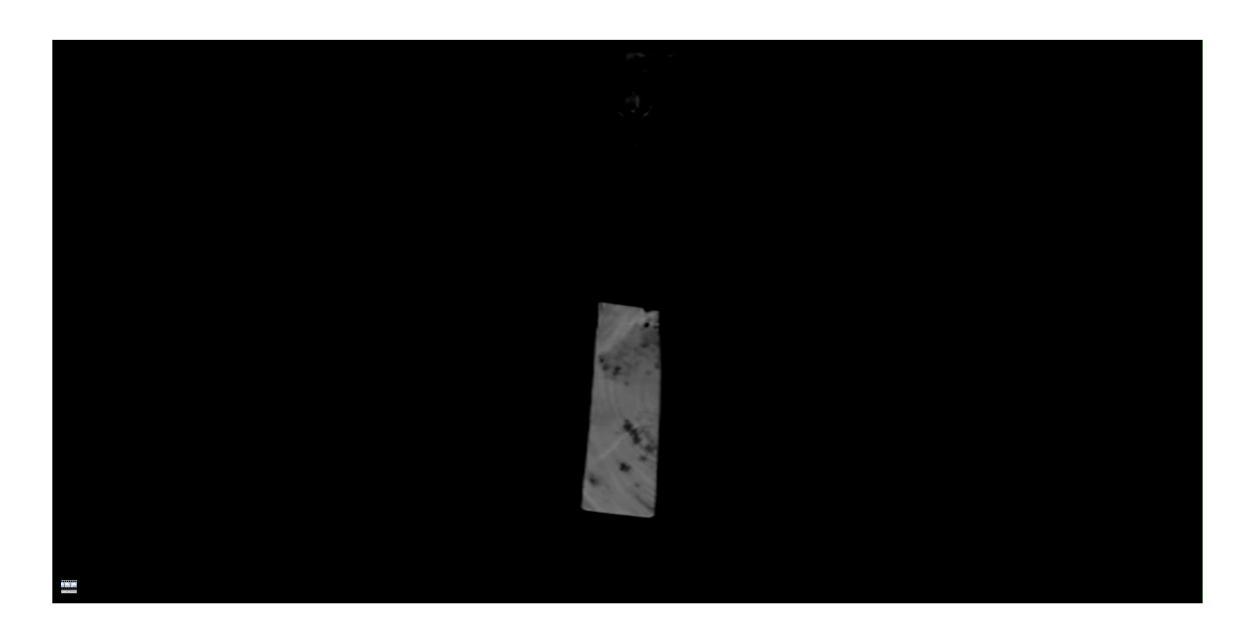
Video clip of the sagittal (side) view of the foot of the Lamont harp, passing through the base of the soundbox. The images reveal the extent of internal woodworm damage, which appears as dark squiggles where the larvae have eaten tunnels through the wood. The wood block let into the foot appears as the lighter grey section at the back of the foot. The front of the harp is towards the top of the tomogram, and the forepillar can be seen extending down into the foot midway through the clip. This video clip is available in the electronic form of this document and also as the file **Lam_foot_sag.mov** on the disc accompanying the paper copy. Tomograms obtained at the Clinical Research Imaging Centre, courtesy of the National Museums of Scotland, 2D rendering by Karen Loomis.

Video clip of the coronal (top) view of the foot of the Lamont harp, descending through the harp from above the front of the soundbox. Extensive woodworm damage is visible in and around the foot. The tenon belonging to the forepillar is visible as a lighter grey oblong in the center of the foot. The metal strap attached to the inside of the soundbox is visible as a white line across the inside of the base of the soundbox. This video clip is available in the electronic form of this document and also as the file Lam_foot_cor_02.mov on the disc accompanying the paper copy. Tomograms obtained at the Clinical Research Imaging Centre, courtesy of the National Museums of Scotland, 2D rendering by Karen Loomis.

The video clips in figures 14 and 15 contain a lot of interesting information, some of which will be discussed in the section on the forepillar. Focusing for the moment on the foot of the harp, extensive woodworm damage is visible. Some of the external damage has been covered cosmetically with putty, which appears bright in the tomograms.

Much of the internal woodworm damage extends from cracks and follows the seams around the replacement block let into the foot. The adult beetles may have used the cracks and seams as entry points. It's possible that the block was let into the foot as a repair to woodworm damage, and that the infestation continued after the repair was made. Another possibility is that the block was let in to repair a crack in the wood (the base of the soundbox and the end of the foot is end grain), and the adult beetles took advantage of the seams around the repair. The metal strap is nailed to the inside of the soundbox across the repair, presumably to reinforce the bottom of the soundbox, distribute the load on the foot across the base, and to prevent the inserted block of wood from pushing upwards when the harp is resting on the foot. There are two holes through the foot for dowels to secure the replacement block to the original wood of the foot. The tomograms show that these dowels are now missing and that the inserted block has shifted upwards slightly under the weight of the harp.

The current state of the interior of the foot as revealed by the tomograms is of importance from the standpoint of conservation. There is extensive interior woodworm damage compromising the foot, as well as evidence that the block of wood that has been let into it is being pushed upwards by the weight of the harp against an antique iron strap. The Lamont harp is currently displayed in the Museum with all of its weight resting on the foot.²⁹ Conservation staff are planning to construct a new display stand that takes the weight off the foot and distributes it over the base of the soundbox. The tomograms of the foot and base of the soundbox reinforce the need for a new stand and will aid conservation staff in considering its design.

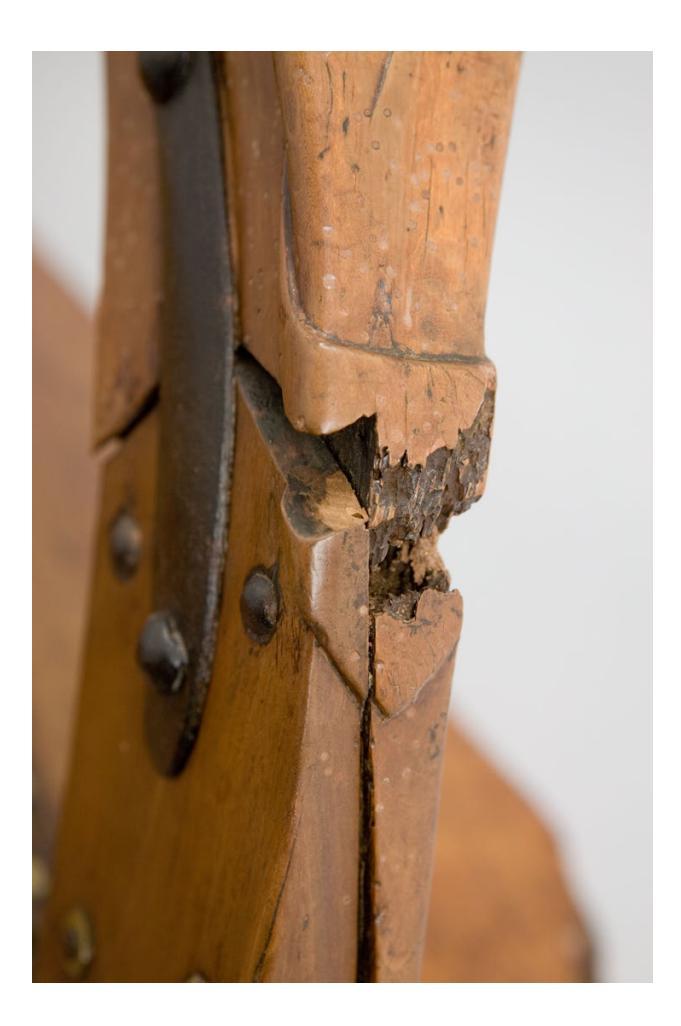
Close up photo of the scarf joint repair to the forepillar of the Lamont harp. The two pieces of wood are fastened together by two iron straps and four additional rivets. Photo: Maripat Goodwin, courtesy of the National Museums of Scotland.

This repair is first reported in Gunn (1807),³⁰ and is described in detail by Armstrong (1904), who gives a very good account of the nature of the break and the repair.³¹ The forepillar has bowed towards the right side of the harp (opposite to the side to which the strings are attached). This would have occurred when the harp was first brought up to tension, and is probably the cause of the break. The point of highest lateral stress would be in the center of the forepillar. This is reinforced by the t-section, however. So, it failed at the first weak point, just below the end of the t-section. The wood around the crack is crushed on the inside face of the curve and on the left side

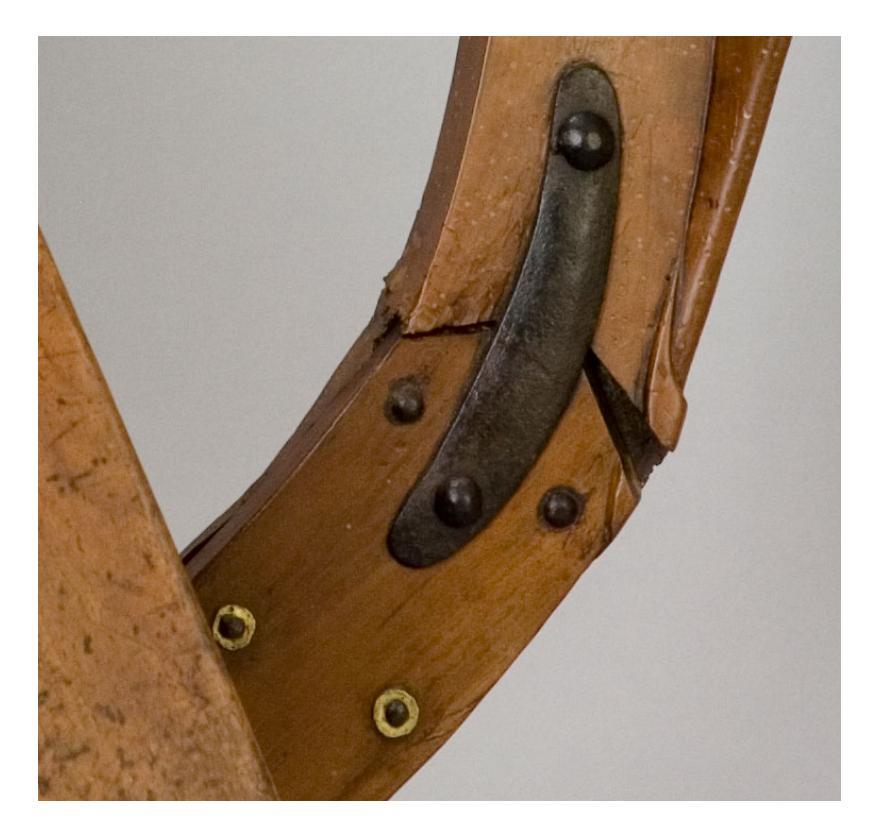
Figure 17.

Right hand side view of the crack and repair in the forepillar of the Lamont harp. Crushed wood at the back of the crack is visible in this photo. The crack has opened up on the right side, and on the front face as well. Photo: Maripat Goodwin, courtesy of the National Museums of Scotland.

When the harp was brought back up to tension, the joint apparently pivoted, causing the wood to be crushed at the back. The joint also bowed towards the right, causing the wood to crush on the left side. Essentially all of the damage and repair are in plain view, but the tomograms did reveal an additional rivet hidden underneath the iron straps, as shown in figure 18. Figure 18.

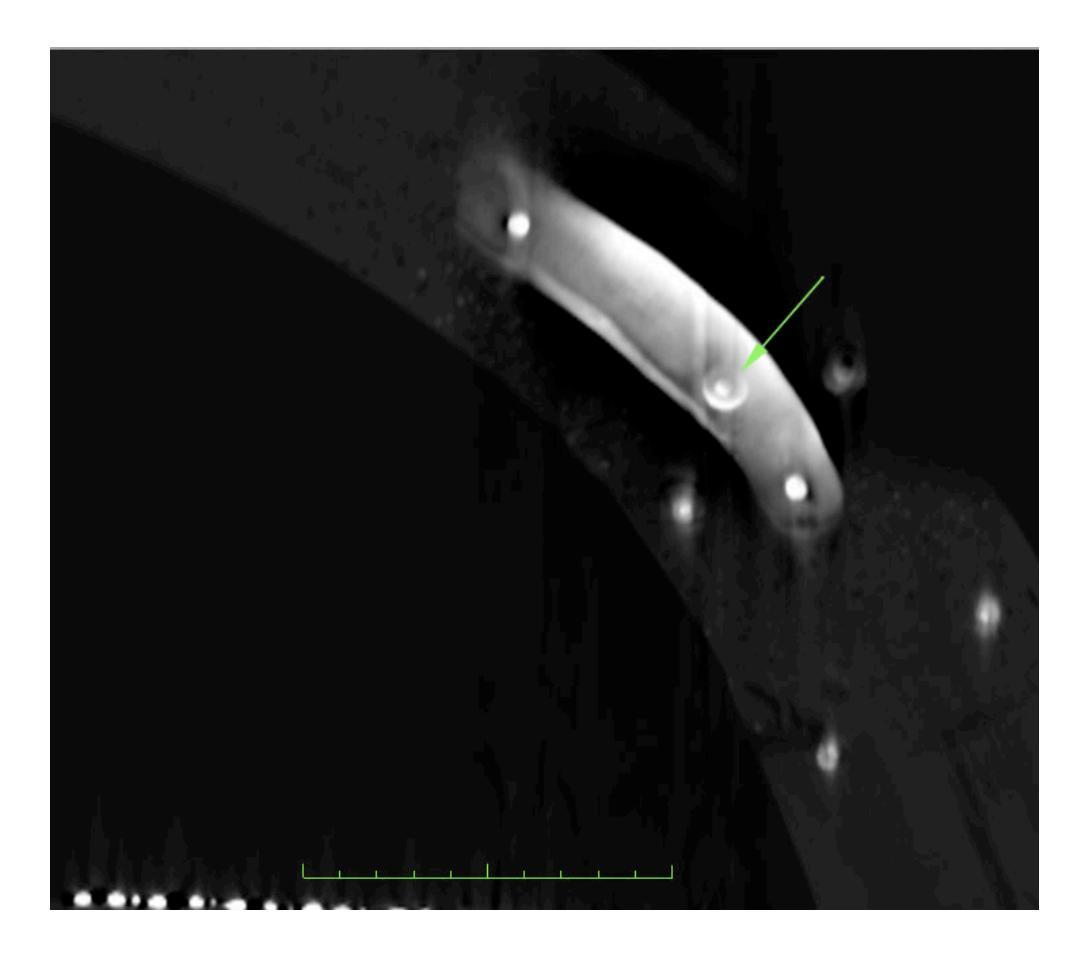
CT cross-section through the repair to the forepillar of the Lamont harp, revealing a rivet and washer hidden under the iron strap (arrowed). The scale is 1 tick = 1 cm. The soundbox is towards the bottom of the tomogram, and the foot is towards the lower right. Tomogram obtained at the Clinical Research Imaging Centre, courtesy of the National Museums of Scotland, 2D rendering by Karen Loomis.

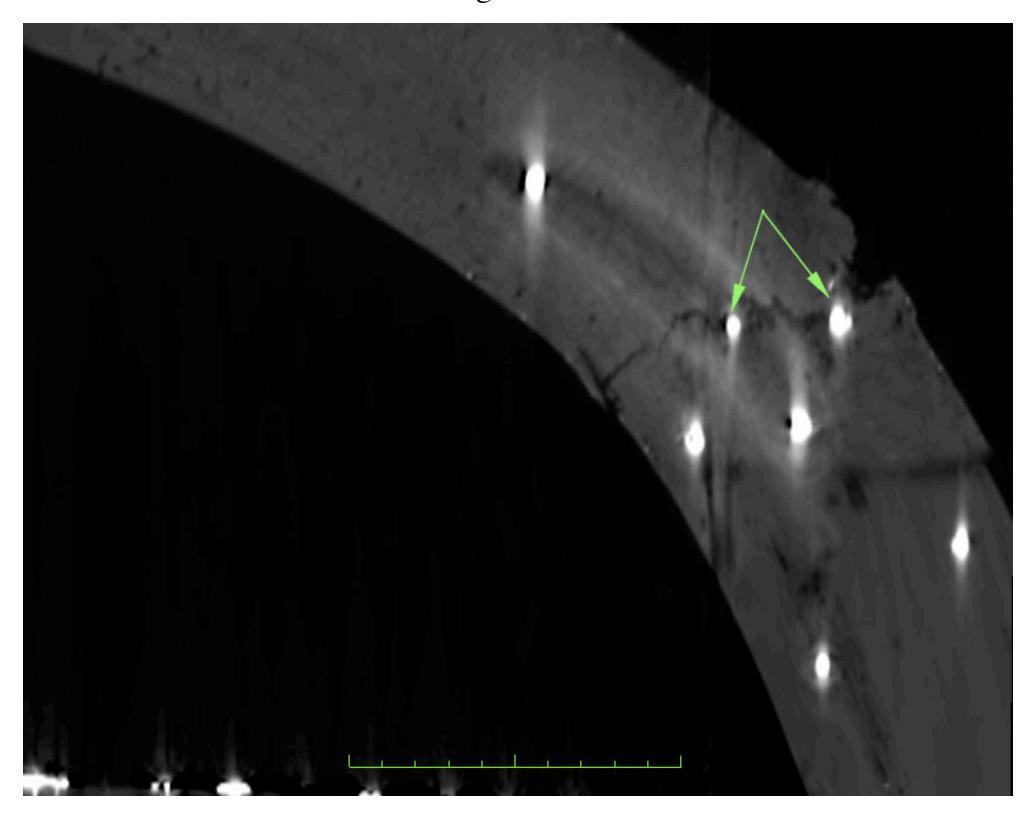
CT cross-section of the crack through the forepillar of the Lamont harp. Two rivets pass directly through the crack (arrowed). The scale is 1 tick = 1 cm. The soundbox is towards the bottom of the tomogram, and the foot is towards the lower right. Tomogram obtained at the Clinical Research Imaging Centre, courtesy of the National Museums of Scotland, 2D rendering by Karen Loomis.

The crack could have spread through the rivets after they were inserted and the harp brought back up to tension and, in this case, the iron straps may have been a second attempt to secure the scarf joint. That would explain the rivet being covered by the straps.

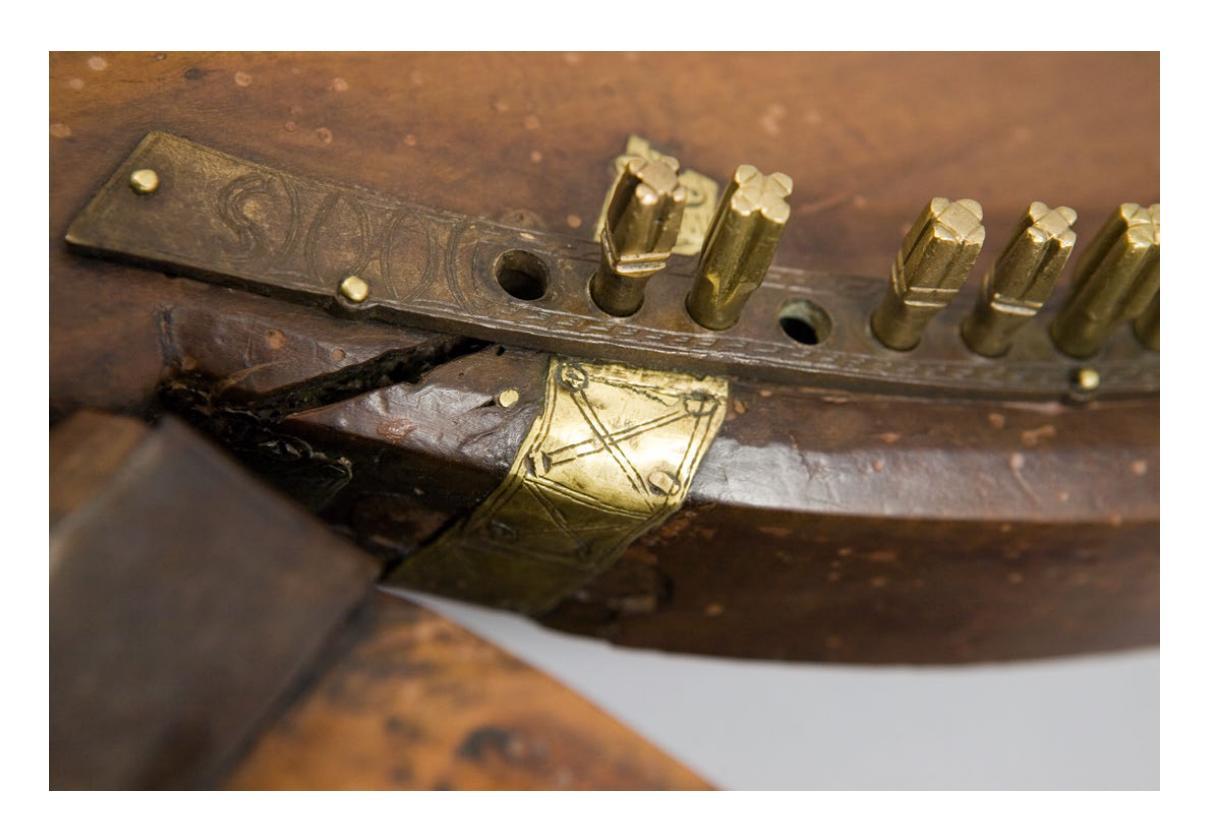
View of the right side of the neck of the Lamont harp near the joint with the soundbox, showing a large crack and two decorated brass patches. Photo: Maripat Goodwin, courtesy of the National Museums of Scotland.

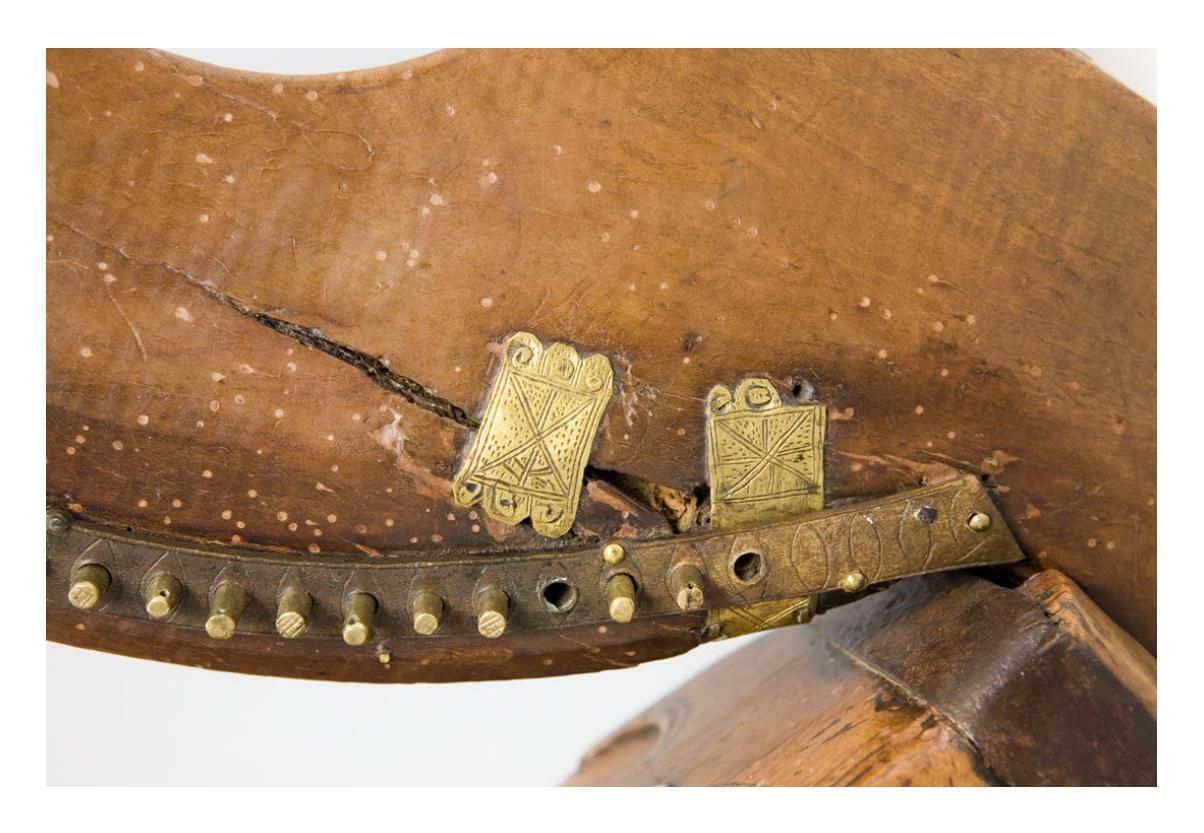
View of the left side of the neck of the Lamont harp, showing the other side of the split visible in figure 20. Two decorated brass patches cover the crack. The one on the right in this photo runs under the neck to the other side. Photo: Maripat Goodwin, courtesy of the National Museums of Scotland.

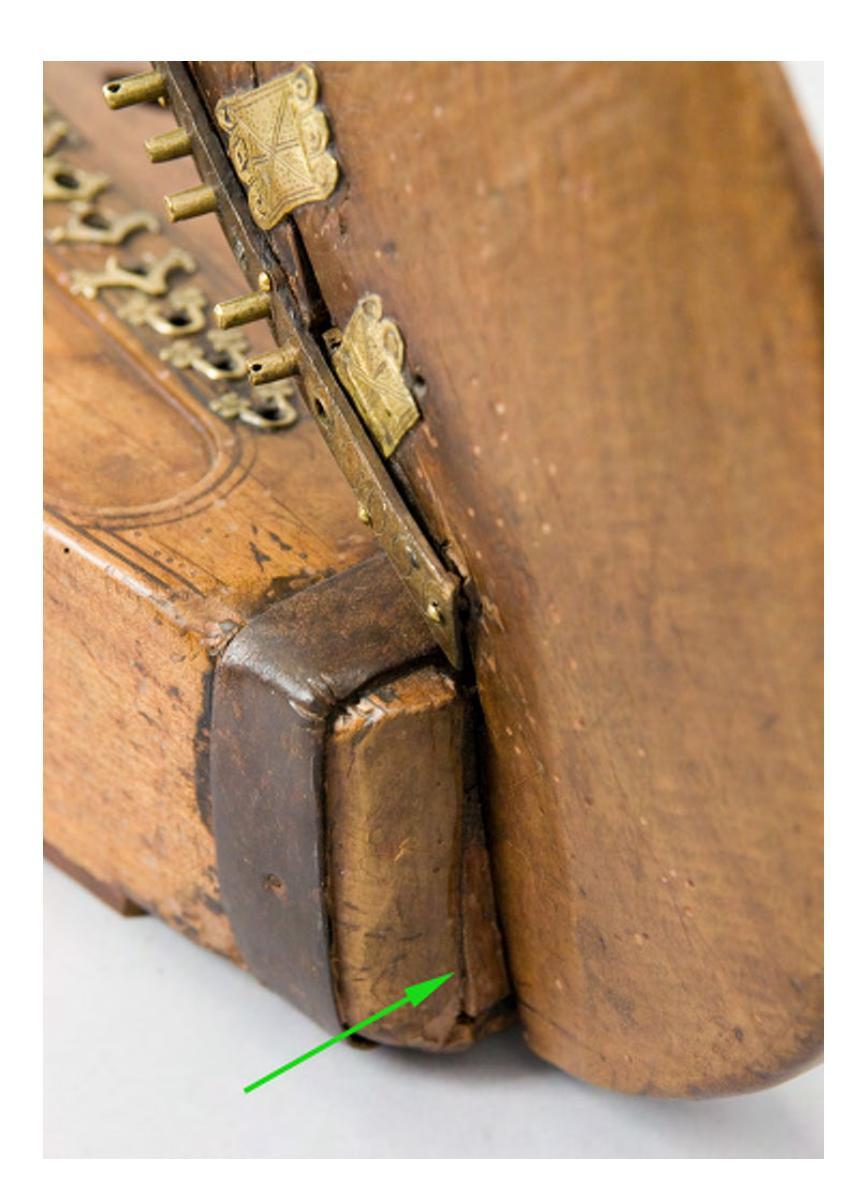
View of the neck joint with the soundbox of the Lamont harp, showing the end of a block in the joint (arrowed). Photo: Maripat Goodwin, courtesy of the National Museums of Scotland.

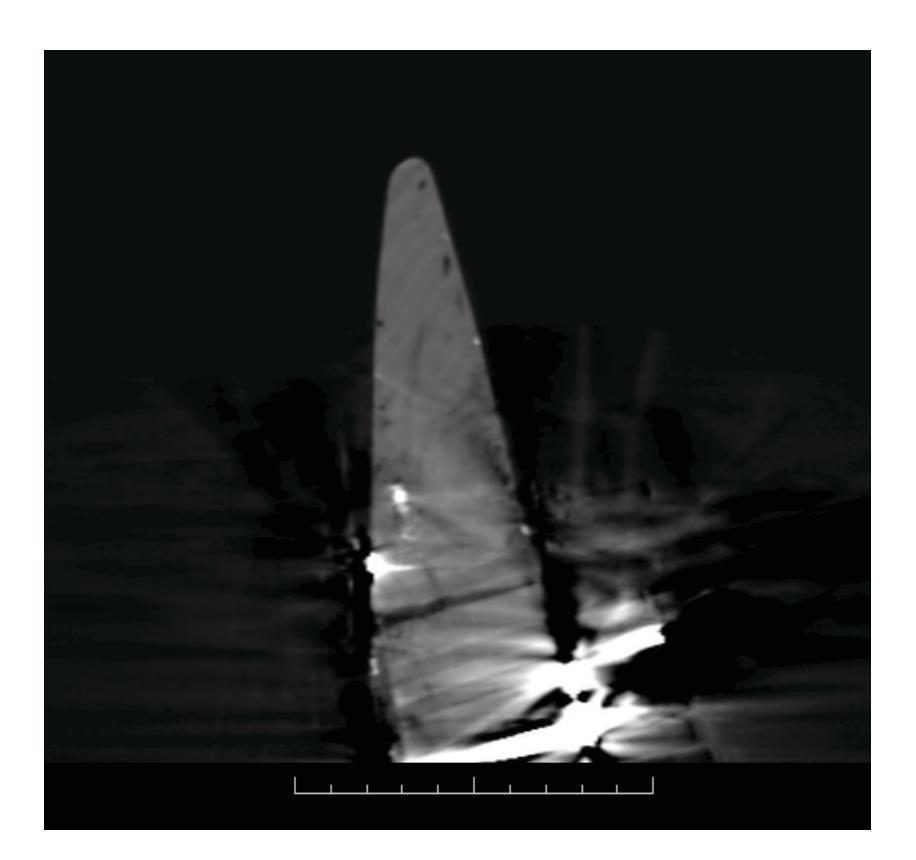
tomograms of the neck and its joint with the soundbox reveal hidden damage and repairs, providing a more complete picture of the failure of the neck and the work done to reinforce and repair it. Figure 23 is a section across the neck of the harp, which shows the size and nature of the split.
Figure 23.

CT coronal cross-section through the neck of the Lamont harp, showing the split in the wood of the neck. The left hand side of the harp is towards the left of the tomogram. The foot of the harp is towards the top of the tomogram. The bright objects at the bottom of the tomogram are tuning pins. The scale is 1 tick = 1 cm. Tomogram obtained at the Clinical Research Imaging Centre, courtesy of the National Museums of Scotland, 2D rendering by Karen Loomis.

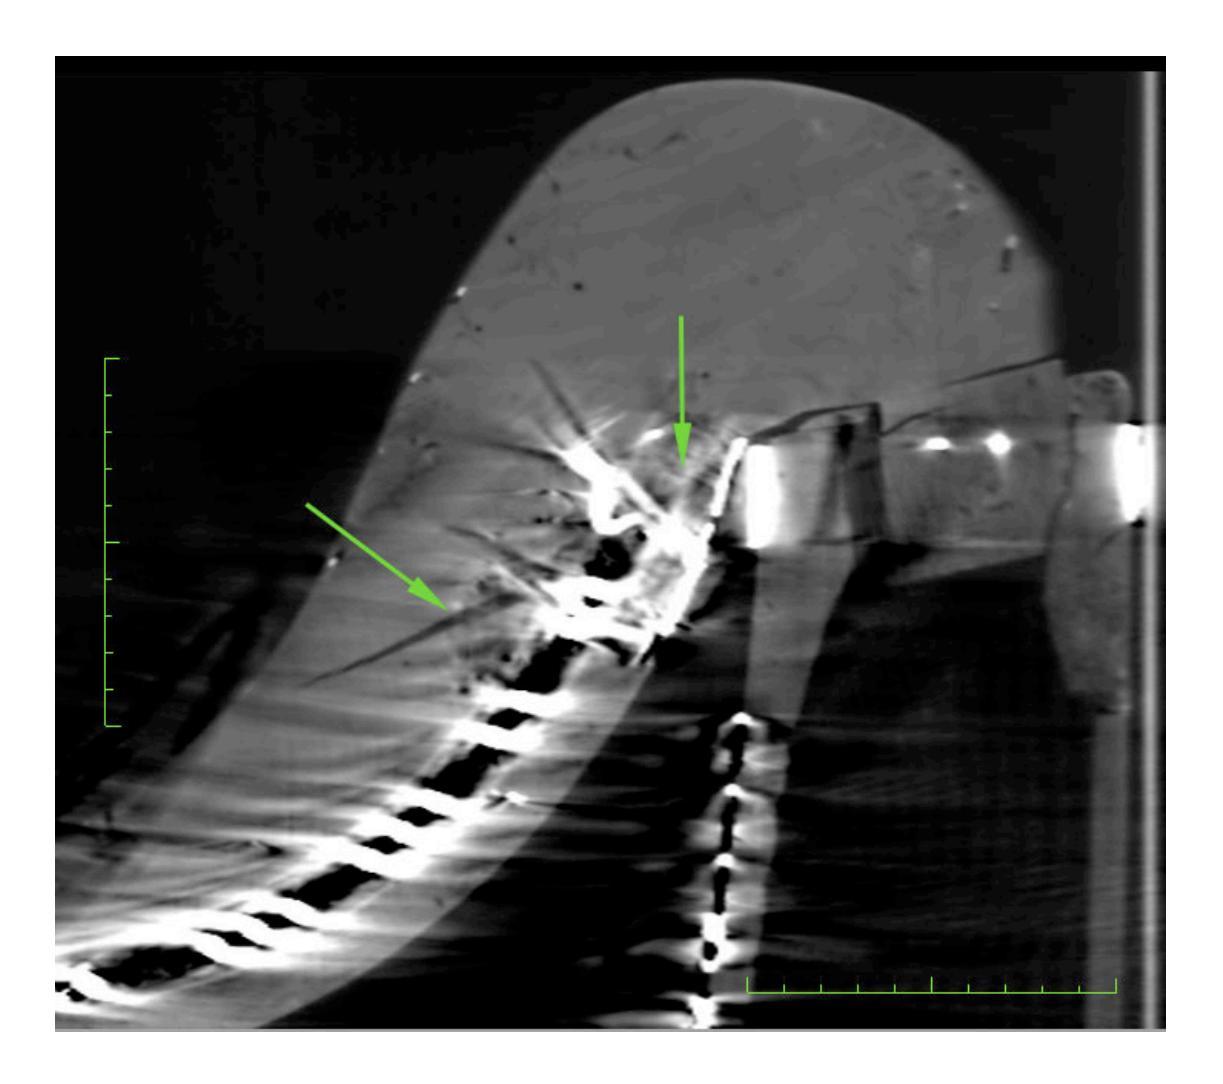
CT sagittal cross-section of the neck of the Lamont harp, showing where the wood has split (arrowed). Nails used to repair it are visible as the irregular grouping of bright objects in between the arrows. The bright horizontal lines along the neck are tuning pins (some were removed for the CT scanning). The dark arc running along the tuning pins is a scanning artifact of the metal cheekbands. The cavity of the soundbox is visible along the right side of the tomogram. The scale is 1 tick = 1 cm. Tomogram obtained at the Clinical Research Imaging Centre, courtesy of the National Museums of Scotland, 2D rendering by Karen Loomis.

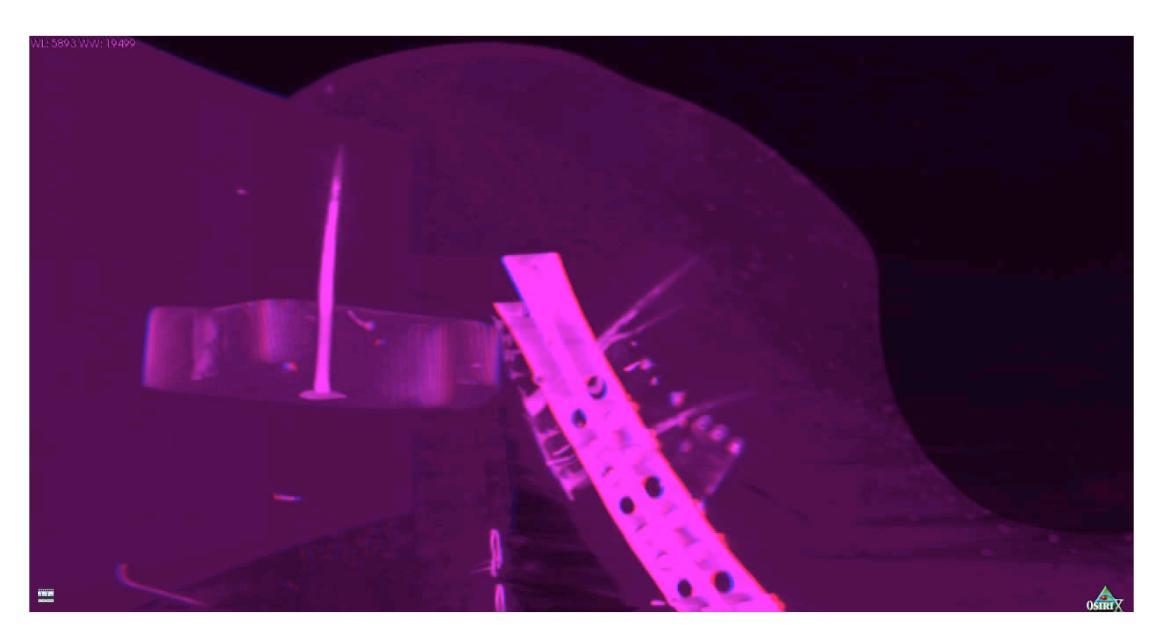
Video clip of CT stereo rendering of the repair to the crack in the neck of the Lamont harp, showing the nails embedded in the wood. The cheek bands and tuning pins are also visible in the tomogram. The video clip is available in the electronic form of this document and also as the file Lam_neck_stereo_02.mov on the disc accompanying the paper copy. It is meant to be viewed with red-cyan anaglyph glasses. Tomograms obtained at the Clinical Research Imaging Centre, courtesy of the National Museums of Scotland, 3D rendering by Karen Loomis.
