The Queen Mary and Lamont Harps: A Study of Structural Breaks and Repairs

A thesis submitted for the MMus in Musical Instrument Research

by Karen A. Loomis 0957990

16 August 2010

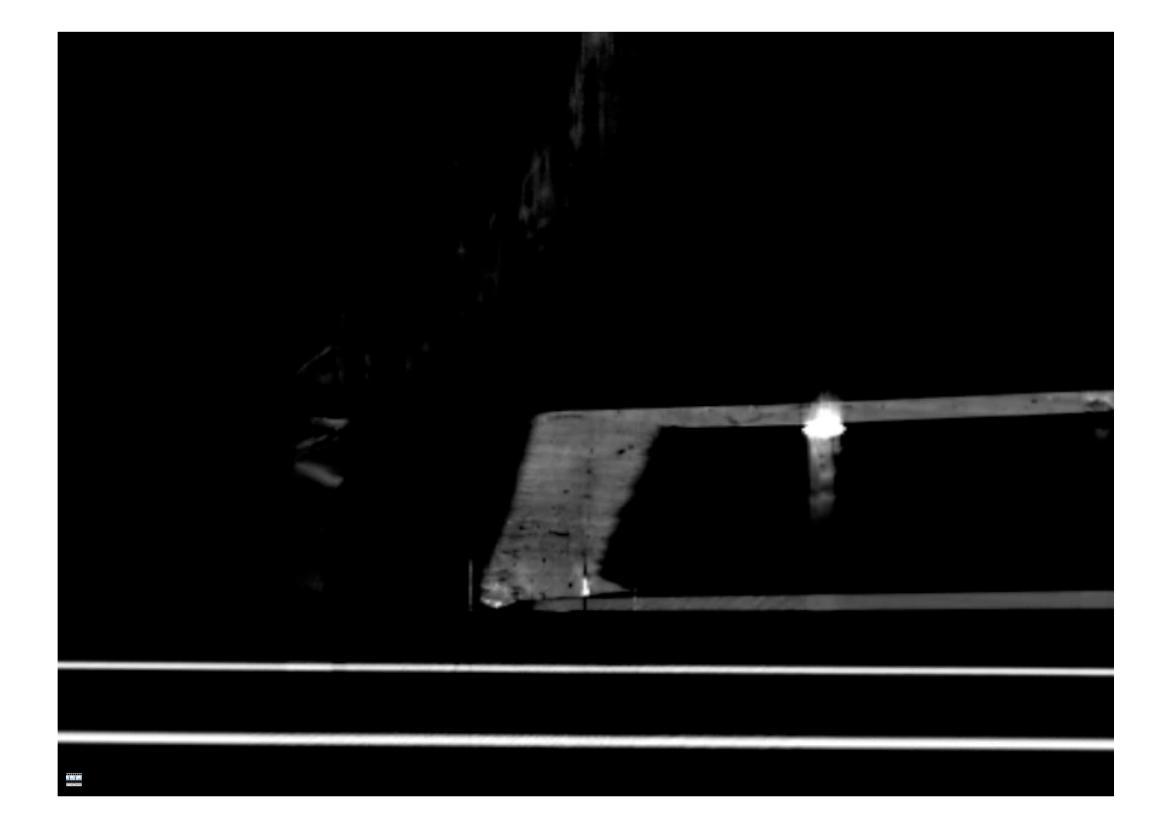
Video clip of sagittal (lengthwise) cross-sections through the Lamont harp, showing the damage and repairs to the neck to soundbox joint. The crack in the tenon can be seen, as well as the metal spike and four wooden dowels used to repair it. The video clip is available in the electronic form of this document, and also as the file Lam_neck_sag.mov accompanying the paper copy. tomograms obtained at the Clinical Research Imaging Centre, courtesy of the National Museums of Scotland, 2D rendering by Karen Loomis. Figure 28.

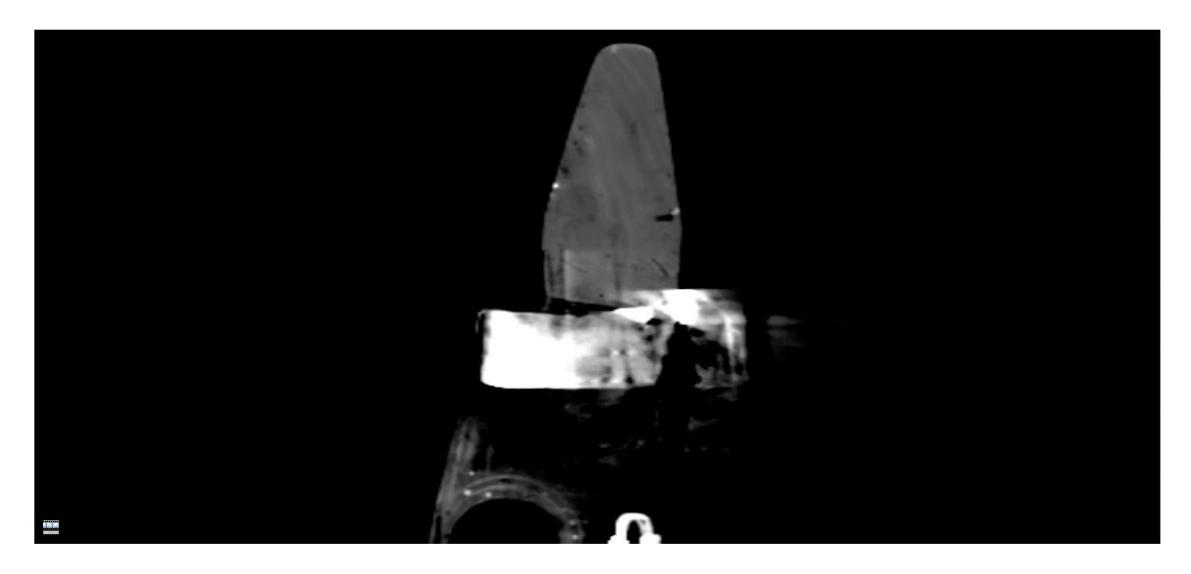
Video clip of coronal cross-sections (descending from above) through the Lamont harp, showing the damage and repairs to the neck to soundbox joint. The spike and dowels can be seen in the tenon, and the reinforcing block nailed to the tenon's left side is also visible. The video clip is available in the electronic form of this document, and also as the file Lam_neck_cor.mov accompanying the paper copy. tomograms obtained at the Clinical Research Imaging Centre, courtesy of the National Museums of Scotland, 2D rendering by Karen Loomis.

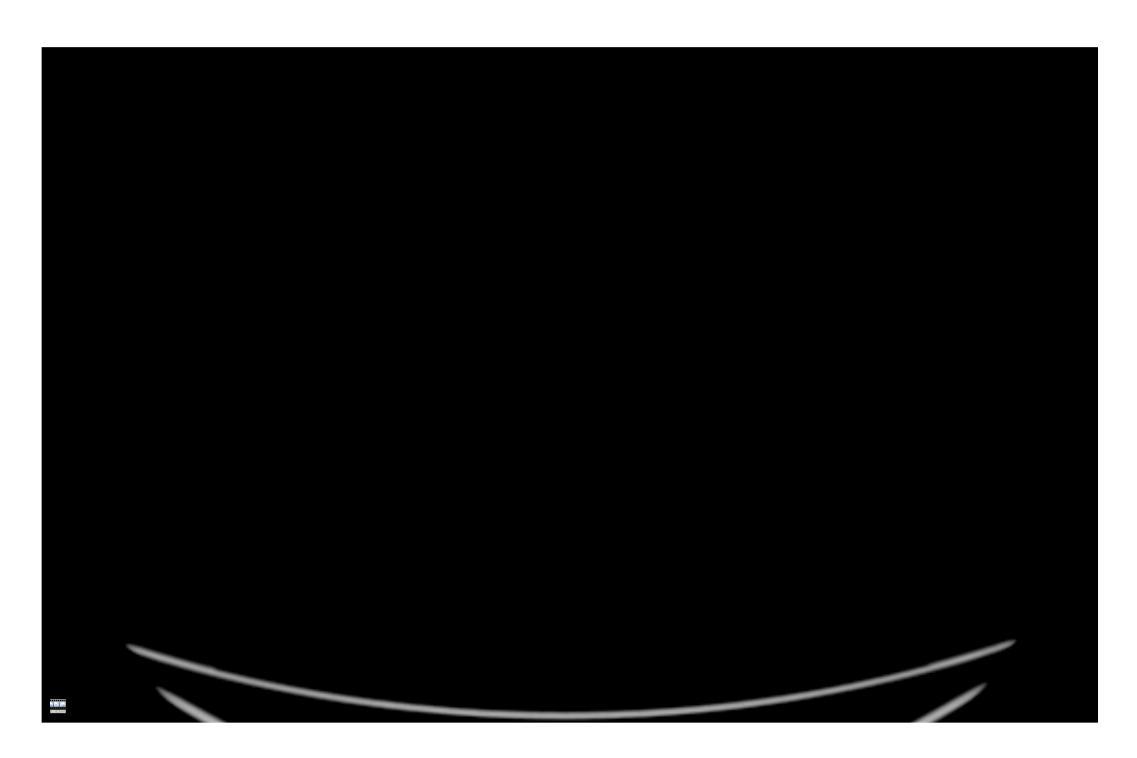
Video clip of axial cross-sections through the neck to soundbox joint of the Lamont harp (starting at the top of the harp), showing the damage and repairs to the neck to soundbox joint. The video clip is available in the electronic form of this document, and also as the file **Lam_neck_axi.mov** accompanying the paper copy. tomograms obtained at the Clinical Research Imaging Centre, courtesy of the National Museums of Scotland, 2D rendering by Karen Loomis.

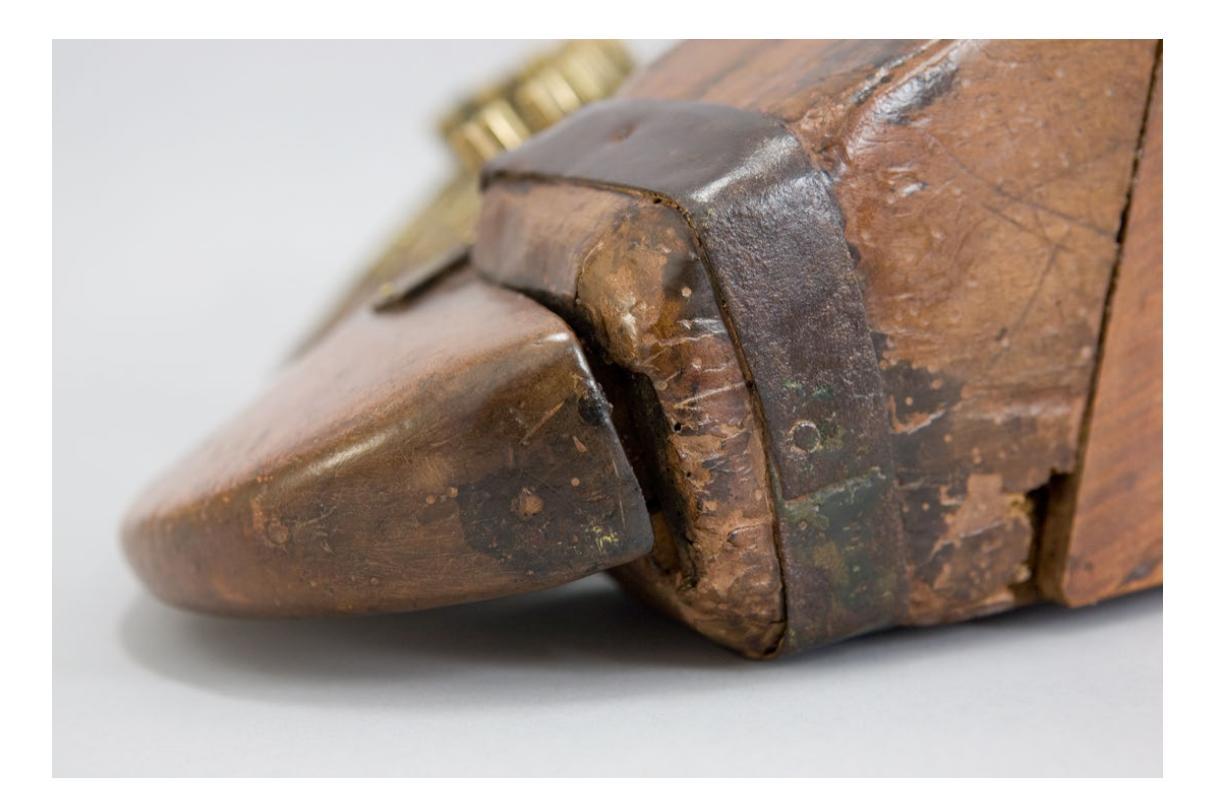
The back of the neck to soundbox joint of the Lamont harp. The front end of the neck has pulled down, causing the back to pull partially out of the joint. The neck has also twisted to the left. Photo: Maripat Goodwin, courtesy of the National Museums of Scotland.

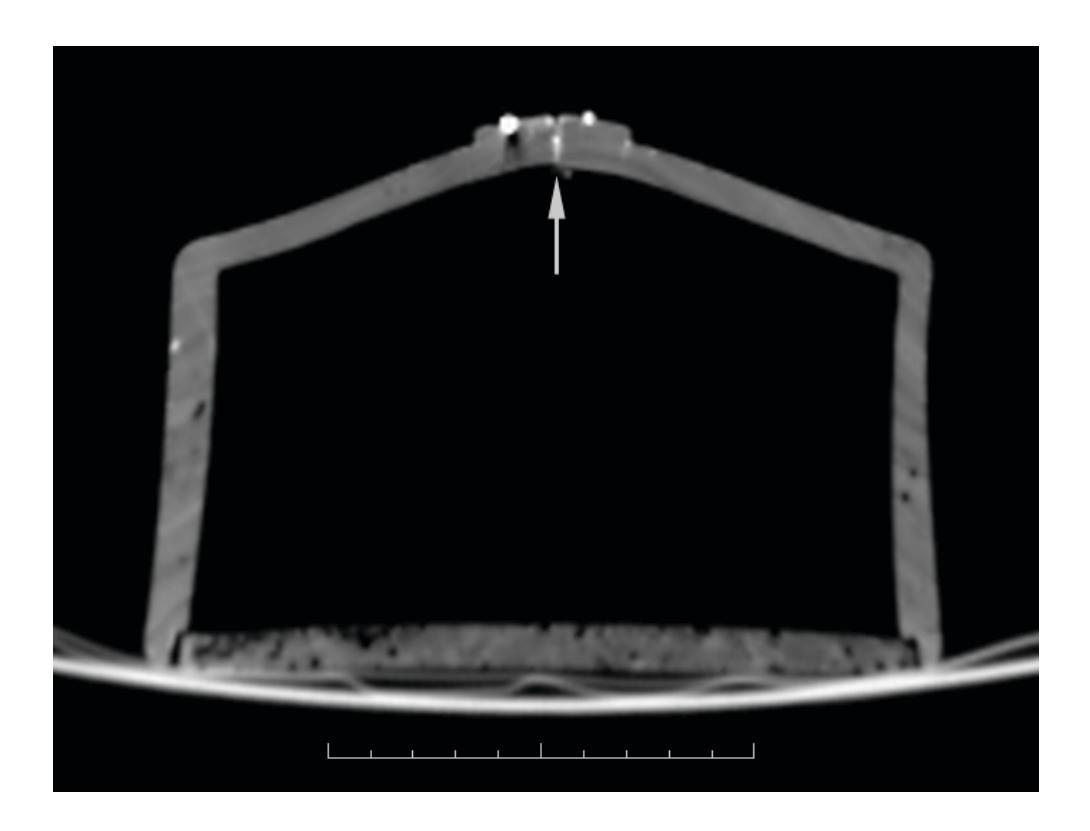
CT cross-section of the soundbox of the Queen Mary harp, showing the crack through the middle of the string band (arrowed). The scale is 1 tick = 1 cm. Tomogram obtained at the Clinical Research Imaging Centre, courtesy of the National Museums of Scotland, 2D rendering by Karen Loomis.

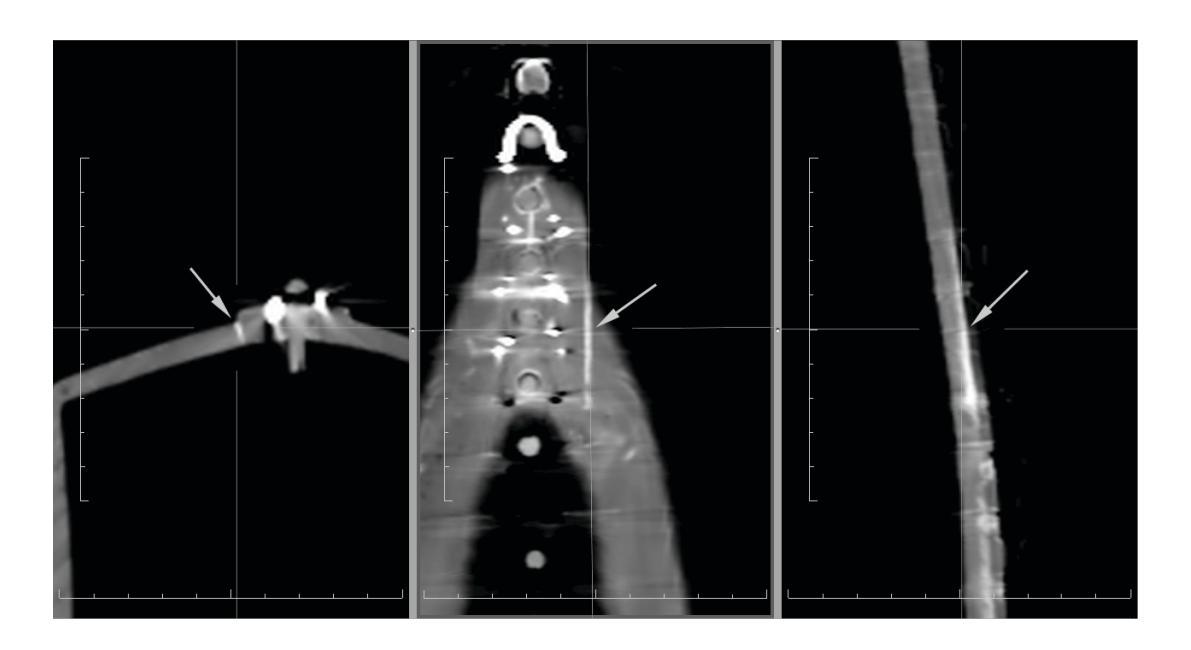
Three CT views of a crack along the left edge of the string band of the Queen Mary harp (arrowed). The left-hand tomogram is an axial cross-section across the soundbox, with the left side of the harp towards the left in the image. The center tomogram is a coronal cross-section parallel to the front surface of the soundbox, with the treble end of the harp towards the top of the image and the left side of the harp towards the right. The right-hand tomogram is a sagittal cross-section longitudinally through the soundbox, with the front of the harp towards the right side of the image, and the treble end towards the top. The scale is 1 tick = 1 cm. Tomogram obtained at the Clinical Research Imaging Centre, courtesy of the National Museums of Scotland, 2D orthogonal renderings by Karen Loomis.

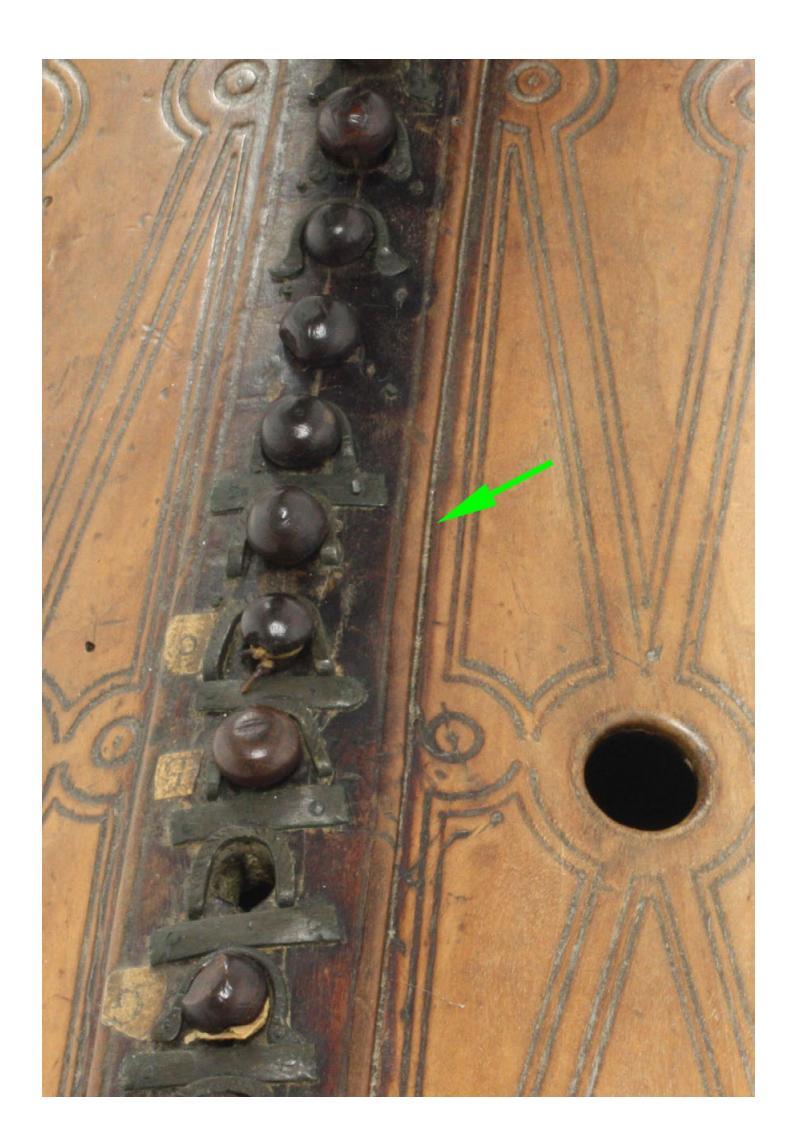
Photograph of the area of the soundbox shown in the center tomogram in figure 5. The location indicated in figure 37 is also indicated on this photograph (arrow). Although the crack shows up in the tomograms, it is not visible in the photograph. Photo: Karen Loomis, courtesy of the National Museums of Scotland.

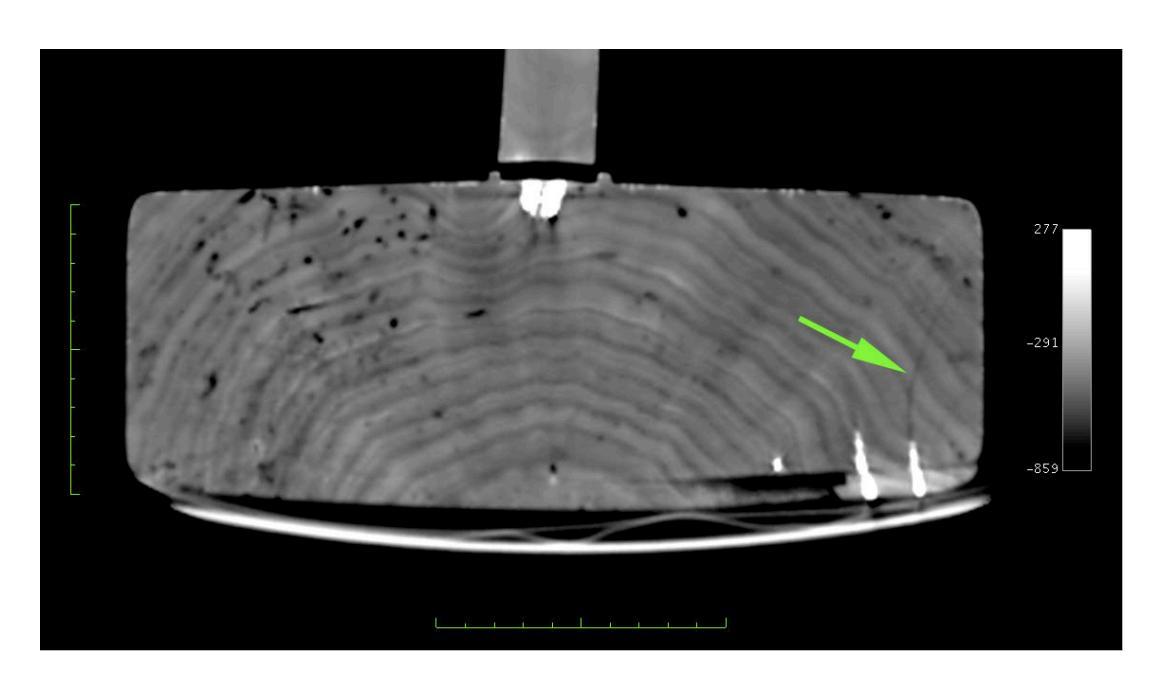
CT cross-section through the base of the Queen Mary harp, showing a crack extending from a nail driven through a patch in the back cover of the harp (arrowed). The front of the harp is towards the top of the tomogram. The scale is 1 tick = 1 cm. Tomogram obtained at the Clinical Research Imaging Centre, courtesy of the National Museums of Scotland, 2D rendering by Karen Loomis.

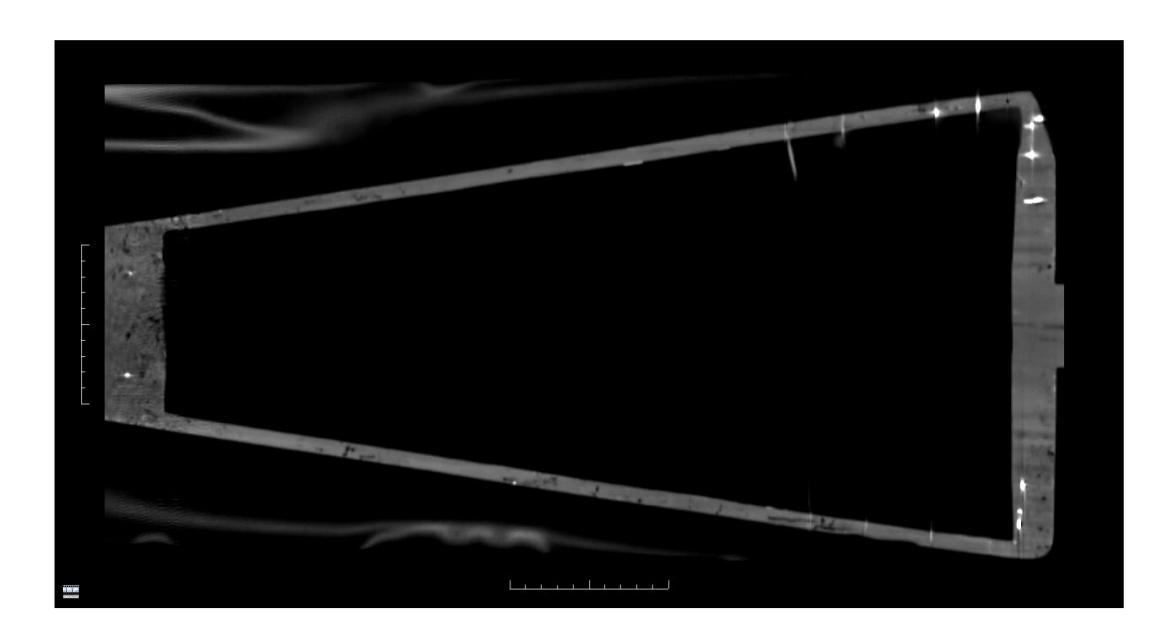
Video clip of cross-sections through the back cover of the Queen Mary harp, showing woodworm damage. The top of the harp is towards the left side of the tomogram, and the right side of the harp is towards the bottom. The grey swirls outside of the soundbox are images of the table the harp was resting on for scanning. This video clip is available in the electronic form of this document, and also as the file **QM_back.mov** on the disc accompanying the paper copy. The scale is 1 tick = 1 cm. Tomograms obtained at the Clinical Research Imaging Centre, courtesy of the National Museums of Scotland, 2D rendering by Karen Loomis.

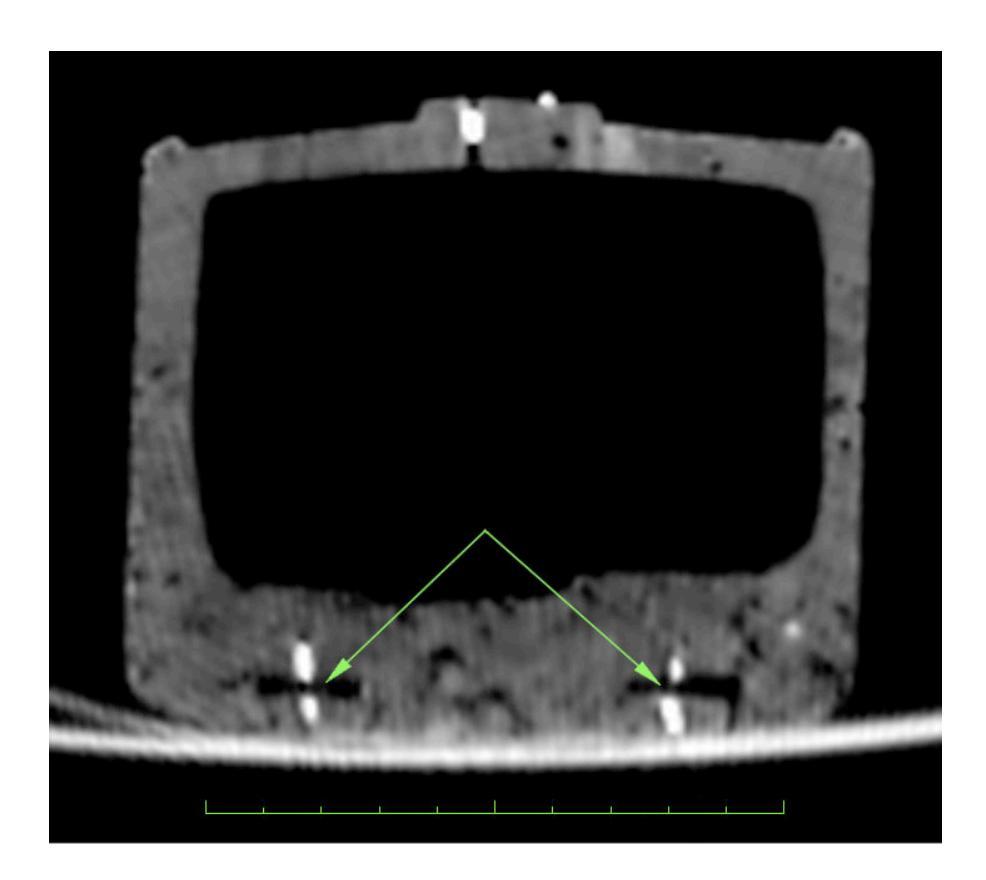
CT cross-section of the Queen Mary harp soundbox, through the top end of the back cover. Nails driven through the two tips of the cover (arrowed) appear to have been cut. The front of the soundbox is towards the top of the tomogram. The left side of the soundbox is towards the right. The scale is 1 tick = 1 cm. Tomogram obtained at the Clinical Research Imaging Centre, courtesy of the National Museums of Scotland, 2D rendering by Karen Loomis.

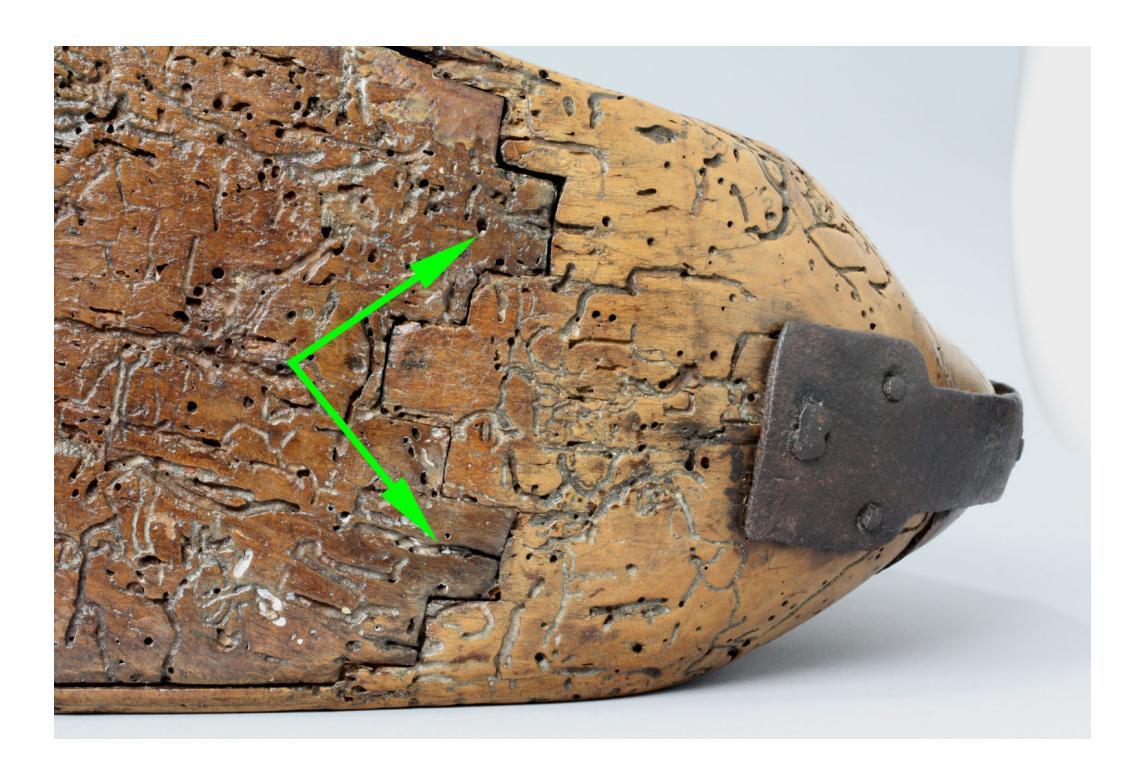
Photograph of the top end of the back cover of the Queen Mary harp, showing the location of two nails (arrowed) that CT imaging revealed were cut. Photo: Karen Loomis, courtesy of the National Museums of Scotland.

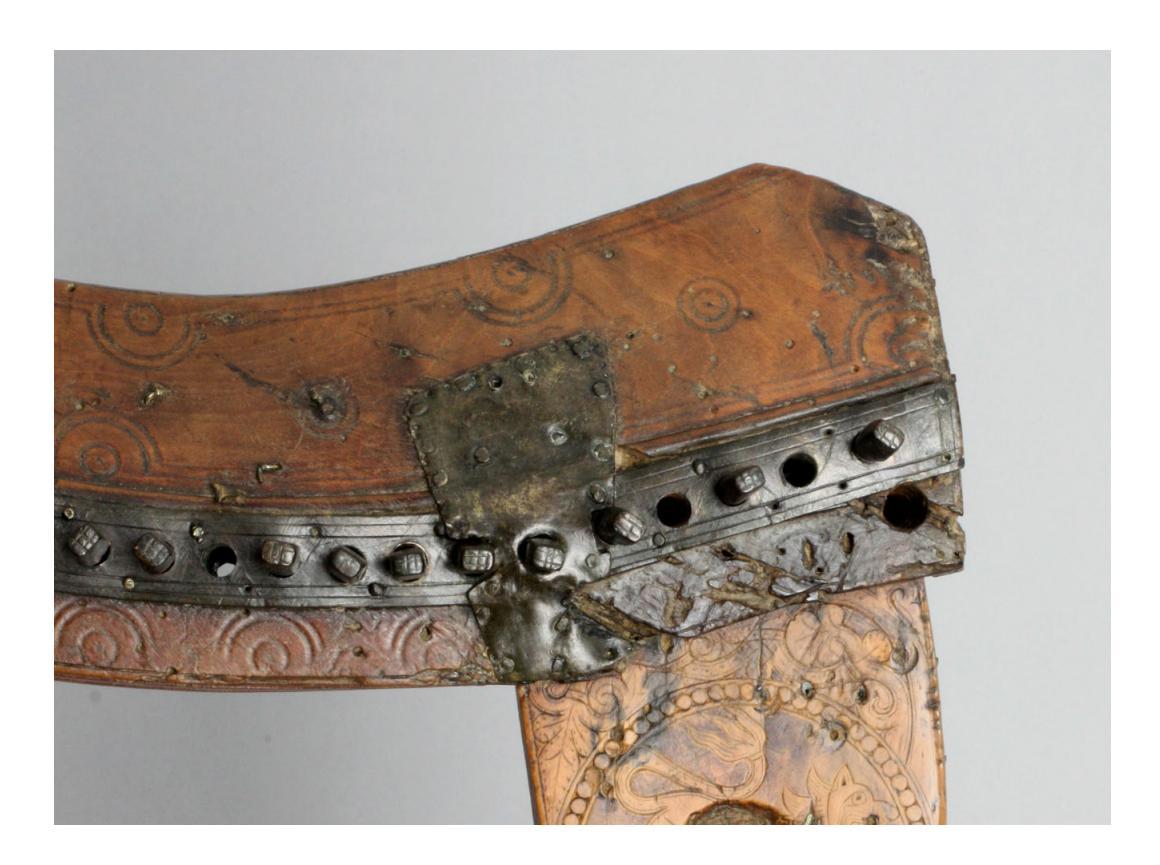
Photograph of the end of the neck of the Queen Mary harp, at the joint with the forepillar. A metal patch is nailed onto the neck, across the cheekband, and several diagonal cracks are visible on the neck. Photo: Karen Loomis, courtesy of the National Museums of Scotland.

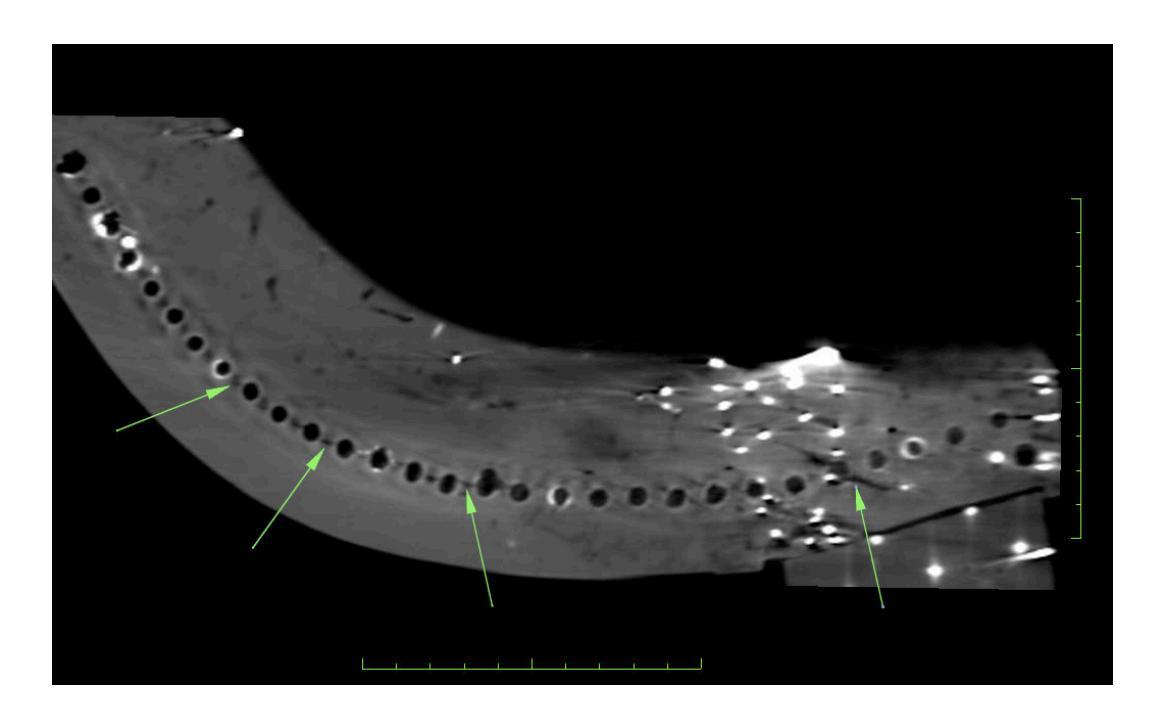
CT cross-section of the neck of the Queen Mary harp, showing an internal crack running diagonally through the 25^{th} tuning pin hole (arrowed). The outline of the metal patch is indicated by the nails driven through it, which appear as bright spots in this tomogram. Other arrows point to a crack running along the harmonic curve, in between the tuning pin holes. The treble end of the harmonic curve is towards the left in this tomogram. The scale is 1 tick = 1 cm. Tomogram obtained at the Clinical Research Imaging Centre, courtesy of the National Museums of Scotland, 2D rendering by Karen Loomis.

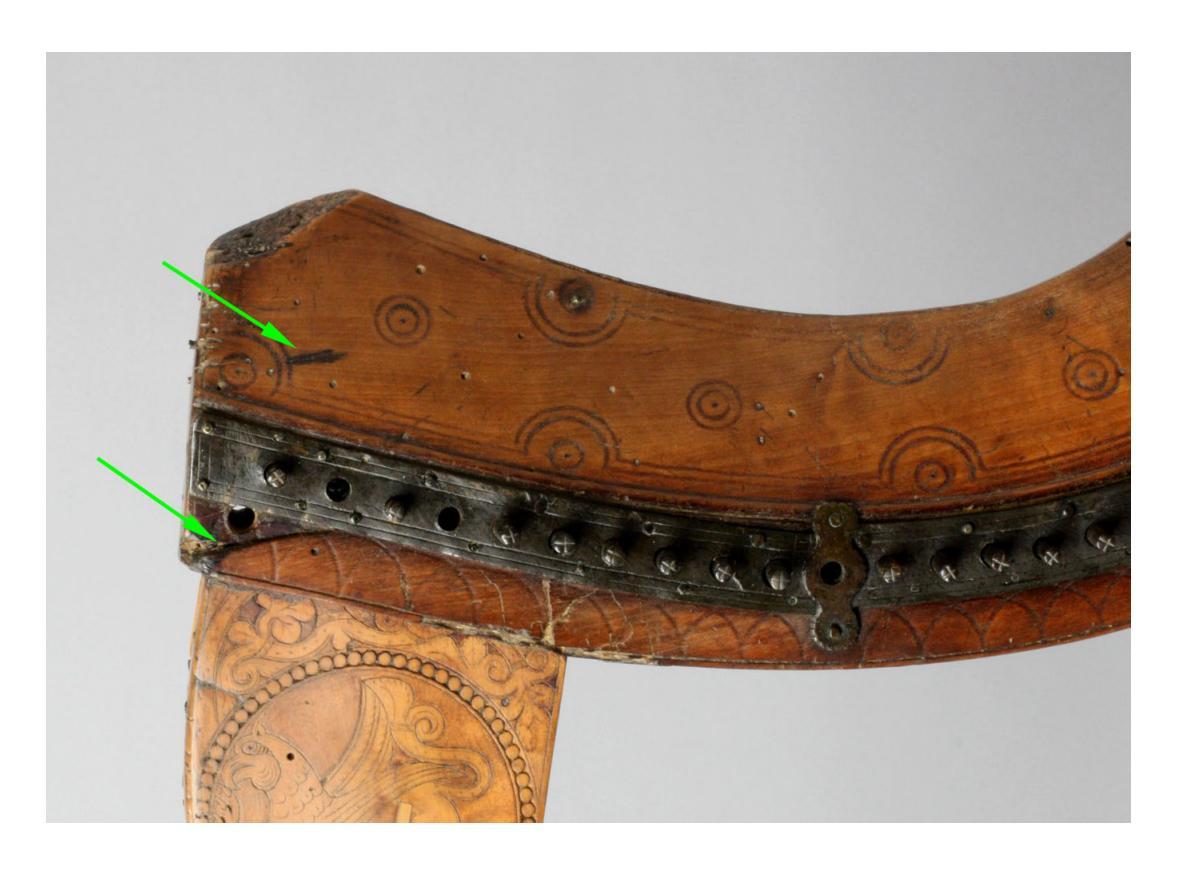
Photograph of the left side of the neck of the Queen Mary harp, showing evidence of cracks (arrowed). Photo: Karen Loomis, courtesy of the National Museums of Scotland.

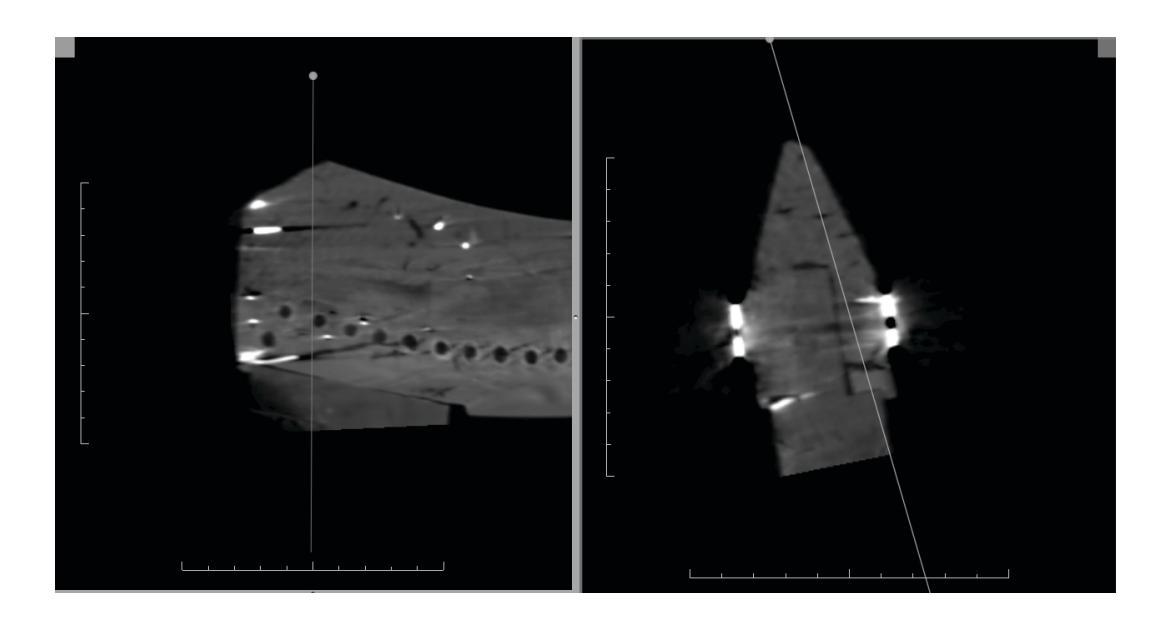
Two CT cross-sections through the end of the neck of the Queen Mary harp. The line drawn across each indicates the location of the other cross-section. Two diagonal cracks can be seen extending from nails driven into the front face of the neck. The lower crack extends into the neck to the forepillar tenon. Other, smaller cracks are also visible. The top of the harp is towards the top of each tomogram. The treble end of the harmonic curve is towards the right of the left-hand tomogram, and the left side of the harp is towards the right in the right-hand tomogram. The scale is 1 tick = 1 cm. Tomogram obtained at the Clinical Research Imaging Centre, courtesy of the National Museums of Scotland, 2D rendering by Karen Loomis.

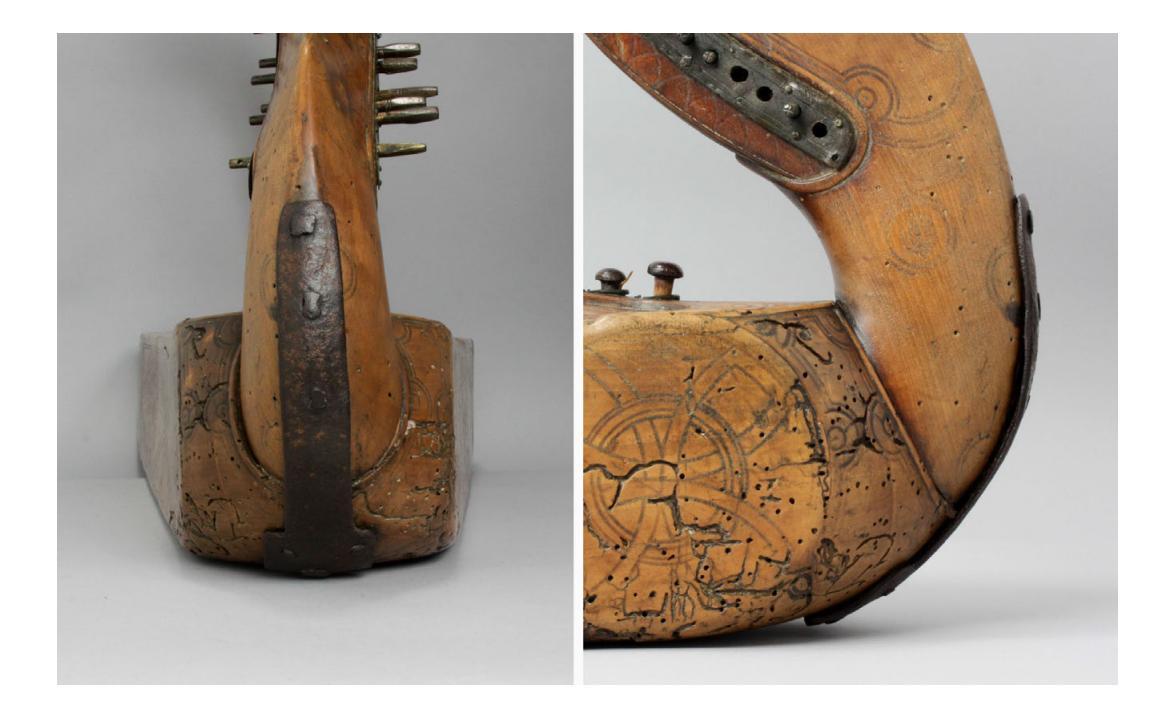
Two views of the joint between the neck and forepillar of the Queen Mary harp, showing the iron strap nailed across the joint. Photo: Karen Loomis, courtesy of the National Museums of Scotland.

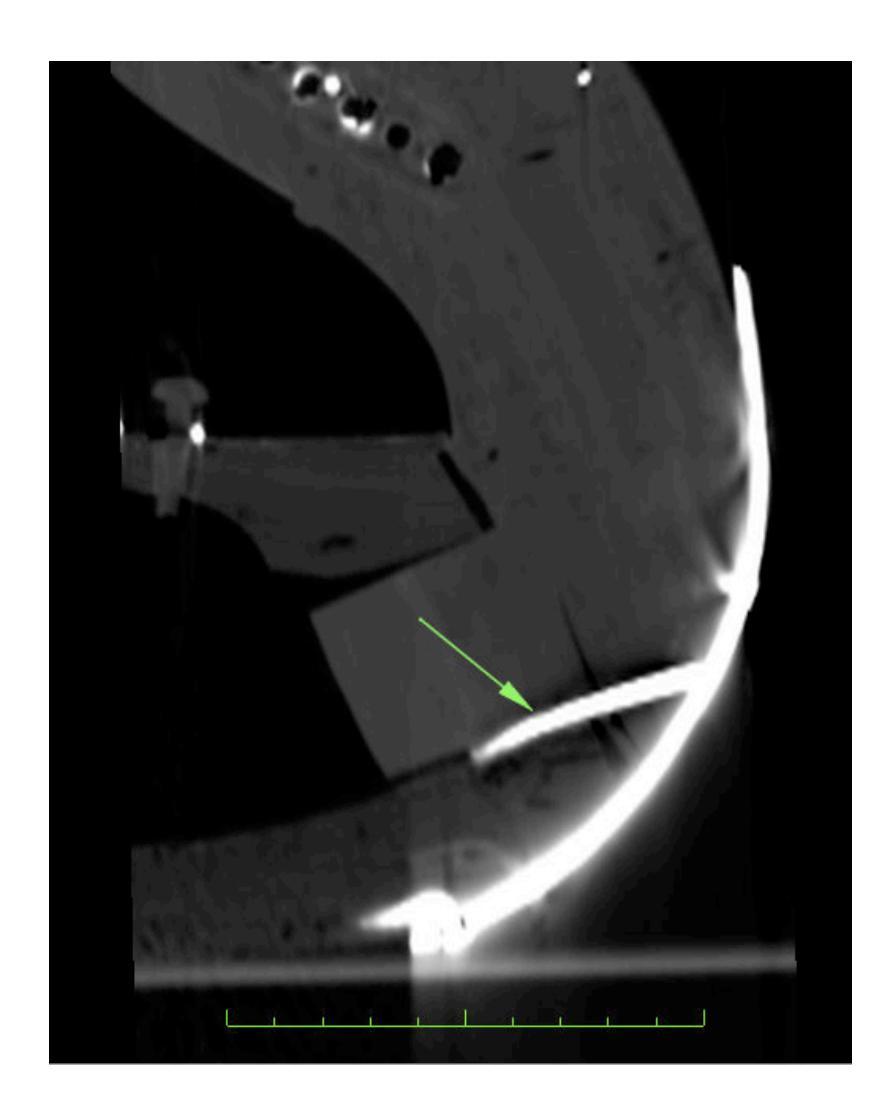
CT cross-section through the joint at the neck and soundbox of the Queen Mary harp, showing the neck tenon, which is cracked, and a metal rod in the joint (arrowed), hidden underneath the iron strap. The view and orientation is the same as that in the right hand photograph in figure 53. The scale is 1 tick = 1 cm. Tomogram obtained at the Clinical Research Imaging Centre, courtesy of the National Museums of Scotland, 2D rendering by Karen Loomis.

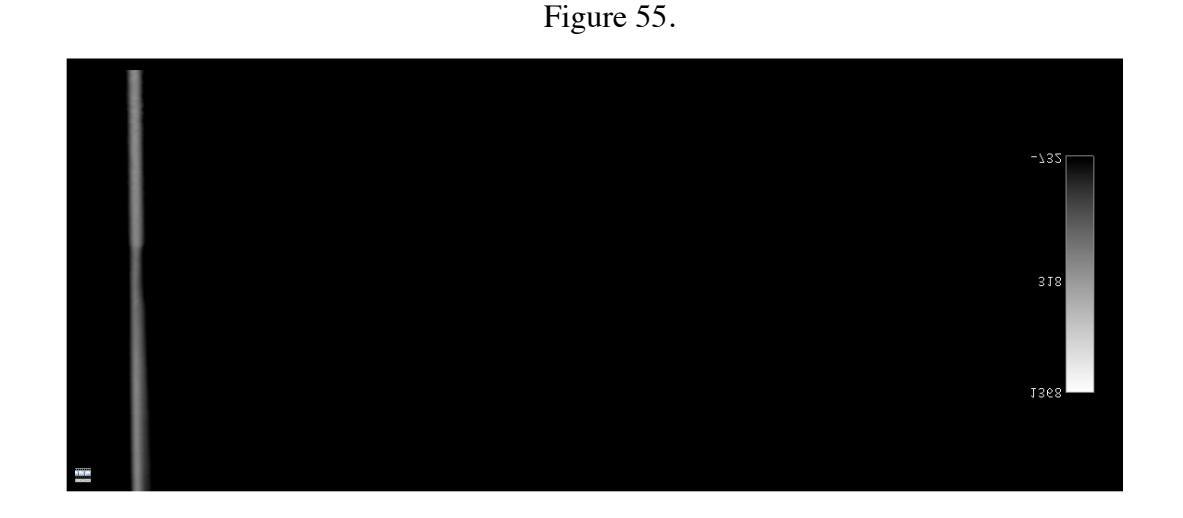
Video clip of sagittal (lengthwise) cross-sections through the Queen Mary harp, showing the iron strap and nails driven through it, as well as the metal rod wedged in the joint. A crack can be seen in the tenon, and a small wedge is visible between the back of the neck and the soundbox. This video clip is available in the electronic form of this document, and also as the file QM_neck_sag_09.mov on the disc accompanying the paper copy. Tomograms obtained at the Clinical Research Imaging Centre, courtesy of the National Museums of Scotland, 2D rendering by Karen Loomis.

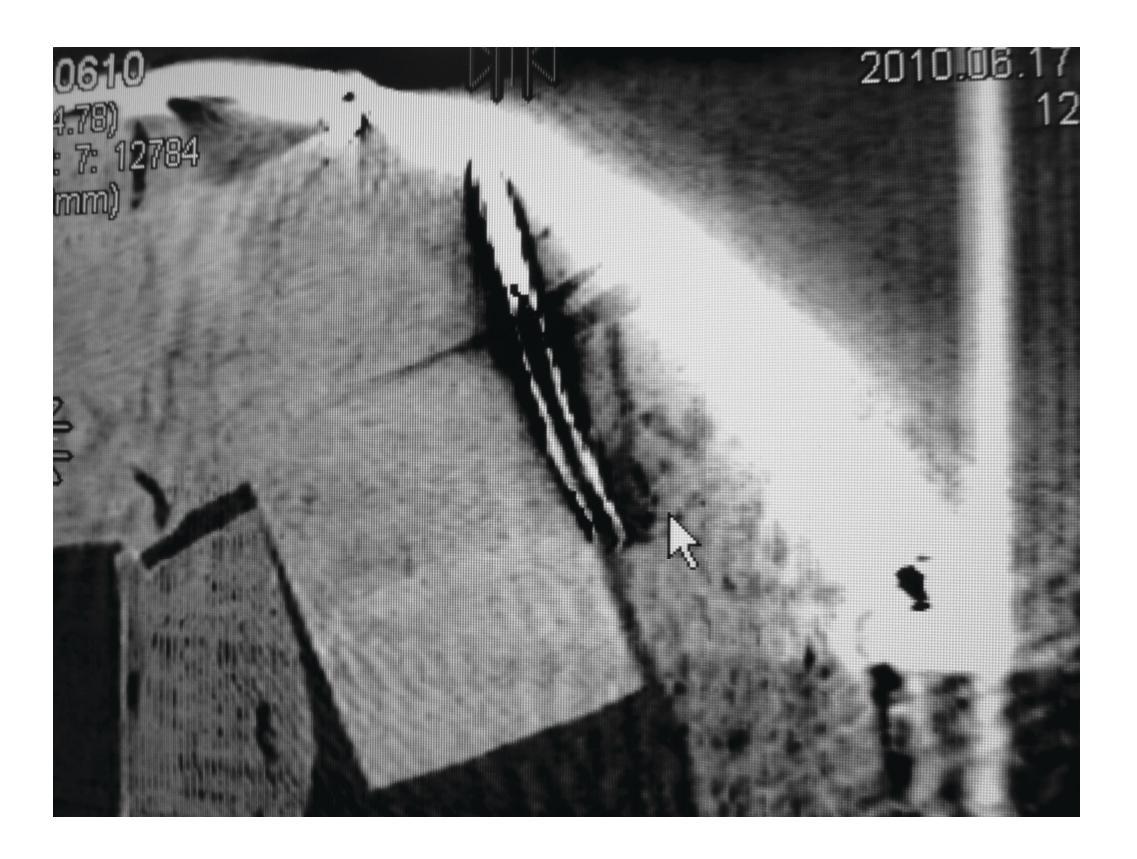
Snapshot of a screen of data taken during the scanning process, showing a sagittal (sideways) view of the neck to soundbox joint of the Queen Mary harp with what may be a hollow metal rod in the neck. tomogram obtained at the Clinical Research Imaging Centre, courtesy of the National Museums of Scotland. 2D rendering by Tessa Smith, CRIC.

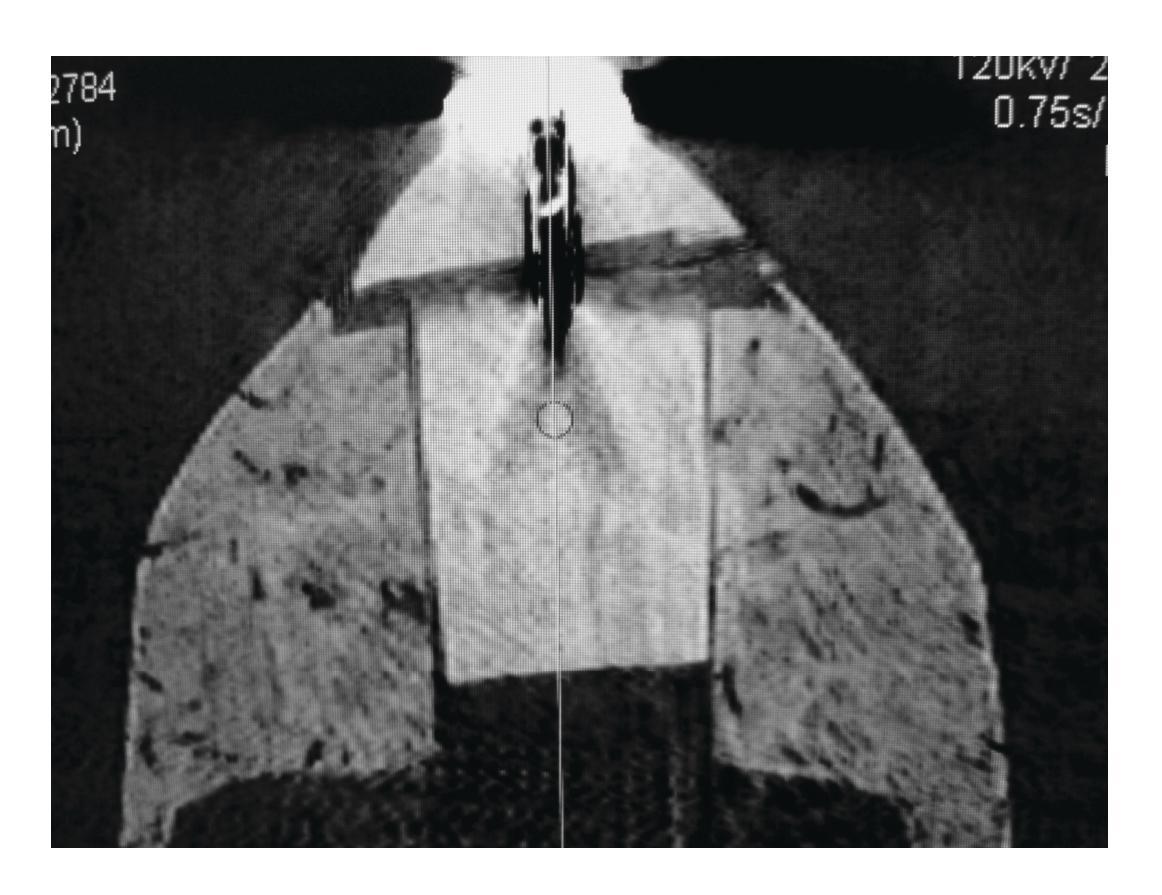
Snapshot of a screen of raw data taken during the scanning process, showing a coronal (parallel to the front of the soundbox) view of the neck to soundbox joint of the Queen Mary harp. In this tomogram, the rod appears to be channel shaped. Tomogram obtained at the Clinical Research Imaging Centre, courtesy of the National Museums of Scotland. 2D rendering by Tessa Smith, CRIC.
