KAREN LOOMIS, DAVID CALDWELL, JIM TATE, TICCA OGILVIE
AND EDWIN J. R. VAN BEEK

The Lamont and Queen Mary Harps

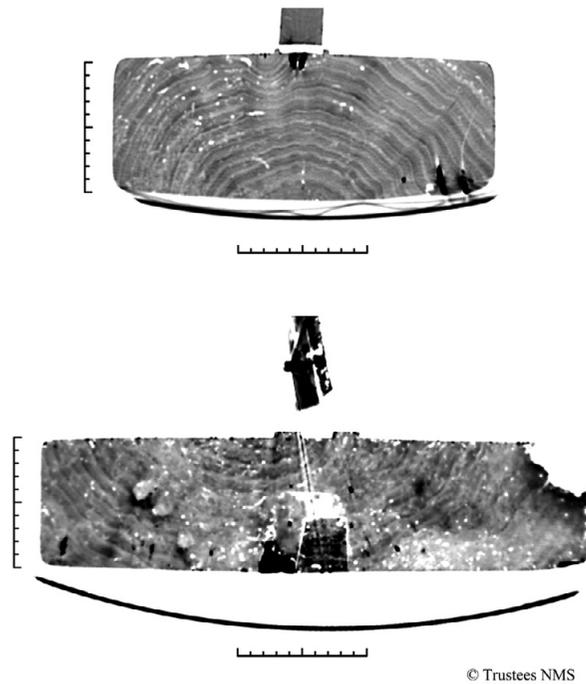
Figure 2. Tomograms of the Queen Mary harp (top) and Lamont harp (bottom), showing the direction of the growth rings in the soundbox wood; scale: 1 tick: 1cm.

is visible on the tomograms. These clearly show that the soundbox is constructed from a half sawn boxed timber, with its central growth rings oriented towards the front, or playing surface (Figure 2). The centre-line of the tree lies 5cm to the right of the centre of the string band, so the box is not quite centred in the log from which it was cut.

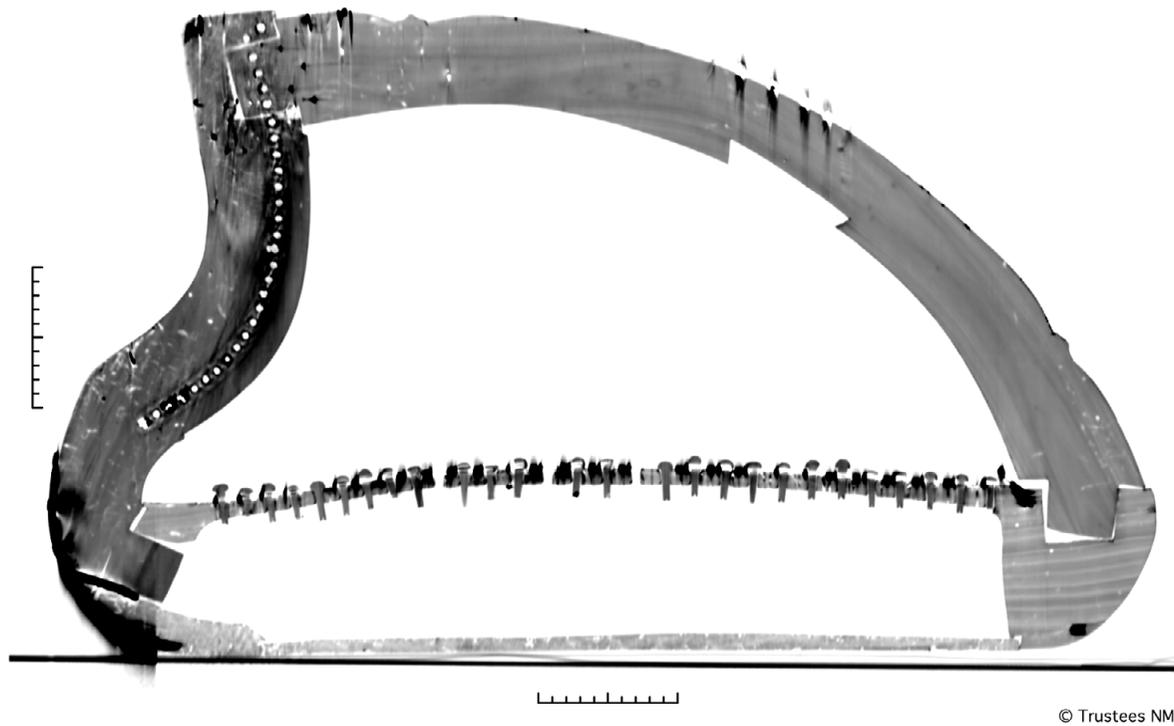
Figure 8. *Sagittal tomogram of the Queen Mary harp. The soundbox cavity, joints, and wood grain are all visible in this cross-section. In order to show all three joints, the cross-section is angled slightly to the long axis of the soundbox. Scale 1 tick : 1cm.*

Looking at the workmanship of the joints, neither of the tenons at the ends of the forepillar fits its mortise particularly well (Figure 8). The tenon at the bottom of the forepillar has rotated slightly out of its joint, but even if it were not rotated, there would still be a gap between the tenon shoulder and the foot of the soundbox because the tenon is angled such that it cannot seat completely in the joint. The tenon at the top of the forepillar is also angled in its joint with the neck. The holes for the tuning pins pass through this tenon, and it is apparent from the line of holes visible in the tomograms that the tenon has not moved or rotated significantly since the forepillar was installed on the harp and the holes were bored through the tenon.

The tomograms reveal that some of the tuning pin holes contain thin irregular sheets of a dense, possibly metallic material (Figure 8). In some instances the material looks like it is lining the inside surface of the hole, in others it appears to be crumpled. In her examination of the Trinity College harp, Rimmer reported that several tuning pin holes were 'lined with thin metal to get a better fit' for the tuning pins,⁵⁷ so it is possible that this is what is

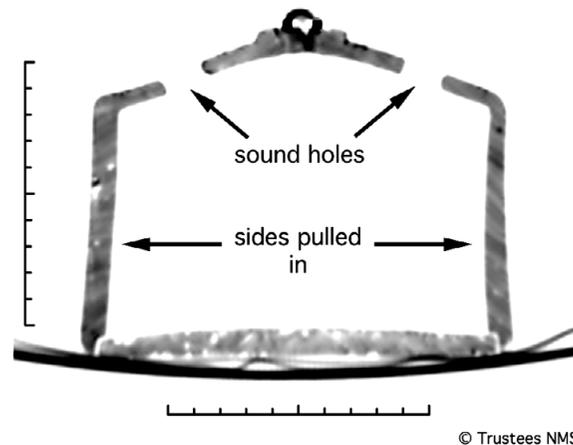
Figure 9. *Axial tomogram of the Queen Mary harp. This cross-section across the soundbox shows the straight-sided profile of the sound holes, the arch of the belly, and the pulled-in sides of the soundbox. Scale 1 tick : 1cm.*
