The Queen Mary and Lamont Harps: A Study of Structural Breaks and Repairs

A thesis submitted for the MMus in Musical Instrument Research

by Karen A. Loomis 0957990

16 August 2010

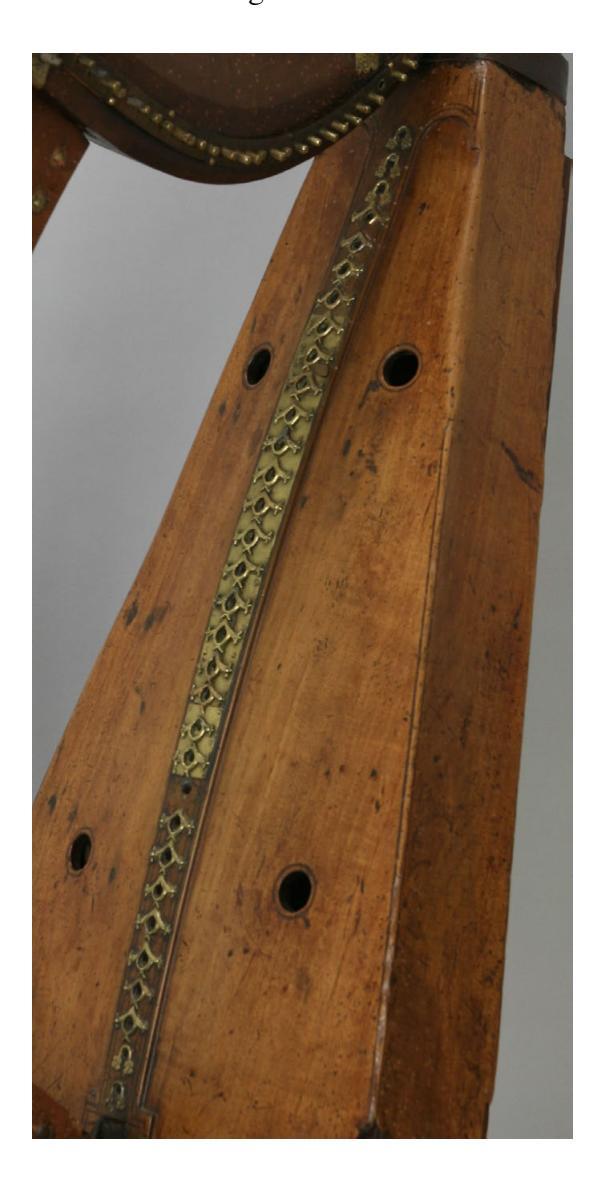
Figure 10.

A notable feature on the front of the soundbox is the presence of a metal band comprising three metal strips inserted under the string shoes along the highest portion of the belly, as shown in the photograph in figure 10. These strips were reported by Gunn (1807),²⁴ and are visible in an 1888 lithograph by William Gibb.²⁵

The stringband of the Lamont harp showing a metal band inserted under the string shoes from holes #8 - #22. Photo: Maripat Goodwin, courtesy of the National Museums of Scotland.

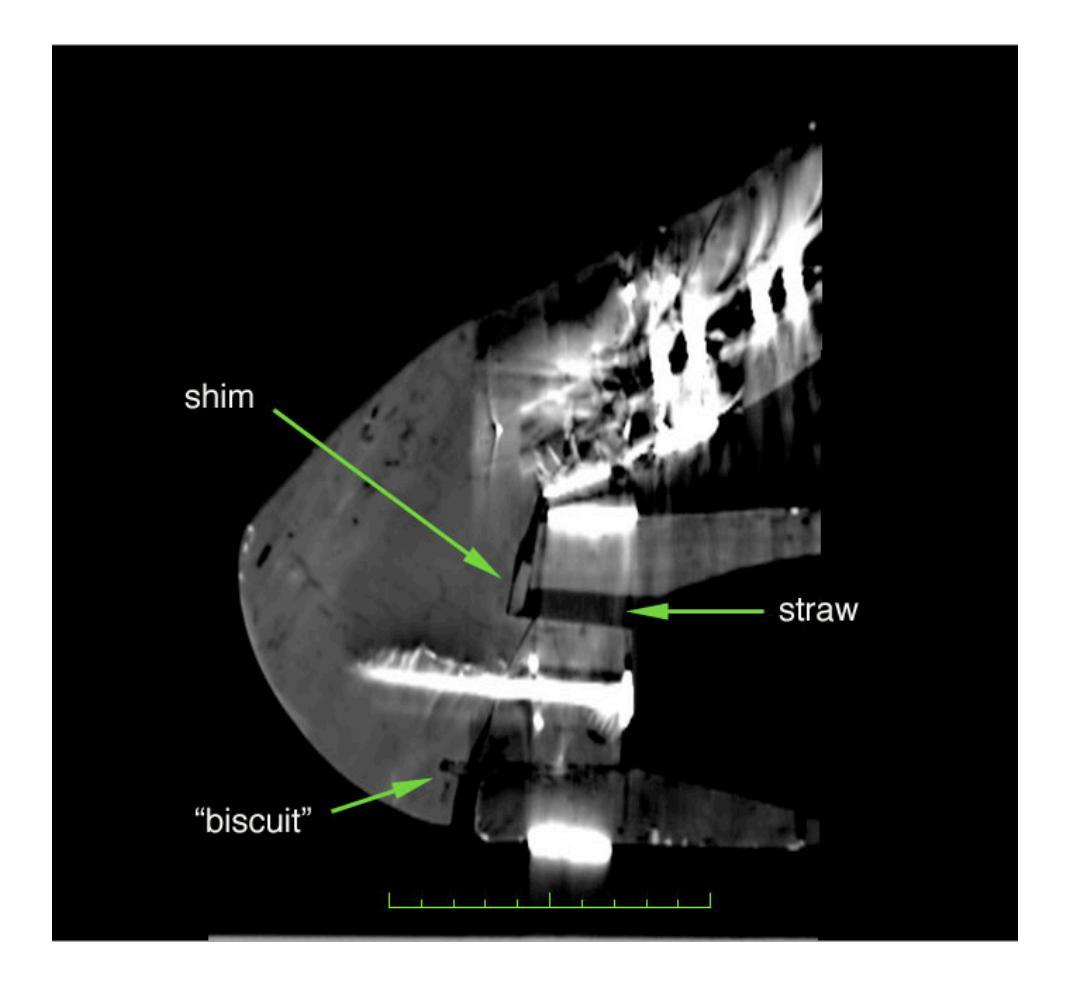
Figure 26.

The mortise and tenon joint between the neck and the soundbox was also subjected to significant stress and torsion due to the tension of the strings. The tomograms of this joint reveal internal damage and repairs as well as efforts to compensate for the twisting and slumping of the neck of the harp. Figure 26 shows a cross-section of this joint.

CT sagittal cross-section of the neck to soundbox mortise and tenon joint, showing a spike through the tenon. Also visible are a shim to raise the neck, a slot and slip of wood (similar to a modern biscuit), and a gap that is filled with straw (arrowed). The scale is 1 tick = 1 cm. Tomogram obtained at the Clinical Research Imaging Centre, courtesy of the National Museums of Scotland, 2D rendering by Karen Loomis.

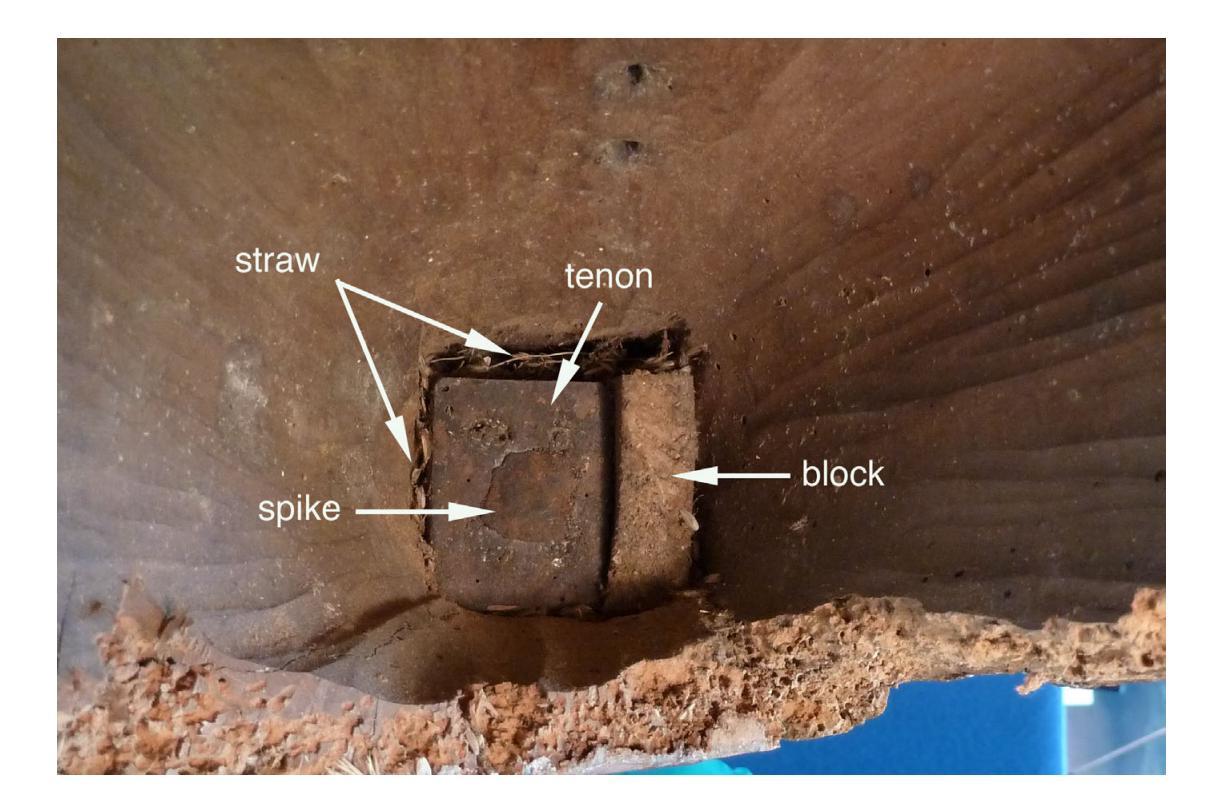
Figure 31.

Interior of the soundbox of the Lamont harp, looking towards the neck to soundbox mortise and tenon joint. The end of the tenon is visible, as are the spike and block seen in the tomograms. The straw that fills the gap in the joint is also visible. The front of the soundbox is towards the top of the photo, and the left side of the harp is towards the right. Photo by Karen Loomis, courtesy of the National Museums of Scotland.

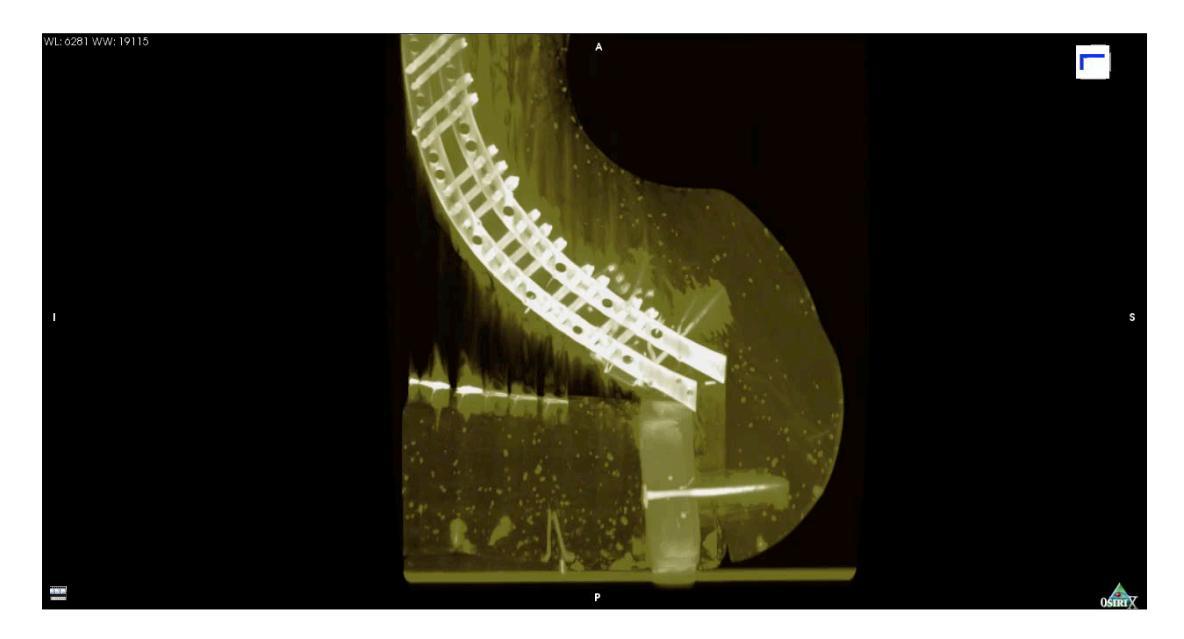
Figure 32.

3D video clip of the neck to soundbox joint of the Lamont harp, showing the spike and nails used to repair and reinforce the tenon. The nails used to repair the neck crack are also visible. The video clip is available in the electronic form of this document and also as the file Lam_neck_3D_02.mov on the disc accompanying the paper copy. Tomograms obtained at the Clinical Research Imaging Centre, courtesy of the National Museums of Scotland, 3D rendering by Karen Loomis.

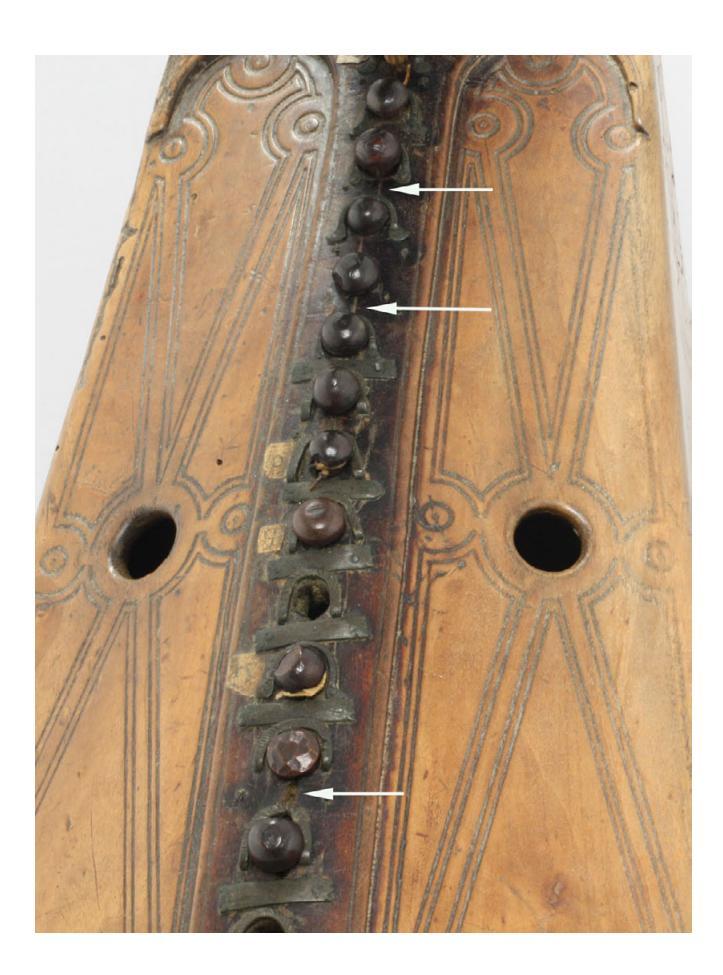
Figure 34.

Beginning with the soundbox, Armstrong (1904) reports seeing a crack in the string band, extending from the 10th to the 15th string holes, ¹/₄-inch deep and ¹/₈-inch wide.³⁷ This crack is readily visible running down the line of string holes, although photographs taken for the current study show it running from the 3rd to the 15th string holes. Most of the crack is visible in figure 34.

Photograph of the string band of the Queen Mary harp, showing a crack running through the line of string holes (arrowed). Photo: Karen Loomis, courtesy of the National Museums of Scotland.

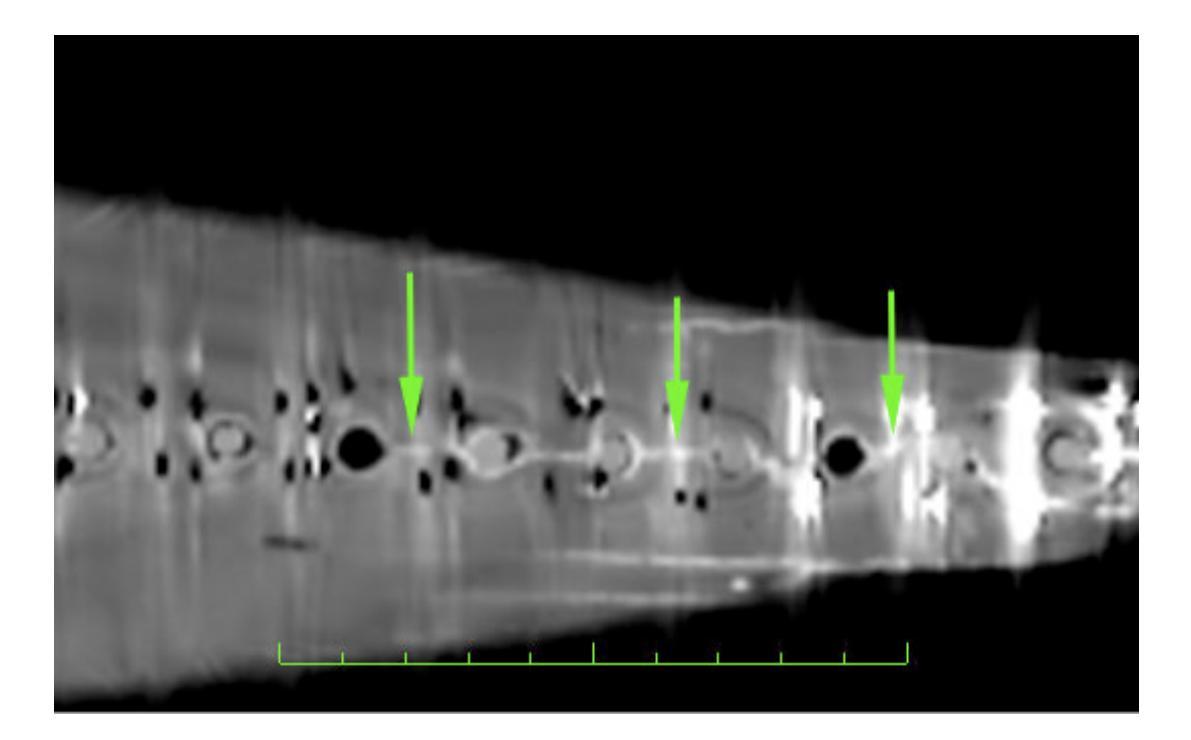
Figure 35.

tomogram of the portion of the string band of the Queen Mary harp from the 8^{th} to the 16^{th} string holes. A crack running along the line of string holes is visible as a light grey line (arrowed). The scale is 1 tick = 1 cm. Tomogram obtained at the Clinical Research Imaging Centre, courtesy of the National Museums of Scotland, 2D rendering by Karen Loomis.

On the Queen Mary harp, surface cracks and crevices are filled with a dark, waxy substance that appears light in the CT renderings because it is more opaque to x-rays than the surrounding wood. So, the crack in the string band is visible as a light grey line in the tomogram in figure 3. Armstrong gives a measurement of ¹/₄-inch (0.6 cm) for the depth of the crack. The tomogram in figure 36 shows a cross-section of the crack just above string hole #13.

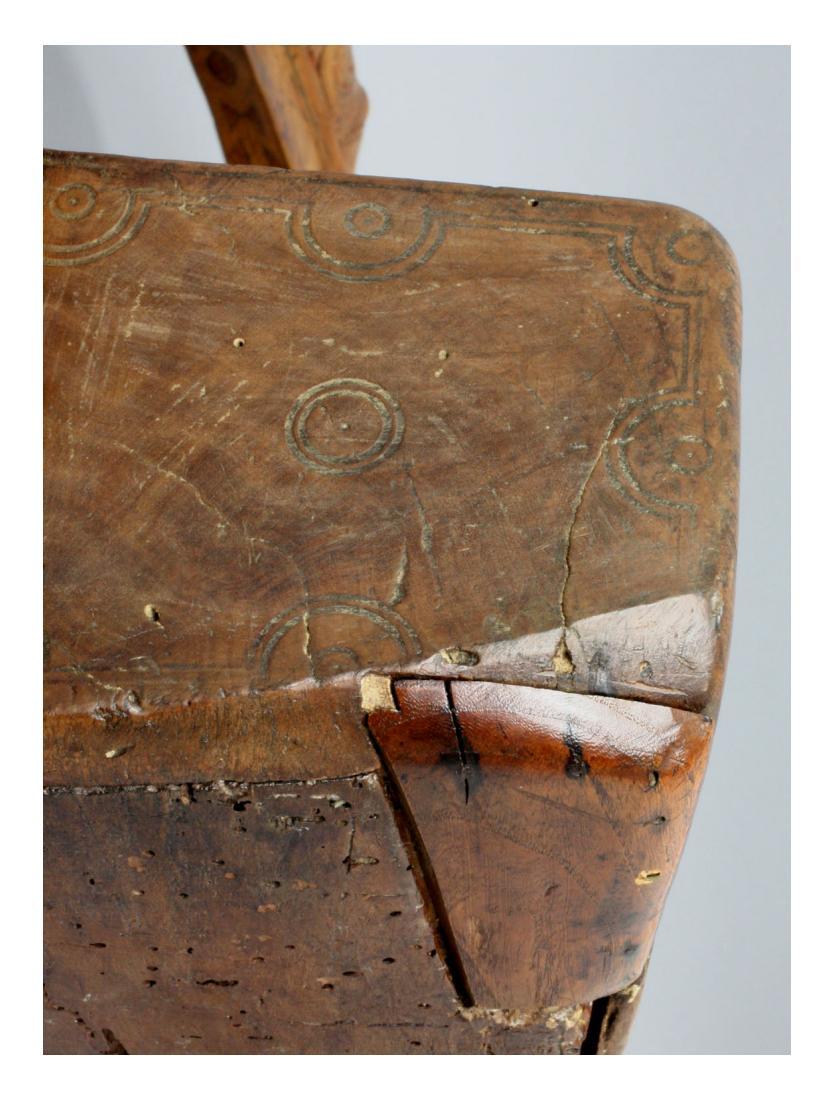
Figure 39.

The base of the soundbox of the Queen Mary harp has a crack on its left back corner. This is readily visible, as shown in the photograph in figure 39, and is adjacent to a patch in the same corner of the back cover of the soundbox.

Photograph of the back left corner of the base of the Queen Mary harp soundbox, showing a crack and an adjacent patch to the back cover. Photo: Karen Loomis, courtesy of the National Museums of Scotland.

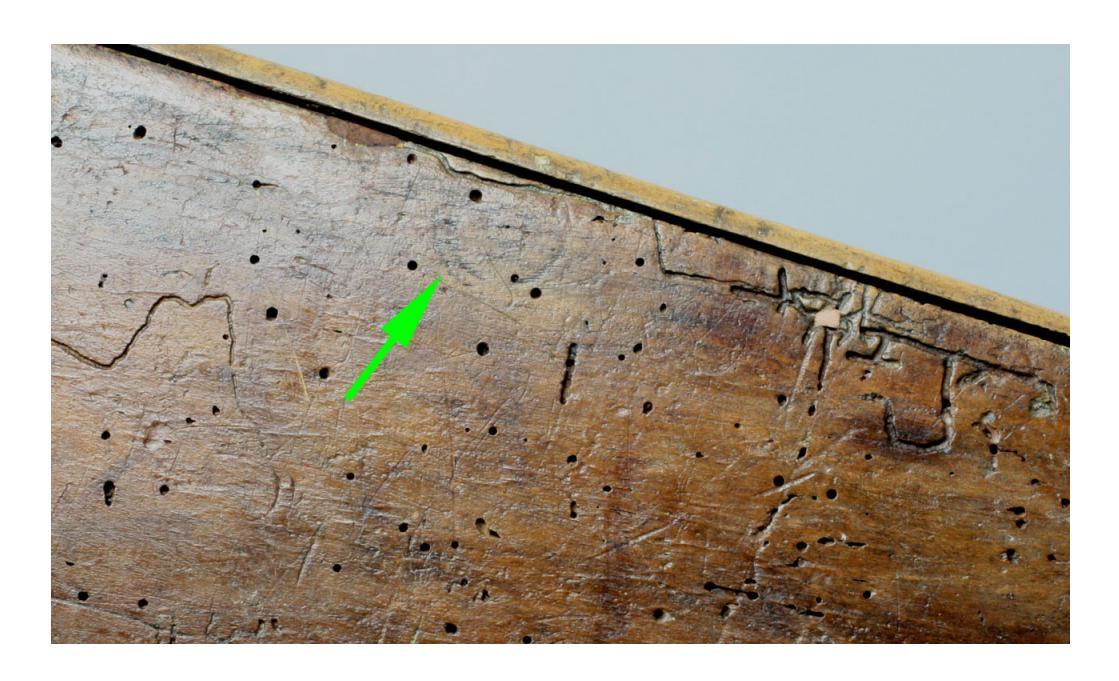
Photograph of a portion of the back cover of the soundbox of the Queen Mary harp, showing traces of decorative work matching that on the soundbox (arrowed). Photo: Karen Loomis, courtesy of the National Museums of Scotland.

The fact that this cover is very likely original (and may be the only surviving one) makes it an item of importance for conservation. The photograph in figure 41 shows a lot of woodworm damage on the surface, suggesting interior damage as well. This is confirmed by tomograms of the back cover, as shown in figure 42, which reveal the full extent of the damage.

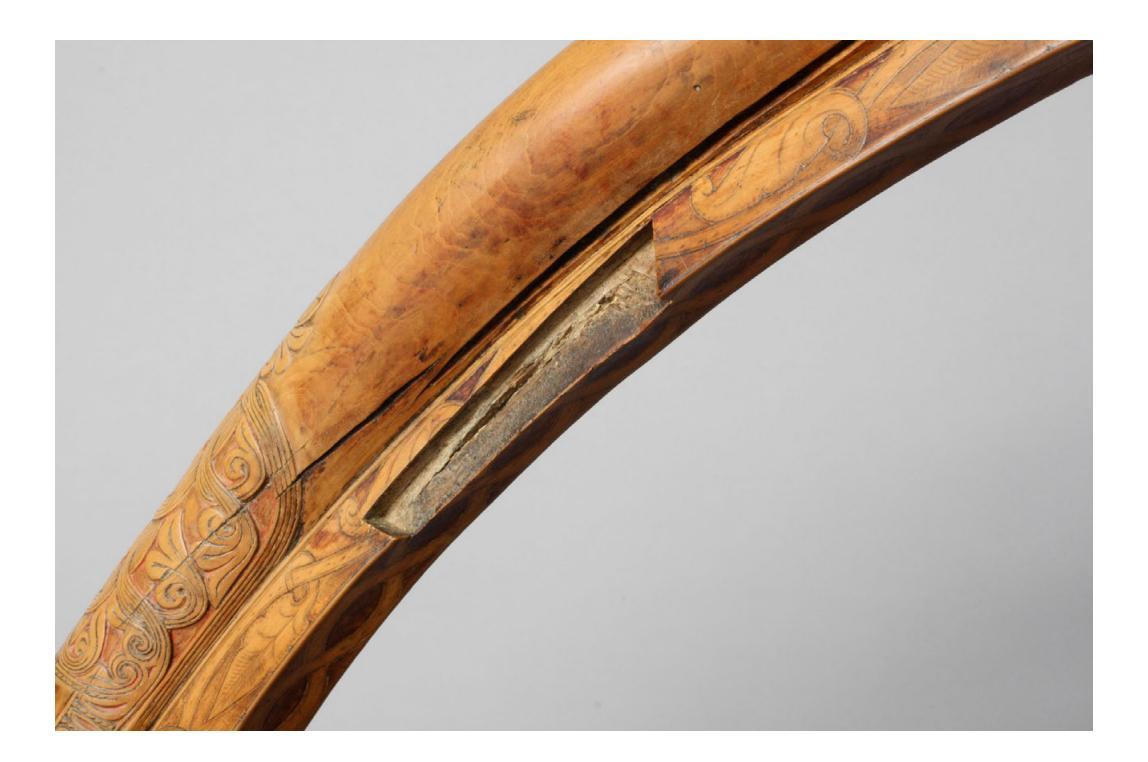
Figure 45.

The forepillar of the Queen Mary harp, though otherwise in exceptionally good condition, has a large crack extending along the middle third of its length on the left side, and a section that has been purposely cut out. This is shown in the photograph in figure 45.

Photograph of the middle section of the left side of the forepillar of the Queen Mary harp, showing a crack running along the underside of the t-section, and a piece of the wood cut out. Photo: Karen Loomis, courtesy of the National Museums of Scotland.

The crack is approximately 19 cm long, and the cut out section is 10 cm at its longest. Armstrong (1904) describes the crack and the cut out section of wood, stating that the builder of the harp probably encountered a defective section of wood, and needed to cut it out and let in a replacement piece that eventually fell out, leaving the gap.⁴⁰ A crack and remnants of what may be glue can be seen on the inside surface of the gap. Figure 46 shows a CT cross-section of the forepillar through the back surface of the cutout section.

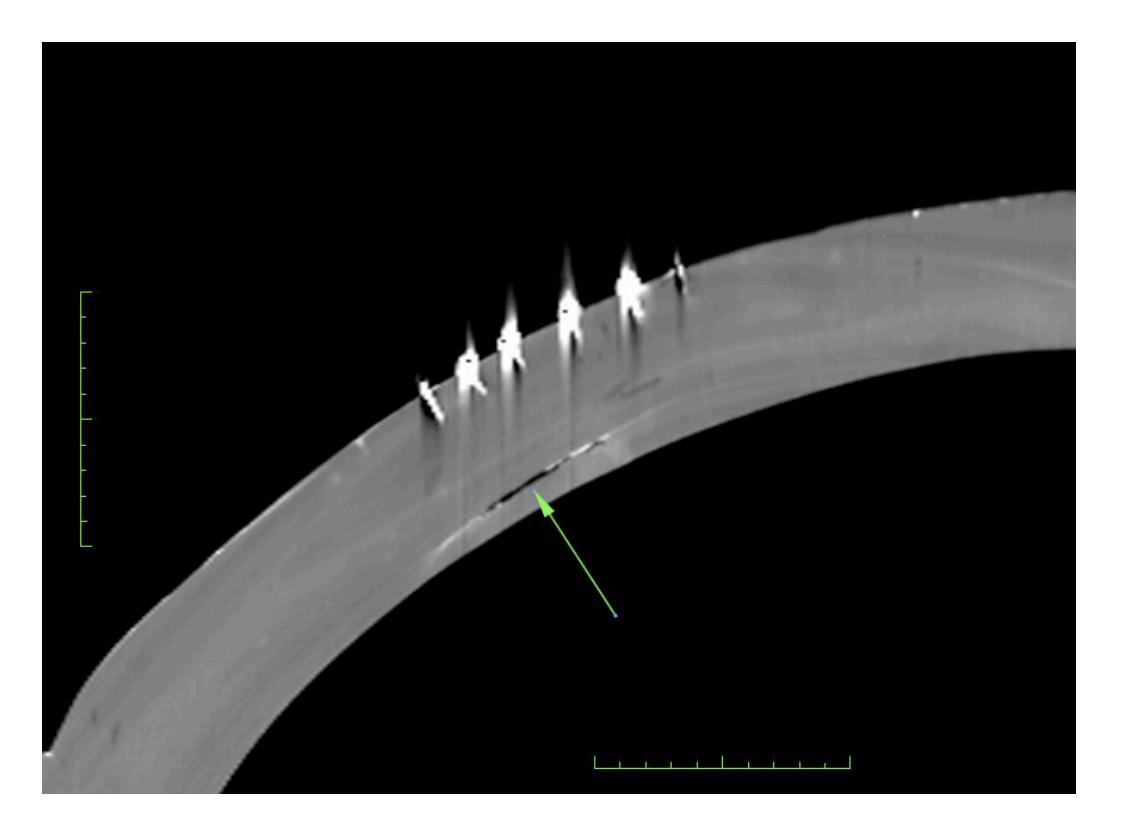
CT sagittal cross-section of the forepillar of the Queen Mary harp, showing the crack on the inside surface of the cutout section (arrowed). The white areas at the edges of the crack may be remnants of glue. The bright spots on the outer edge of the forepillar are decorative metal studs. The treble end of the harp is towards the right of the tomogram. The scale is 1 tick = 1 cm. Tomogram obtained at the Clinical Research Imaging Centre, courtesy of the National Museums of Scotland, 2D rendering by Karen Loomis.

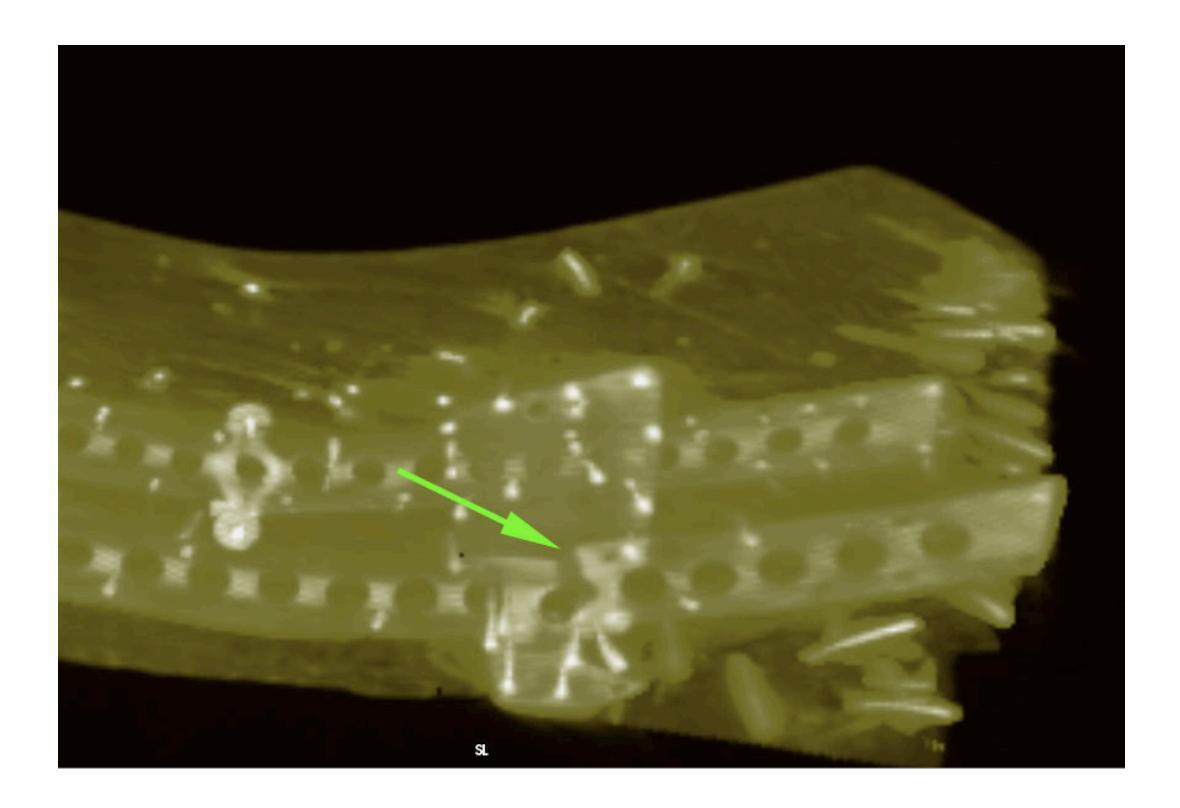
Figure 49.

In this photograph, one can see the metal patch described by Armstrong as well as several small diagonal cracks in the wood. The smooth curve of the cheekband is disrupted underneath the patch. Armstrong (1904) suspects that the patch is covering

a break in the cheekband.⁴³ A 3D reconstruction from the tomograms of the neck confirms Armstrong's suspicion, as shown in figure 49.

3D reconstruction from tomograms of the neck of the Queen Mary harp, showing a hidden break in the cheekband at the 24th tuning pin hole (arrowed). Tomograms obtained at the Clinical Research Imaging Centre, courtesy of the National Museums of Scotland, 3D reconstruction by Karen Loomis.

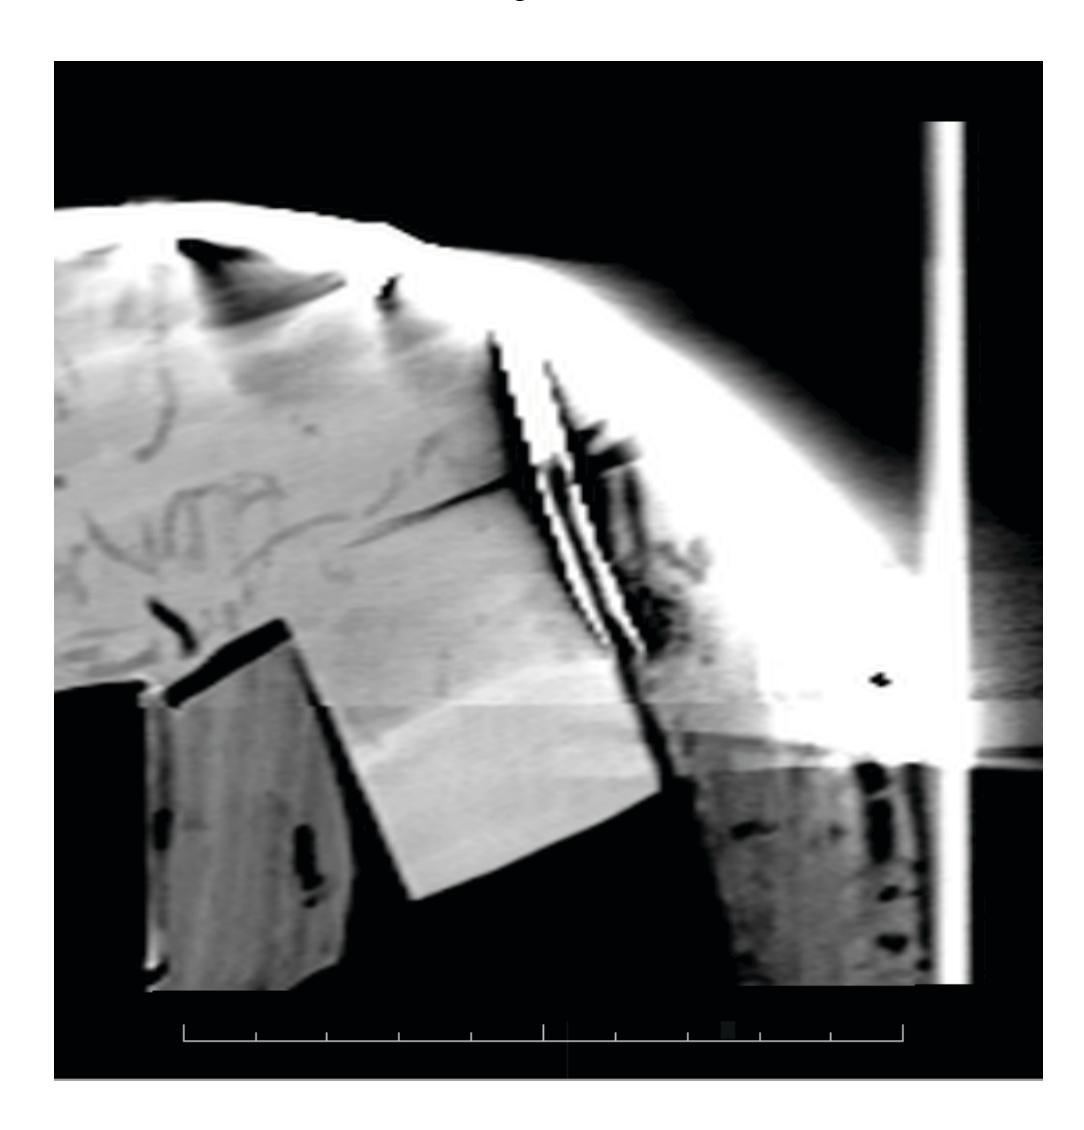
Figure 59.

It is possible to reproduce these tomograms with processing as shown in figures 59 and 60, but it is not at all clear that the apparent hollowness of the rod is not an artifact of the image processing.

A post-processed cross-section of the neck joint of the Queen Mary harp similar to that shown in figure 57. The scale is 1 tick = 1 cm. Tomogram obtained at the Clinical Research Imaging Centre, courtesy of the National Museums of Scotland. Minimum Intensity Projection, thick slab mode 6. 2D rendering by Karen Loomis.

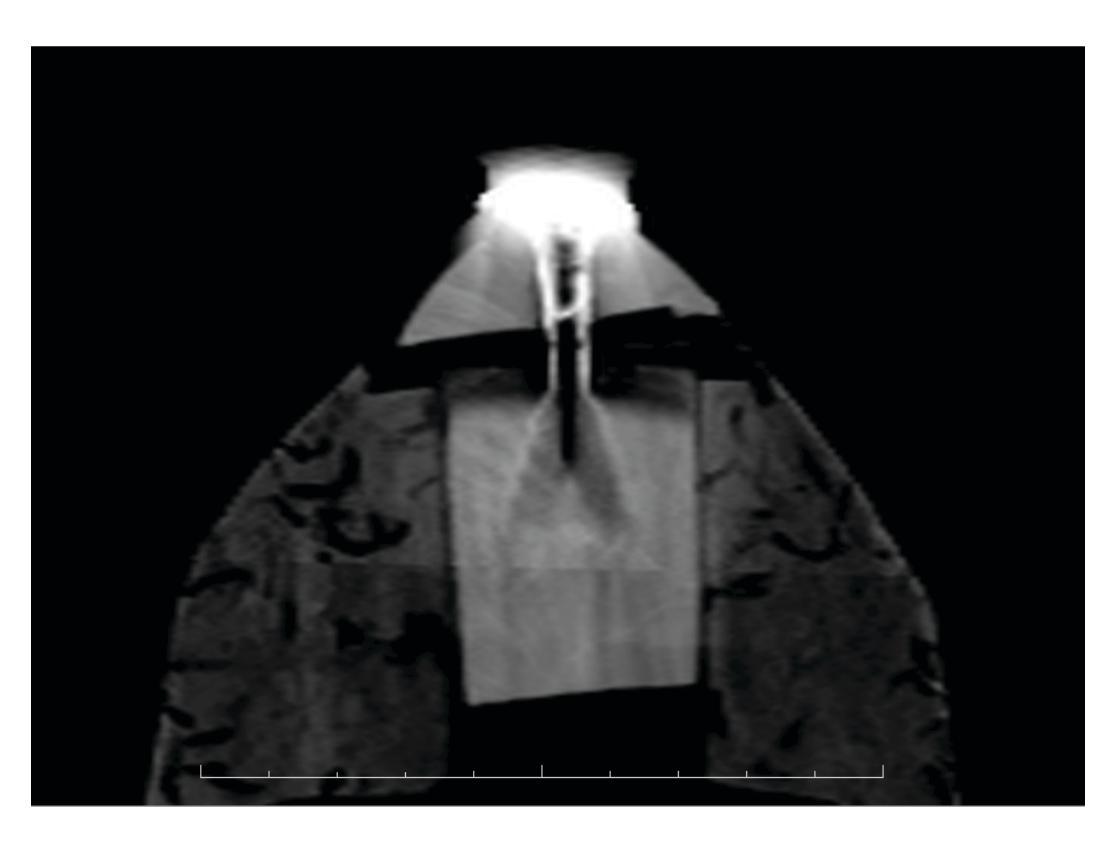
Figure 60.

A processed cross-section of the neck joint of the Queen Mary harp similar to that shown in figure 58. The scale is 1 tick = 1 cm. Tomogram obtained at the Clinical Research Imaging Centre, courtesy of the National Museums of Scotland. Minimum Intensity Projection, thick slab mode 6. 2D rendering by Karen Loomis.

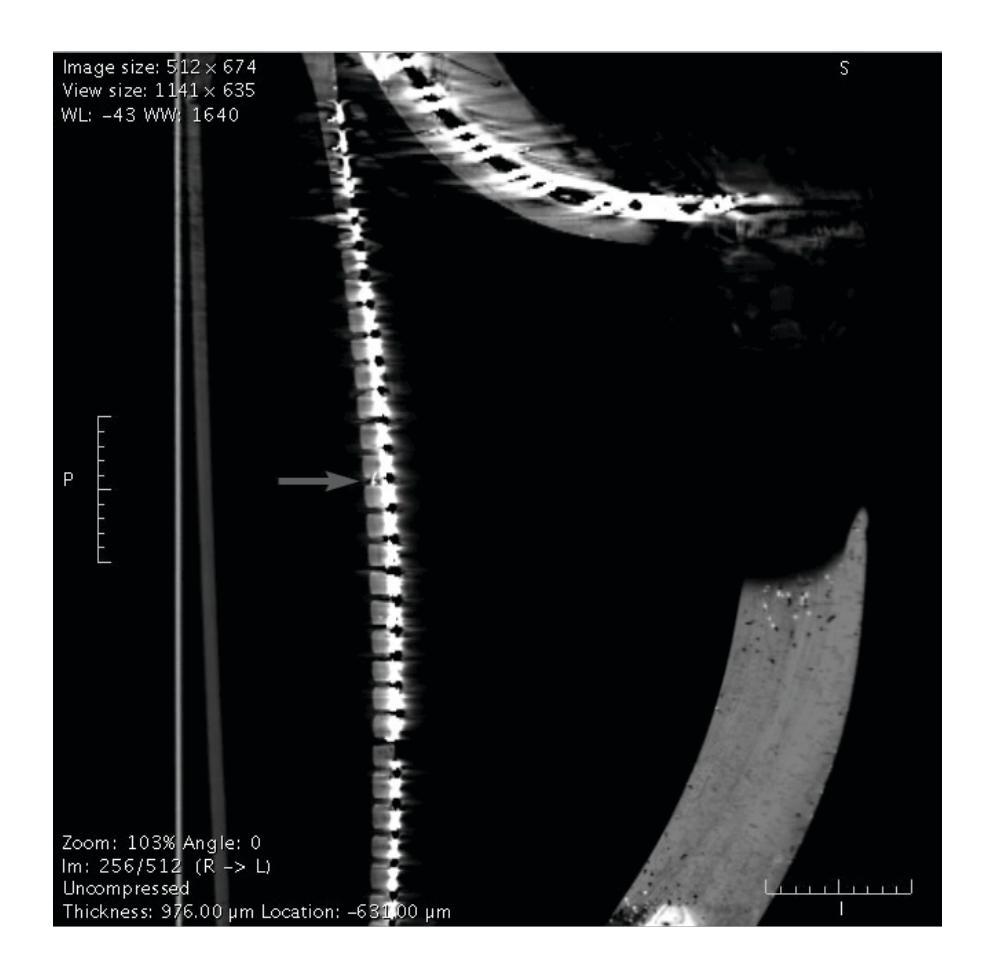
Figure 3.

The photograph in figure 1 only shows one end of the fragment, tomograms of the Lamont harp revealed the rest, hidden further up the string hole and, as it turns out, embedded in the wood. Figure 3 shows a sagittal (side view) cross-section of the harp through the string band in the soundbox, showing the string holes and the wire fragment, and figure 4 is a detail of this cross-sectional view, showing the wire fragment and the surrounding wood. Firstly, the appearance of the image of the fragment in the CT view shows that it has a high degree of opacity to x-rays, comparable to the known metal objects on the harp and much higher than the surrounding wood. This confirms that the object observed in the string hole, and visible in the photograph in figure 1, is metallic. The profile of it apparent in figures 3 and 4 suggests that it is a piece of wire.

Tomogram of the Lamont harp through the string band, showing the string holes. The white areas are metals, and the grey areas are wood. The metal areas on the string band are the string shoes nailed to the front of soundbox, through which the strings pass. The treble end of the harp is towards the top of the tomogram, and the inside of the soundbox is towards the left. A portion of the forepillar is visible in the lower right. The wire fragment (arrowed) is readily visible. The scale is 1 tick = 1 cm. Tomogram obtained at the Clinical Research Imaging Centre, courtesy of the National Museums of Scotland, 2D rendering by Karen Loomis.

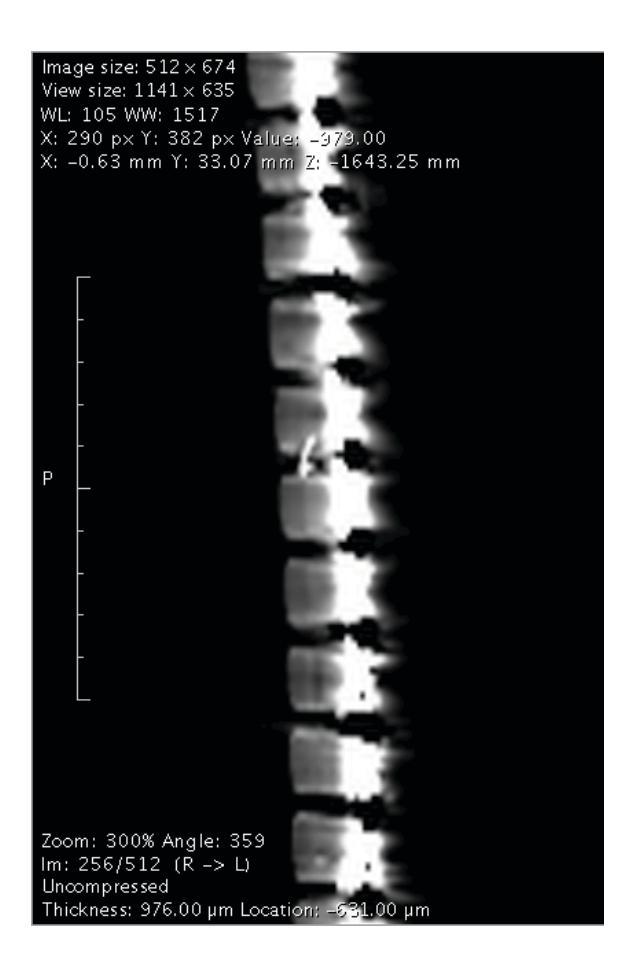
Figure 4.

Detail of CT cross-sectional view through the string band of the Lamont harp. The inside of the soundbox is towards the left side of the tomogram, and the treble end of the harp is towards the top. As in figure 5, grey areas are wood and white areas are metallic. The straight end of the wire fragment appears to be embedded in the wood. The scale is 1 tick = 1 cm. Tomogram obtained at the Clinical Research Imaging Centre, courtesy of the National Museums of Scotland, 2D rendering by Karen Loomis.

The tomogram in figure 4 shows that approximately 5 mm of the wire fragment is embedded in the wood surrounding the string hole, however it doesn't show the overall shape of the fragment. This is revealed in figure 5, which is a 3D reconstruction from tomograms of a cross section of the Lamont harp (see also the file wire_fragment_6.mov included with this document).

This information is crucial to any decision as to how, or whether, to remove the wire fragment for analysis. It would have to be removed without damaging the surrounding wood and ideally would be removed intact. Had the tomograms not been available, an attempt might have been made to pull the wire out in a manner that could have caused it to become more deeply lodged in the string hole or could have caused the embedded end to snap off. The soundbox wood of the Lamont harp is fragile and the string hole could also have been damaged. Forthcoming discussions with Museum conservation staff will include these tomograms and an informed decision will be made as to how to proceed with the wire fragment.

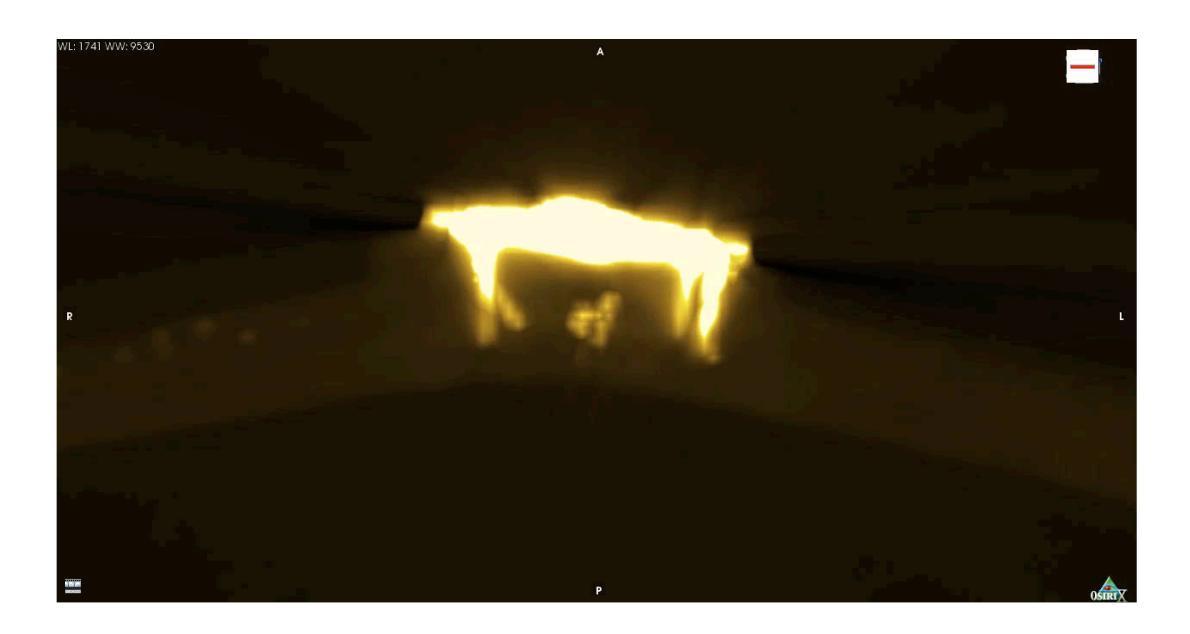
Figure 5.

3D rendering of tomograms of a cross section of the Lamont harp showing the wire fragment embedded in string hole #14. The front of the soundbox is towards the top of the tomogram. The inside of the soundbox is towards the bottom. The very white object just above center is the string shoe for hole #14. The wire fragment is visible as the smaller object "floating" between the nails of the string shoe. The video clip is available in the electronic form of this document and also as the file wire_fragment_06.mov on the disc accompanying the paper copy. Tomograms obtained at the Clinical Research Imaging Centre, courtesy of the National Museums of Scotland, 3D rendering by Karen Loomis.

Figure 5 shows that the end of the fragment that is not deeply embedded in the wood is bent downwards, towards the inside of the soundbox, and close examination of the coronal cross sections (parallel to the plane of the soundboard) shown in figure 6 suggests that the tip of this end may actually be embedded in the wood as well.

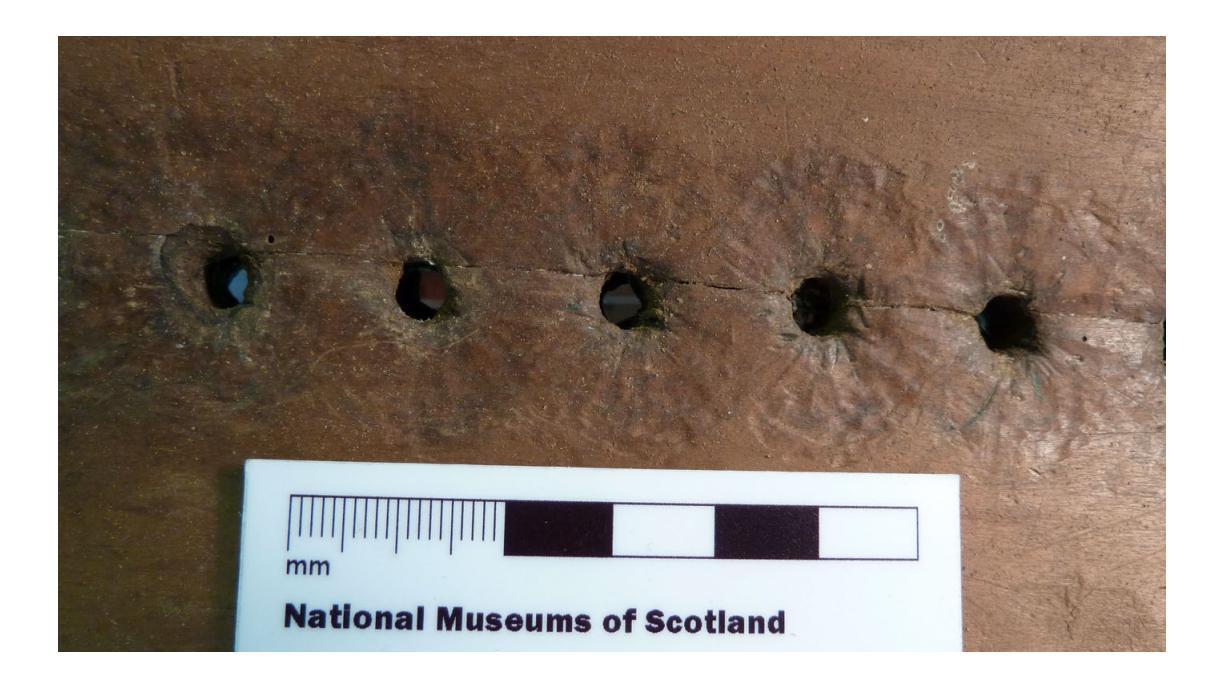
Figure 7.

describing restringing through a soundhole: "Through these holes the pegs attached to the strings were passed when new strings were required"⁷⁹ and Bunting (1840), in naming the parts of the Gaelic harp in use in the late 18th century, includes the "wooden pegs to which the strings are fastened."⁸⁰ The inside of the Lamont harp soundbox shows numerous impressions around the string holes that were very likely made by toggled strings. Figure 7 is a photograph of these impressions, which were first reported by Hobrough (1979)⁸¹ and will be discussed in depth in a future paper, but for the moment they serve as a strong indication that the strings were knotted or looped around a toggle which rested against the inside of the soundboard.

Toggle marks visible on the inside of the soundboard of the Lamont harp. The treble end of the harp is towards the right side of the photo. The wire fragment is in the second hole from the right. Photo: Karen Loomis, courtesy of the National Museums of Scotland.
